# IMCA Safety Flash 06/13

April 2013

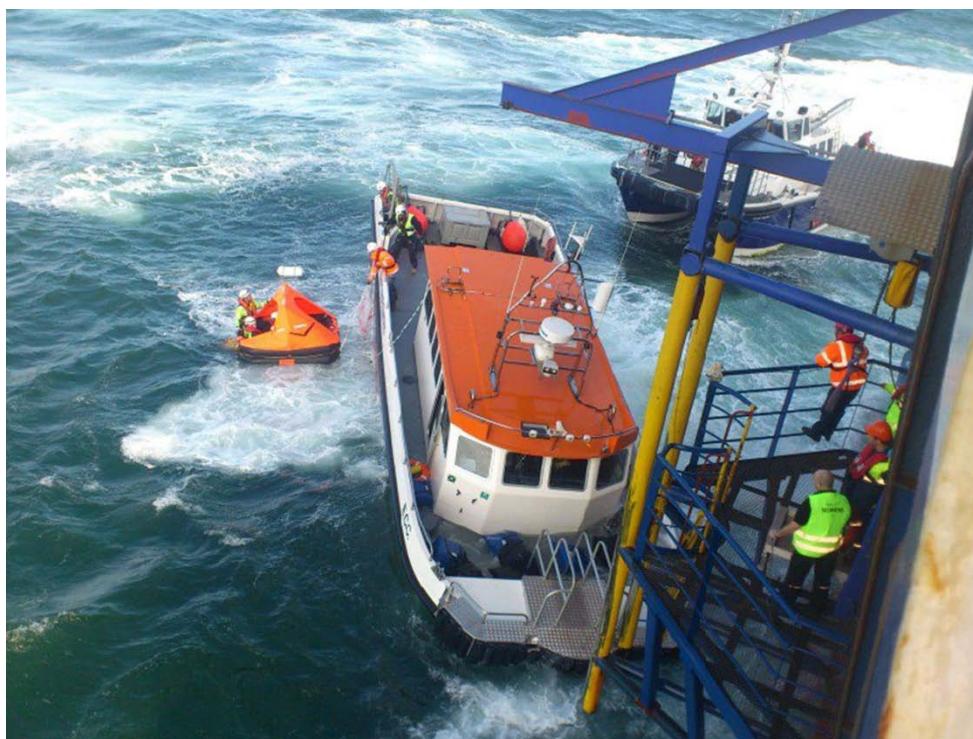
Figure: Crew transfer vessel shown trapped

During the investigation a number of immediate causes were noted, including:

- ◆ Defects or failures in design of equipment (the boat landing and the bow of the crew transfer vessel);
- ◆ Inadequate risk assessment or consideration of the deteriorating weather and sea state;
- ◆ Unexpected relative motion between the crew transfer vessel and the accommodation vessel;
- ◆ The trim and draft of the accommodation vessel.

- ◆ Inadequate structural integrity of the boat landing - inadequate design;
- ◆ Existing work procedures not adequate to the work in hand;

- ◆ The bow height of the crew transfer vessel;
- ◆ Inadequate communication.

- ◆ Repair, redesign and subsequent extension of boat landing system;
- ◆ Use of fall arrest equipment when transferring from crew transfer boat to accommodation vessel;
- ◆ Ensure life-rafts are properly attached to vessels;
- ◆ Development of more adequate procedures and detailed risk assessment for this method of crew transfer.

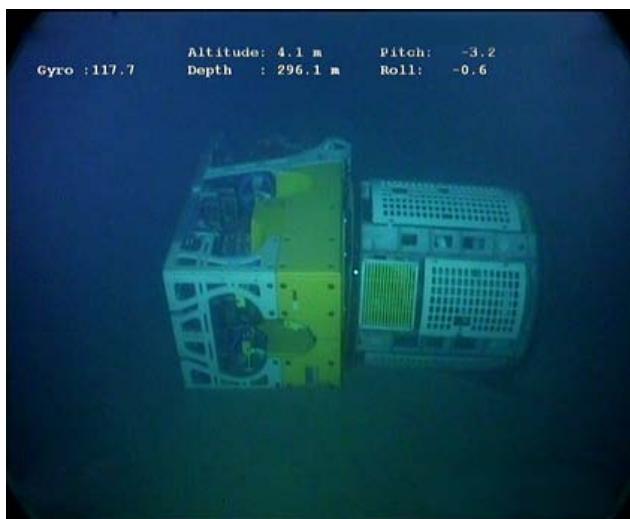
Another vessel was able to assist in the recovery of the ROV. The ROV was inspected on the seabed and based on that information and the sea conditions (3m significant wave height), a risk assessment and toolbox talk was carried out between the two vessels, and recovery was considered safe and possible. A soft sling was used and attached into the bullet. The sling was routed through the legs in the bullet, and doubled back. The TMS and ROV were then recovered to deck. After breaking the splash zone it was discovered that the “tools” were loosened from the manipulator. When landing on the seabed, the front of the ROV frame was on top of the “tools”. The crane driver held the ROV with 2 T tension while a tag line was attached to the “tools”. When lifting off again, approximately 1 metre, the soft sling snapped. The ROV frame collapsed from the weight of the TMS (2.9 tons). There were no injuries to personnel but the ROV, TMS and umbilical were damaged.

Figures: (Left) ROV on the seabed (Right) Parted umbilical

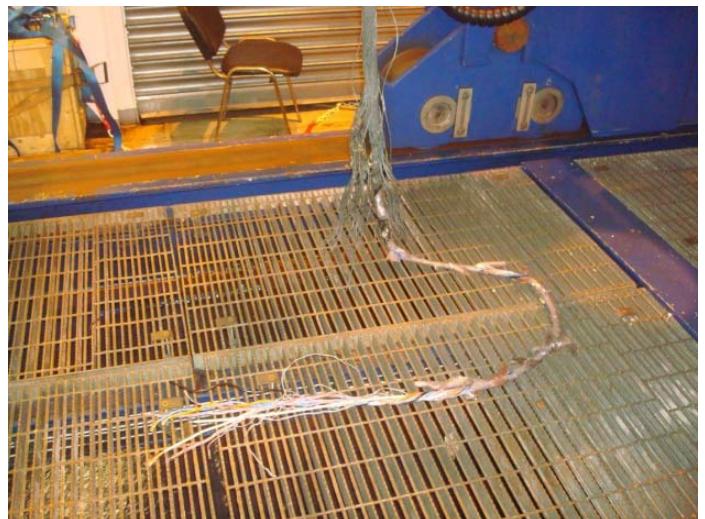
- ◆ Three main factors combined to cause the umbilical to fail;
- ◆ The overall effect of these factors was a failure to wedge the potting properly into the bullet;

- ♦ If one or more of the below factors had not occurred the break point would more likely to have been above the bullet;
- ♦ The factors were:
  1. The lack of seating was hindered by the rough internal surface of the bullet. The cast had not been seated properly in the socket cone, limiting the strength of the termination to the cohesion/friction between the steel wires and the cast;

2. The reported use of a booster pack, at temperatures higher than recommended, dramatically shortened the curing time, causing the wirelock to gel rapidly. It is not known whether or not this caused the insufficient filling at the bottom part of the socket, but considered as likely. The use of a booster pack at temperatures above 9°C is not in accordance with manufacturer's recommendations and is strongly advised against.

3. Un-axial loads were imposed on the termination occurred, which caused snagging. This was confirmed by several witnesses onboard. This is a result of the design of the bullet/socket allowing the bullet/socket to catch/stop when entering the docking head receptacle. Un-axial loads are likely to have been a contributory factor. It was reported by the crew that the socket occasionally got caught on the edge of the receptacle of the snubber. Normally such a scenario would be more likely to cause overload of the wires than snagging should the termination have been arranged correctly. If, as argued above, the socket was not properly seated or if sufficient filling was not achieved at the bottom of the cone, un-axial loading is likely to have instigated the failure. Un-axial loading is a possible explanation for the fact that the termination failed at a significantly lower load than the load test. Snagging may have broken the bonding between the cast and the steel wires and the wires could have worked themselves out of the cast over time until the length of wires remaining in the cast were insufficient to support the weight of the ROV and TMS.

- ◆ Umbilical re-termination procedures to be revised:
  - Prevent flat edge on the cone and use machine tools to prevent surface roughness inside the socket, all edges to be rounded and polished.
  - Use of a booster pack at temperatures above 9°C not in accordance with manufacturers recommendations and is strongly advised against.
- ◆ Emergency strop to be mounted on TMS systems;
- ◆ Bullet design to be approved and quality checked before use;

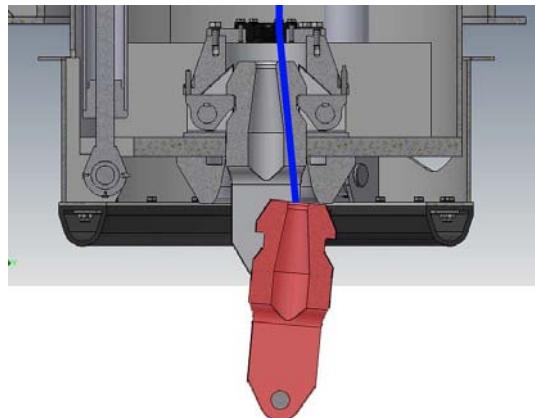
*Illustration of un-axial load on cable from edge of socket getting caught on snubber*

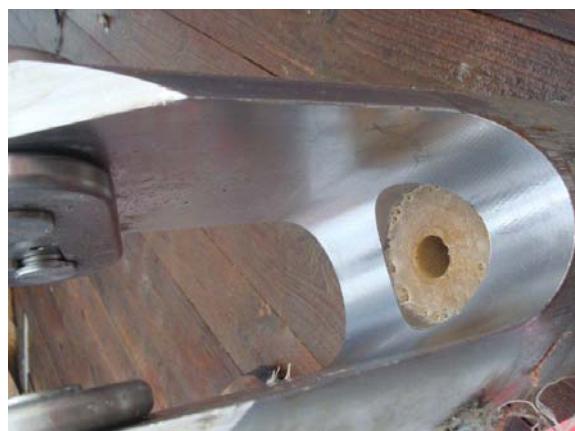
- ♦ Sharp edges on the bullet cut through the soft-sling and caused the ROV and TMS to drop to the deck during landing;
- ♦ The edge inside the bullet grade was sharp and not polished. An emergency recovery strop was not installed on the TMS.

*Figure: Showing sharp edges on bullet*

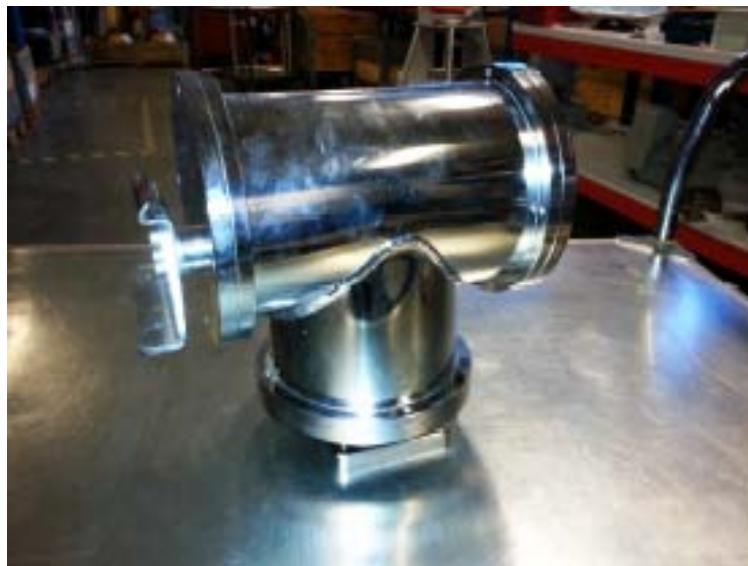
A member has reported an incident in which the mounting for a fixed camera gave way allowing the camera, weighing 25kg, to fall 4 metres. Electrical cable and a gland held it in place, preventing the camera from landing on the deck. This happened in an area where personnel could have been working. There were no injuries.

Figure: Camera of the sort that fell

- ◆ The equipment was so reliable that it had become part of the fixtures and therefore "invisible";
- ◆ Weak fastening / mounting;
- ◆ Securing wire not fit for purpose;
- ◆ Possibility of excessive vibration from nearby machinery;
- ◆ The camera had not been identified as a potential dropped object.

- ◆ Similar cameras are now secured with wire (safety sling);
- ◆ Recommended inspection routine advised based on physical and environmental circumstances.
