IMCA Safety Flash 06/15

May 2015

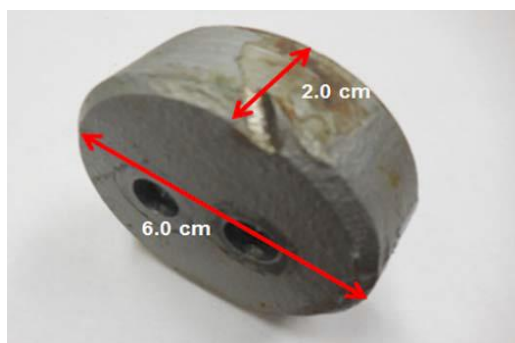
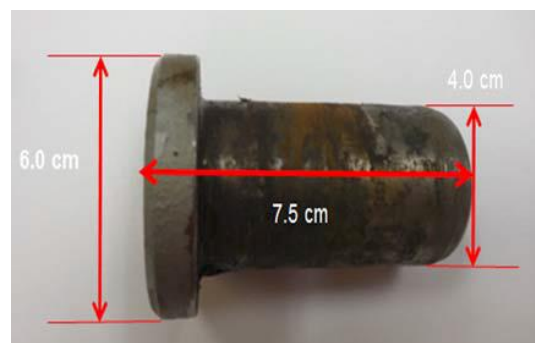
The objects which fell from the tower

- ◆ During the earlier reinstallation of the garage assembly, the securing bolts for the shaft end cap were installed without any means of thread locker (Loctite). This resulted in the bolts for one of the shaft end caps vibrating loose, resulting in the shaft being unrestrained and free to vibrate out along with the end cap;
- ◆ There was no written work instruction or method statement for the earlier corrective maintenance;
- ◆ There was no means of securing the end cap retaining bolts other than the torque of the bolt itself in the shaft;
- ◆ The drawings for the garage assembly and parts list did not reference the use of thread locker;
- ◆ The garage assembly was not listed on the vessel asset equipment register and therefore no maintenance was assigned to it.

- ◆ Use of secondary means of securing fasteners for all equipment, particularly at height;
- ◆ Checked security and integrity of remaining fasteners;
- ◆ Fasteners cleaned, torqued to the correct value, thread locked (Loctite) and wire moused;
- ◆ Equipment entered into the appropriate asset equipment register and planned maintenance scheduled;

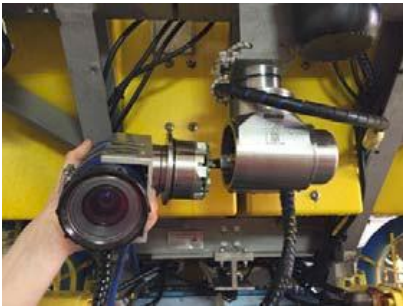
An explosion blew the single axis driver assembly (SADA) with the camera unit attached (approximately 5kg weight) away from the main rotator unit. The explosion resulted in the SADA with camera becoming separated (the 6 x 5mm grommet screws connecting the SADA to the camera pan and tilt main housing were sheared) and propelled at a high speed away from the pan and tilt main housing. Flames were noticed coming out of pan and tilt rotator unit and extinguished.

Close up of pan and tilt unit

Our member noted that the origin of the over-pressure that led to the explosion is still unknown and under investigation with the unit manufacturer.

- ◆ Never be in the line of fire;
- ◆ Maintenance/repair work on the pan and tilt units should be reduced to ALARP – as low as reasonably practical;
- ◆ Ensure there is a robust management of change process – ensure that there is proper risk assessment when the situation has changed, as in this case.

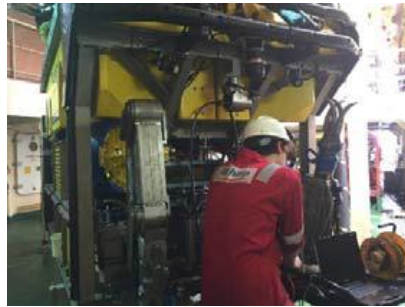
Broken pan and tilt unit shown in situ

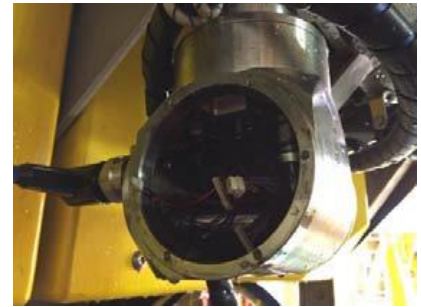
Close up of broken pan and tilt unit

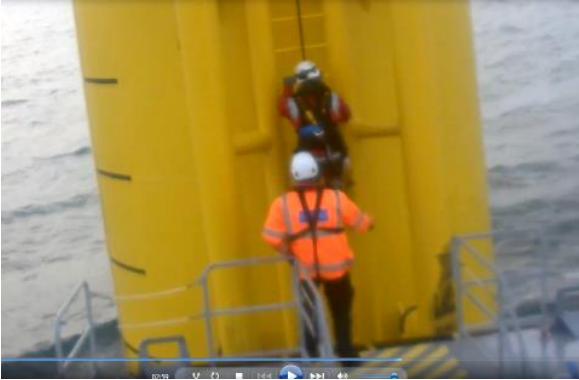
The vessel is pushed onto the boat landing centrally and transfer operations are underway

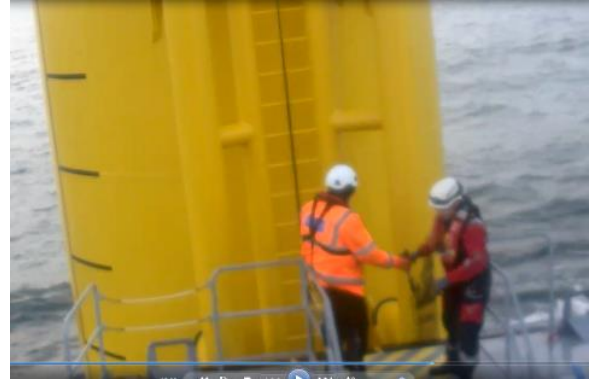
After craning operations finish and just after one of the technicians descends the ladder onto the vessel, the vessel slides a short way to starboard

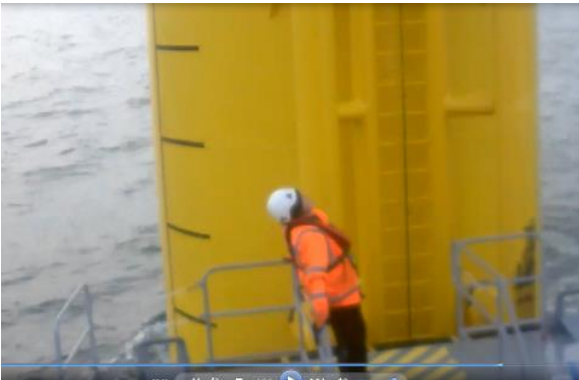
The crewman holds onto the handrail whilst the Master slowly repositions the vessel back into the boat landing; he shouts up to the technicians to STOP transfer until he tells them otherwise. Note: the vessel is now not centrally on the boat landing

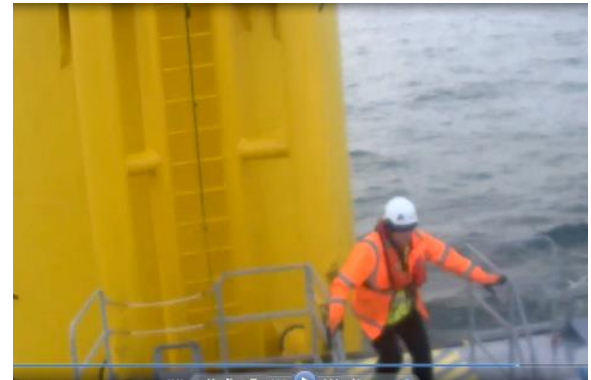
The vessel moves suddenly to starboard, the crewman evacuates the transfer platform

Our member noted that if the Master knew he was about to make a significant steering alteration he should have informed the crewman first to allow him to safely evacuate the transfer platform before the movement began.

Our member's recommendation was that if a crew transfer vessel moves significantly off centre of a boat landing, the Master should first instruct the crewman to remove himself from the transfer platform and tell him to order the technicians to STOP transfer and standby. Then the Master should pull the vessel away from the wind turbine and begin correct push-on again before recommencing transfer.

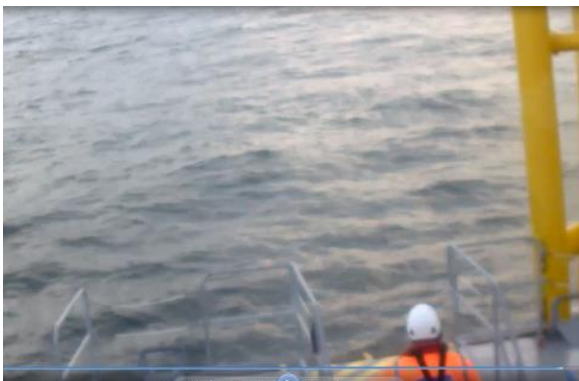
The vessel becomes unattached from the boat landing. The Master in interview said he was unable to reverse away from the monopile due to sea state/current; the photo shows the waves bow on

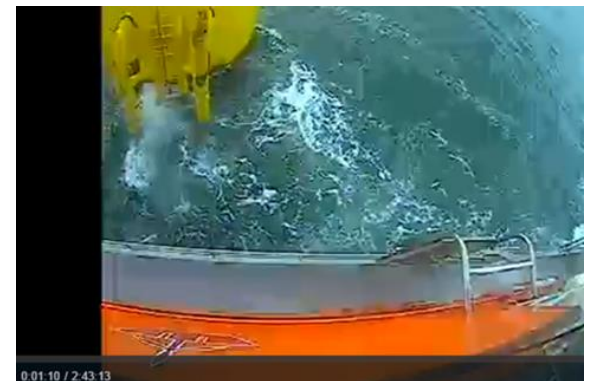
The vessel accelerates forwards in order to avoid contact with the monopile and manoeuvres into position to re-begin push-on. There were four technicians left on the monopile during this time

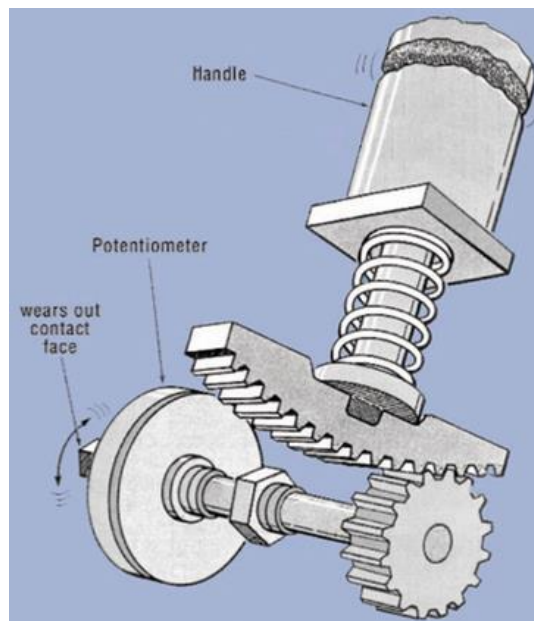
This incident is similar to incident 2 above. Within the previous week on another crew transfer vessel the Master noticed the vessel was not steering correctly when on passage to site. Suddenly the steering on both units would not centralise and was stuck hard to starboard, the jet display alarmed with fault code: **JS steer fault (joystick)**.

The Master, under advice over the phone from the superintendent, removed the joystick from the fly bridge steering console and replaced it with the faulty unit in the wheelhouse. All steering was regained. The faulty unit was sent back to the supplier, and under investigation it was found that the steering potentiometers had worn. Our member considered introducing planned maintenance/replacement of such units to prevent recurrence.

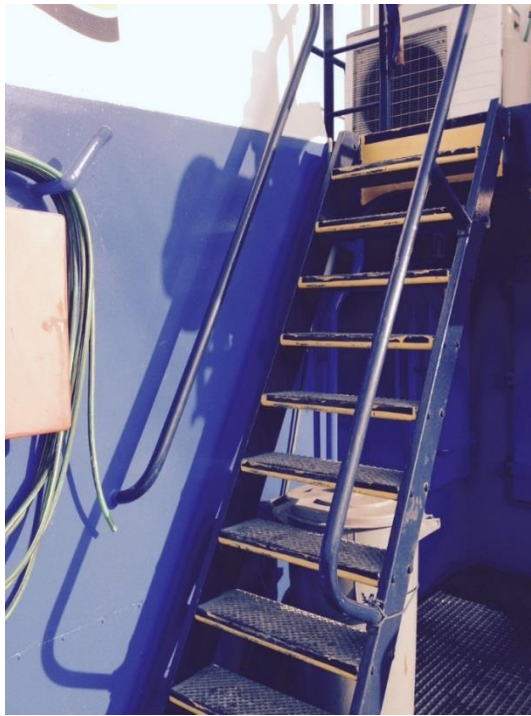
Showing steep staircase outside onboard vessel

- ◆ Conditions were wet at the time;
- ◆ Other than being wet, the steps were clean;
- ◆ The injured person fell without hitting any other steps on way down and took the full impact on his foot when he hit the deck;
- ◆ The injured person was descending facing away from steps;
- ◆ The design of the stair (approx. 40 degrees from vertical) meant that when descending in this manner, only the person's heel **COULD** be placed on the tread;
- ◆ Steep stairs were not identified as a hazard on this vessel;
- ◆ The injured person was wearing correctly fitted, laced/zippered work boots with good tread, and was not carrying anything at the time of the fall.

- ◆ Although risk assessments for the project covered all operational tasks they did not extend to cover descending stairways;
- ◆ No warnings signs were in place identifying the steep stairway or the need to use the hand rail.

- ◆ Individuals should always consider the safest method of descending stairs before doing so;
- ◆ Stairways to be kept clean, and where possible, non-slip treads/nosings fitted;
- ◆ 'Caution steep stairway use handrails' signage fitted;
- ◆ The fact that you have not been told how to descend the stairs does not remove the need for you to assess your own safety before descending, and decide how to descend the stairway;
- ◆ Ensure hazards not directly linked to operational tasks, are considered and addressed in the workplace, and included in vessel induction for all crew, client personnel and passengers;
- ◆ Ensure that work boots and all other PPE is fitted and worn correctly.
