# IMCA Safety Flash 06/19

April 2019

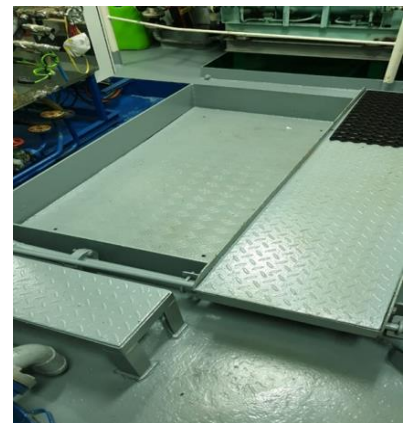
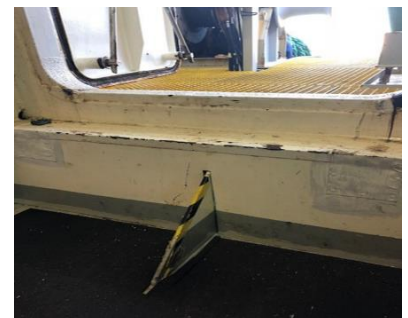
A member reports several trip hazards in vessel machinery spaces. On one occasion, a crew member entered the emergency generator room, stepped on an exposed support gusset, and twisted their left foot and ankle resulting in a lost time injury (LTI). On another occasion, a crew member on routine watch keeping duty tripped on an uneven surface in the upper bow thruster room, causing a medical treatment case (to the shoulder).

Uneven surfaces were the cause of both incidents. One was due to a redundant support gusset located on top of a step and the other because of multiple uneven walkways.

A fleet wide latent hazard hunt was conducted, focussed on all lessons learned. Many similar hazards were identified and rectified immediately and/or included in maintenance schedules including an MoC process.

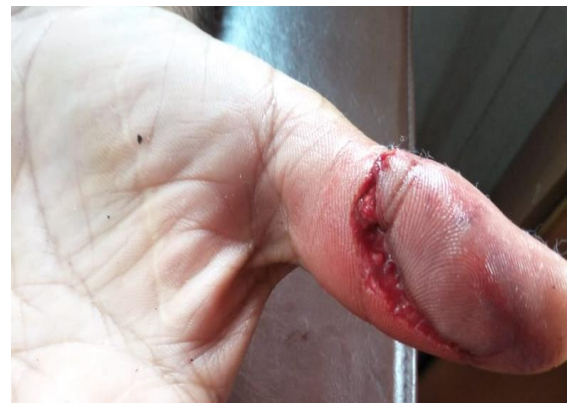
Four crewmen made a journey by small boat to inspect an SPM and floating hoses. After completion of the inspection and maintenance work, two of them were closing the SPM hatch, but were informed by the control room that the door was not sealing properly. The hatch was repeatedly opened and closed without achieving the required seal. On further inspection, it was noticed that a hatch locking part was misaligned. This was corrected, and the hatch was closed. The moment the hatch stopper was removed, the hatch door swung inside towards one of the workers, and as he tried to move away from the path of the hatch he slipped, causing his left thumb to be pinched between the hatch and bulkhead.

- ◆ The worker slipped on a slippery/wet uneven surface;

- ◆ The hatch would not lock properly because the locking mechanism was mis aligned;
- ◆ Hatch door on the SPM was not secured by rope in the open position.

- ◆ Added names of local land hospital on Emergency Response Plan and list of Emergency Contacts;
- ◆ Means to secure the hatch when open were added to the Hazard Identification and Risk Assessment Register.

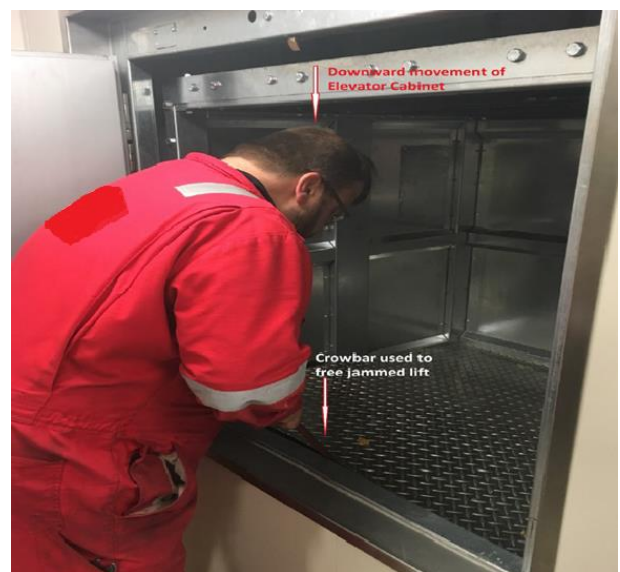
The vessel provisions lift was loaded with items to be stored onboard when one of the crew identified that the lift had become stuck. This was due to packaging from some of the food items fouling the lift shaft. The chief engineer asked for the pry bar to see if he could clear it. He then struck the jammed object (food packaging) with the pry bar and at this point the elevator dropped suddenly to the main deck. The crew member was struck in the back of his head by the front horizontal cabinet bar after it had dropped from the jammed position. It is estimated that the elevator cabinet fell about 15-20 cm before it made contact with his head.

The provisions elevator dropped in an uncontrolled manner;

- ◆ The elevator lifting chains were in a slack position and not supporting the weight of the elevator cabinet due to the packaging being stuck. When the food packaging jam was removed, it allowed the provision elevator to drop in an uncontrolled manner;
- ◆ The Chief Engineers body position was in the line of fire. When using the crow bar, he lent forward, and his head was then inside the elevator cabinet.

- ◆ Manufacturers' quality control – deficiencies in the quality control and document control process;
- ◆ Oversight during commissioning – inadequate oversight during commissioning;
- ◆ There was inadequate risk perception: formal work planning tools were not in place (permit to work (PTW), risk assessment).

- ◆ The incident may have been avoided had the formal work planning tools (i.e. PTW, risk assessment, tool box talk (TBT)) been in use when the problem with the jammed provision elevator occurred;
- ◆ It was also identified after further investigation that the manufacturer's approved electrical drawings had a design flaw allowing some safety interlocks to be electrically bypassed.

- ◆ Provisions elevator removed from service until issues identified have been addressed and repaired by manufacturer;
- ◆ New risk assessment developed to cover any work required on the elevator;
- ◆ Vessel training sessions developed and will be conducted with onboard management. Onboard management will then present these topics (i.e. risk management process, life-saving rules, to their teams at safety meetings.
