I Exhaust Valve Cage Assembly Blow-Out

Keywords: Near Miss

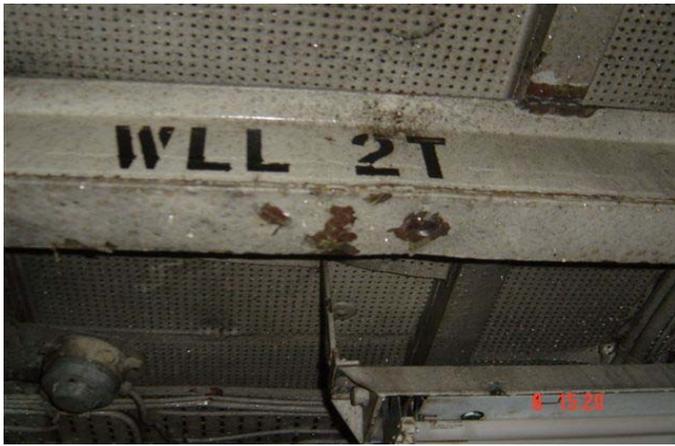
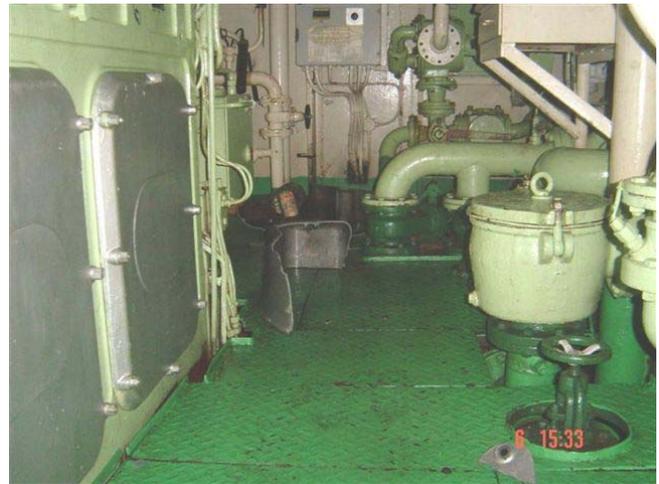
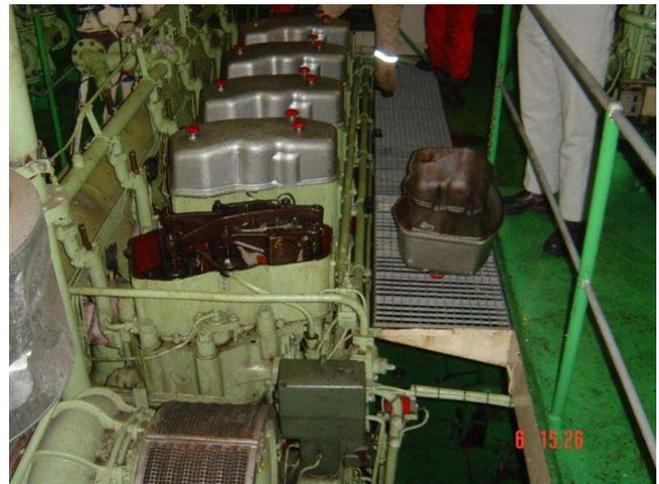
- ◆ the exhaust valve cage assembly was blown out of the cylinder head, shearing one holding-down stud and stripping the thread out of the nut of the second holding-down stud;
- ◆ the rocker arm assembly was damaged beyond repair;
- ◆ the rocker cover was destroyed;
- ◆ the rocker gear bridge piece casting had a section of the holding-down base broken off and was beyond repair;
- ◆ the lifting beam gantry above the main engine had a significant dent;
- ◆ the alarm light and fluorescent light above the main engine were destroyed.

The company's subsequent investigation established that the incident could be directly attributed to sea water entering the combustion space of the unit via the scavenge air system, hydraulically locking the engine cylinder, due to the failure of a sea water cooling tube on the charge air cooler, the failure of the scavenge air/water drains and the failure to check the drains' condition during normal watchkeeping rounds.

The exact time of the failure of the sea water cooling could not be ascertained, but it is believed that it could have been leaking over a period of time. The company is of the opinion that a slug of water had been trapped behind the built-up sludge at the charge air cooler. This slug of water/sludge travelled along the charge air manifold, blocking the drain cocks and entered the cylinder.

- ◆ Location of impact above cylinder;
- ◆ Rocker cover fragments;
- ◆ Position of engineer when incident happened

- ◆ removal of current scavenge air drain cocks and replacement with ball valves with a bigger bore;
- ◆ fitting of drain cock clearing devices at each drain cock;
- ◆ further development of previous engine room rounds check sheet to provide regular and accurate inspection of plant and equipment against specific performance criteria;
- ◆ more thorough checking during watchkeeping rounds in accordance with engine room practice.
