IMCA Safety Flash 07/07

August 2007

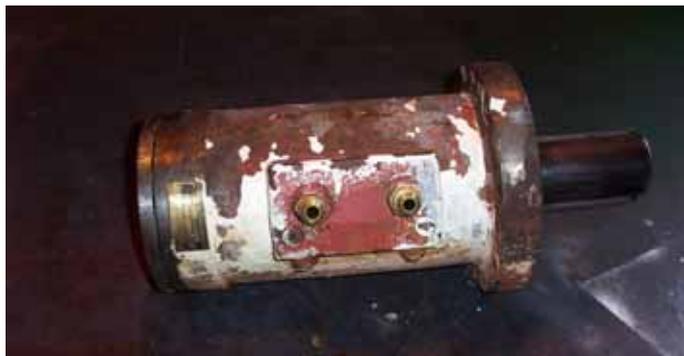
Failed actuator

Upon further investigation it transpired that the heliox gas mix had managed to migrate past the seals inside the rotary actuator and had pushed the hydraulic fluid out of the hydraulic lines, losing hydraulic control of opening and closing the door.

The actuator was removed from the chamber and stripped down completely. All the seals inside the actuator were found to be completely perished inside.

This particular actuator had never been removed, stripped and seals checked for over ten years due to the inaccessibility of the unit and being hidden under deck plating.

Members are reminded of the importance of identifying critical components and the subsequent inclusion of these components into the planned maintenance systems.

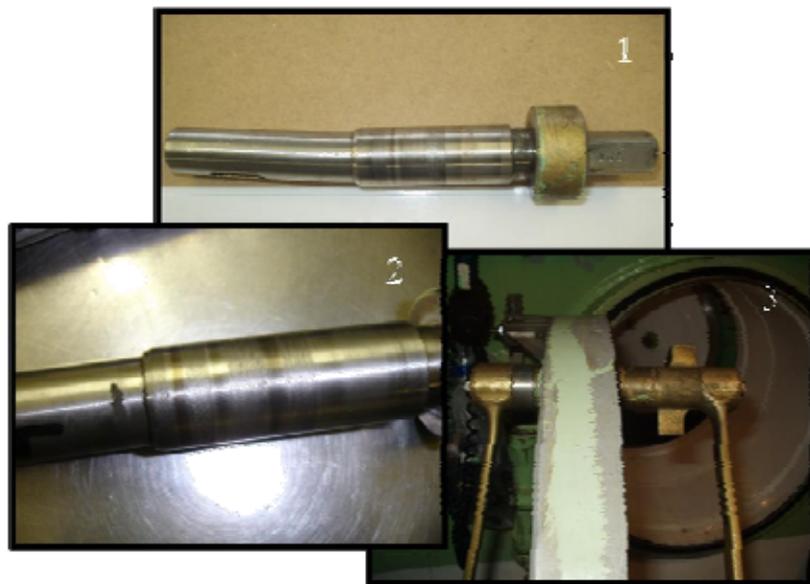
Both leaks were identified as being at the seals in the door spindle shafts that passed through the chamber doors to enable the retaining 'dogs' to be operated from both sides of the chamber door. The two leakages prompted an inspection of all the door spindles in the system, identifying the following:

- ◆ There was no history available on the spindles or seals, as they were not part of the planned maintenance system.
- ◆ Almost 70% of the door spindles were found to be unserviceable due to surface damage in the sealing area or bending of the shafts and required replacement.

1. Shaft damage. 2. Shaft surface damage. 3. Door spindles in place in chamber door.

- ◆ The door spindles and associated seals should be identified as critical components.
- ◆ Inspection and replacement of the door spindles and seals should be included in the planned maintenance system.

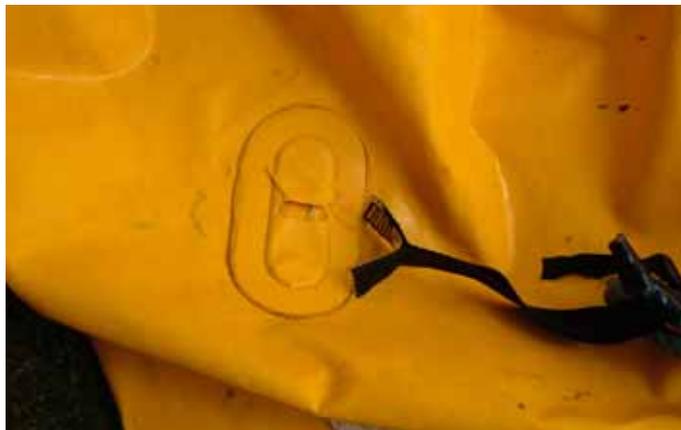
The inverter line was attached to one of the handling loops on the top of the bag. When the lift bag was required to be deflated, the bag dump valve was unable to be operated, leaving the lift bag inflated. The decision was taken to cut the rigging attaching the bag to the load in an attempt to invert the bag using the inverter line. When the rigging was cut, the inverter line came under tension and the attachment point (handling loop) on top of the bag failed. This allowed the lift bag to freely ascend to the surface.

Handling loop attachment point failure

- ◆ Some lower capacity lifting bags in use do not have a dedicated inverter line attachment point.
- ◆ Many lift bags in use have webbing loops and handles which are intended to assist with manual handling and may not be suitable for use as attachment points for lines and rigging.
- ◆ Some lift bags that do have dedicated fit-for-purpose inverter line attachment points may not be clearly marked as such.

Members are reminded of the importance of identifying the inverter line attachment point on lift bags and that this point is certified fit for purpose and clearly identified as such.
