IMCA Safety Flash 07/08

April 2008

I Fatal Accident in Connection with the Operation of an A-frame based Launch and Recovery System (LARS) used for ROV Operations

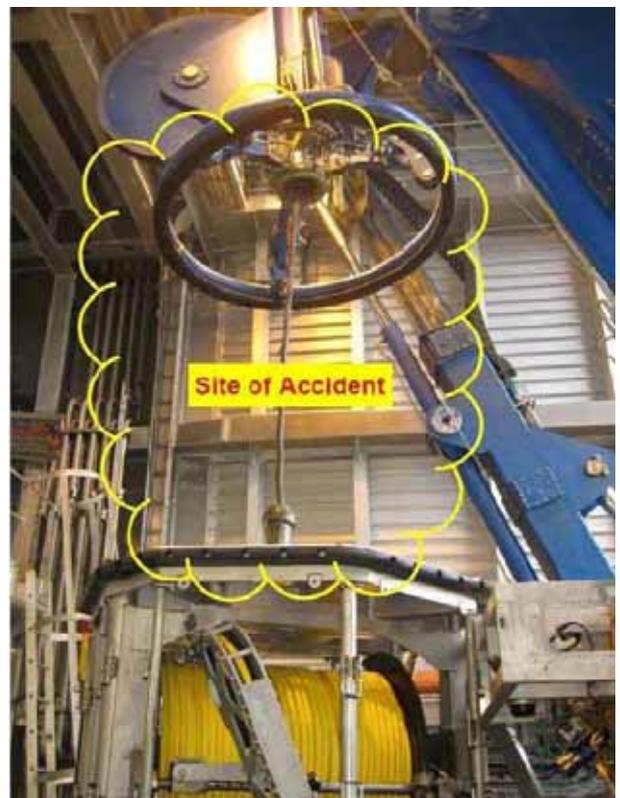
Prior to the incident, the ROV had been separated from the TMS and both units were resting on the base platform in the hangar, with the TMS located just underneath the docking head which was situated 2.5m above the top of the TMS. The ROV was located adjacent to the TMS towards the port side of the hangar.

A total power black out occurred onboard the vessel due to lack of cooling water supply to the auxiliary engines. At this time the TMS unit made a sudden and significant vertical upward movement (of approximately 2.5m) until it was stopped by the docking head overhead. The ROV senior supervisor was standing on top of the TMS with the aim of assisting with the pull-out of the umbilical. He was thus trapped between the TMS and the docking head and subjected to a massive force of 13.7 tonnes, resulting in his death.

The accident occurred at the same time as the power black out. The ROV winch spooled in the umbilical instantly and in an uncontrolled manner, lifting the TMS module vertically up towards the docking head, causing the fatality.

The ROV supervisor was standing on top of the TMS with the aim of assisting the pull-out of the umbilical of which about 5m had been slacked off when the incident occurred. He was trapped and his body subjected to a massive force of 13.7 tonnes between the TMS and the docking head.
