IMCA Safety Flash 07/09

June 2009

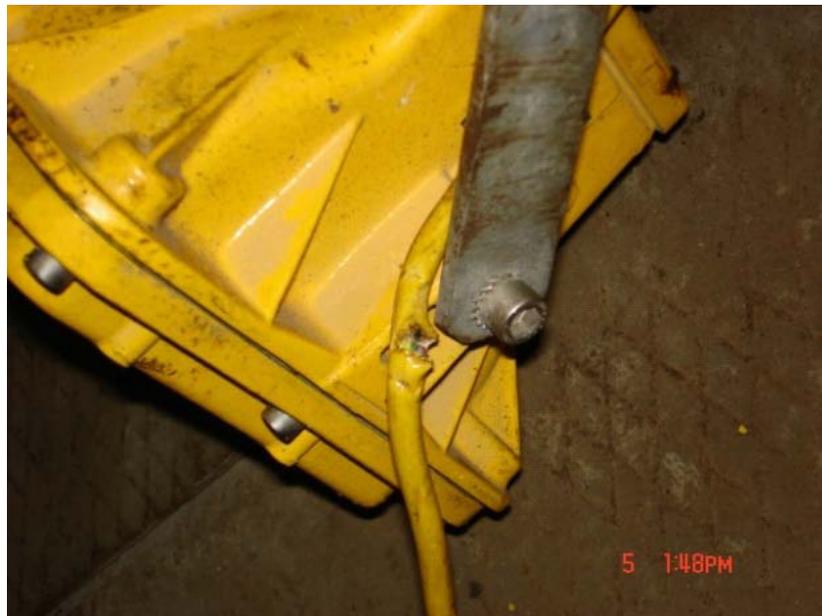
IMCA has learnt of a fatal incident in which a person was electrocuted. A rig sub-contractor suffered fatal injuries from electrical shock whilst performing a welding operation. A lamp used to illuminate the worksite was found to be a potential source of electrical shock as the lamp's electrical cord was found to have been damaged. The damage may have been caused by a pinching action of the cord between the loose mounting bracket of the light and the light housing which was observed to be in contact with the victim's body.

Damaged electrical cord

- ◆ A ground fault circuit interrupter (GFCI) was not utilised and the circuit breaker did not trip when the incident occurred;
- ◆ The lamp used was designed for permanent exterior mounting and had been modified for use as an interior portable illumination source;
- ◆ Sub-contractor personnel had not been effectively supervised;
- ◆ An effective pre-job (pre-start) safety discussion had not taken place;
- ◆ The approved job safety analysis (JSA) overlooked the potential for electric shock hazards and for cord damage and did not address the actual work that was performed;
- ◆ Confined space entry was not considered or included in permits;
- ◆ The hot work permit review process was not effective.

- ◆ When using portable electric tools in potentially damp areas, a GFCI (fixed or portable) should be utilised to protect personnel from potential electrical shock;

- ◆ All tools and equipment should only be used for their intended and manufacturer's recommended purpose; any change to a tool or equipment's intended purpose should be thoroughly reviewed and approved through an effective management of change (MoC) process;

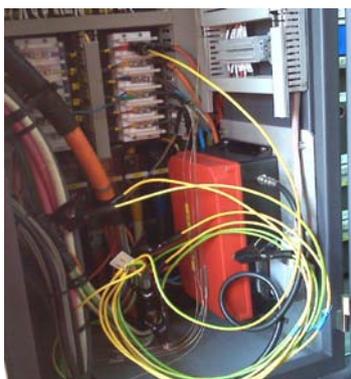
High voltage (HV) junction box with earthing equipment attached

- ◆ A toolbox talk was carried out where the operation and safety aspects were discussed;
- ◆ The immediate cause of the electric shock was the ROV technician coming into contact with a conductor at the end of the ROV tether;
- ◆ This conductor, whilst isolated from a direct power source, was identified as having an induced voltage present. The voltage was induced in the main lift umbilical on the deck winch;

- ◆ One of the functions of the earthing equipment was to tie conductors to earth and eliminate any induced voltage that may be present. On this occasion, two of the clips of the earthing equipment had become dislodged. The 'crocodile' clip arrangement was found not to be a secure method of attaching such a safety critical device;
- ◆ Some of the persons involved with this earthing equipment had not fully understood the criticality of the equipment, particularly in the case of high voltage (3000V) and a long umbilical (3300m). Nevertheless, this equipment was correctly used and all appropriate procedures were followed;
- ◆ Personnel needed to be more aware of induced voltages and their potential to be fatal. The umbilical manufacturer confirmed that the induced voltage found in this tether was potentially fatal rather than superficial as some of the persons involved had thought.

- ◆ Improve design of earthing equipment in such a way as to remove the possibility of inadvertent disconnection;
- ◆ Follow up with the manufacturer to include start up, induced voltage and isolation in training course material;
- ◆ Ensure all personnel working on work class ROV systems have completed HV training courses;

Ensure signage is posted at all high voltage junction boxes warning of HV dangers and necessity to use appropriate earthing equipment.

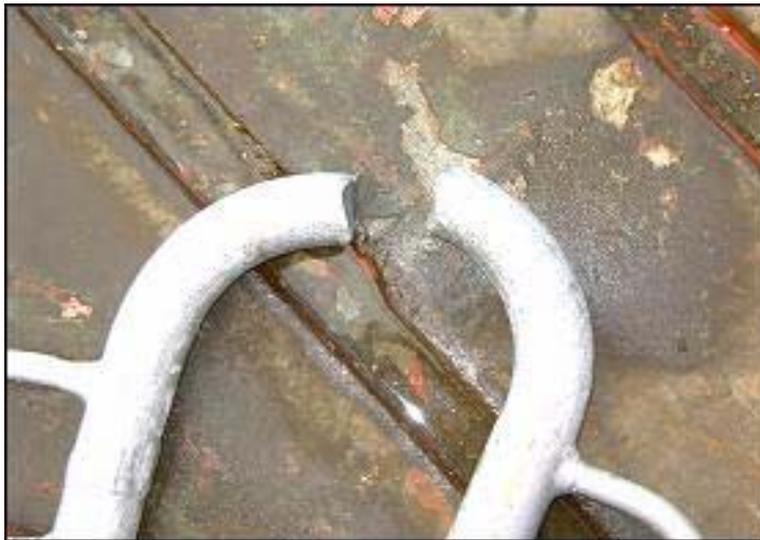
A recent incident in offshore operations highlighted some actions related to lifeboat/Fast Rescue Craft (FRC) maintenance that should be taken immediately. During the incident, the lifeboat fall D-ring failed while load testing the lifeboat and wire fall assembly. It was found that the failed D-ring was non-OEM (Original Equipment Manufacturer) and was of welded construction rather than the forged construction originally supplied by the OEM.

- 1) Only use OEM equipment on new and existing lifeboat/FRC and lifeboat/FRC fall assemblies, except when changes have been subject to the appropriate MOC and approved by the relevant Marine Authority; and
- 2) Conduct all load testing, maintenance and inspection of lifeboat/FRC and lifeboat/FRC fall assemblies using detailed procedures that have been subject to a risk assessment and approved by the relevant Marine Authority.
