IMCA Safety Flash 07/10

November 2010

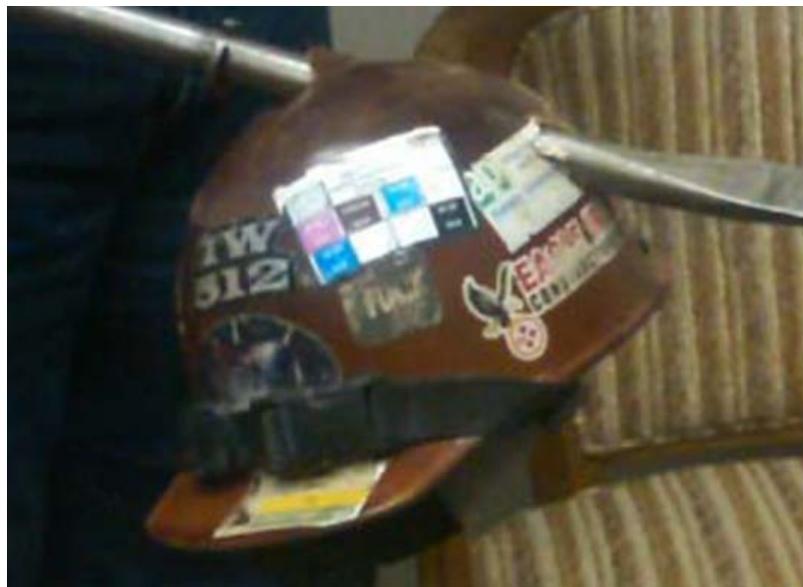
As the worker was manoeuvring the basket of the aerial lift, and properly tied off, his safety lanyard got caught on his tools (attached to his tool belt) and flipped a sleeve bar sideways in its sheath causing the bar to flip out and fall. The bar fell and struck the hard hat of the worker piercing the hard hat. The hard hat fell off the worker and fell an additional distance to the ground below. There were no injuries.

Figure 1 - hard hat destroyed by falling sleeve bar

- ◆ Only tools essential to complete assigned tasks should be carried in tool belts;
- ◆ More appropriate tool belts and holders should be developed to prevent tools falling from height;
- ◆ Persons should not work directly below areas where work at height is being conducted;
- ◆ Emphasis to employees of the importance of full communications and heightened safety awareness when working in areas where overhead fall object hazards exist.

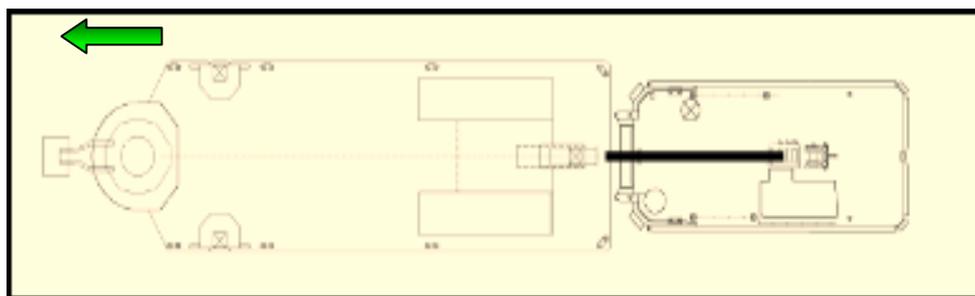
At the project worksite, one vessel was being manoeuvred towards the appointed workplace using a mooring line and winch. Rigging was slackened by the winch on one vessel; then the angle between the two vessels increased, which caused an increase in tension. At that moment the chain snapped at the pad-eye connection on one vessel, and a deckhand was hit by the chain and mooring rope as it swung across the deck causing fatal injuries.

Figure 1 - vessels move towards appointed workplace

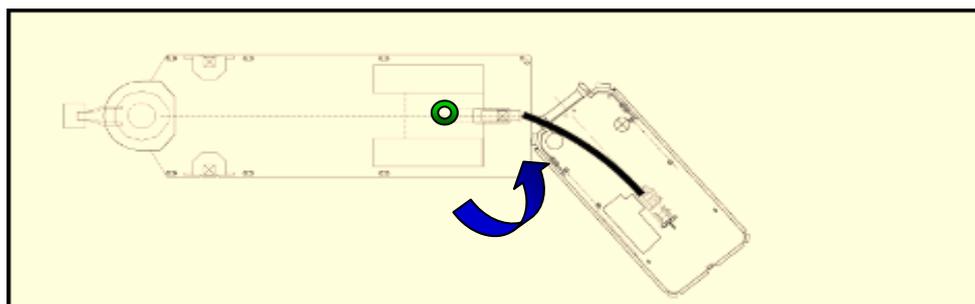
Figure 2 - Position of crewman in line of fire (green circle)

- ◆ The deckhand moved into 'in the line of fire' in the path of the breaking chain;
- ◆ The breaking strain of the equipment used was underestimated in relation to the work being undertaken;
- ◆ Limited communication and poor sight lines between vessel masters, winch operator and deckhand were a factor.

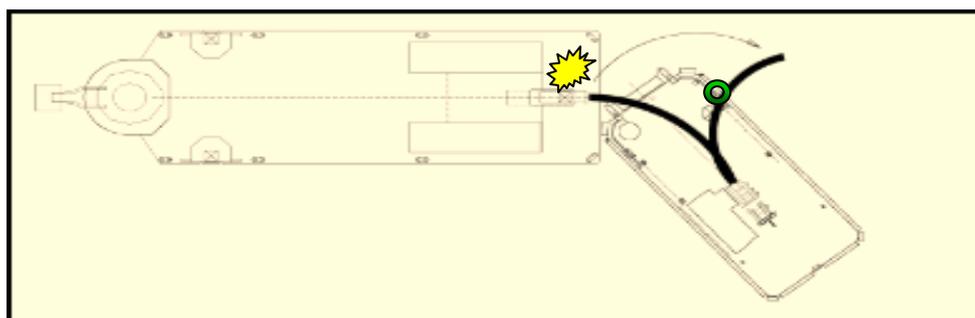
Figure 3 - Path of chain after failure under tension

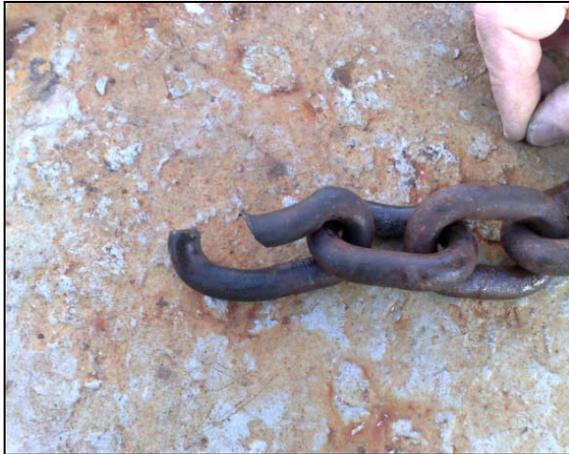
Figure 4 - Snapped chain

- ◆ Thorough revision of company procedures and risk assessments for this task, including types of connection, winches and towing equipment, and communications;
- ◆ Ensure all persons involved are involved in toolbox talks before this task;
- ◆ Check certification and fitness for use of all lifting and towing equipment (bollards, 'bridle' connection, wires, ropes);
- ◆ Establish clear communication (radio, signals and visibility) between the master of the towing/pushing vessel, the crane or winch operator and any personnel on deck.

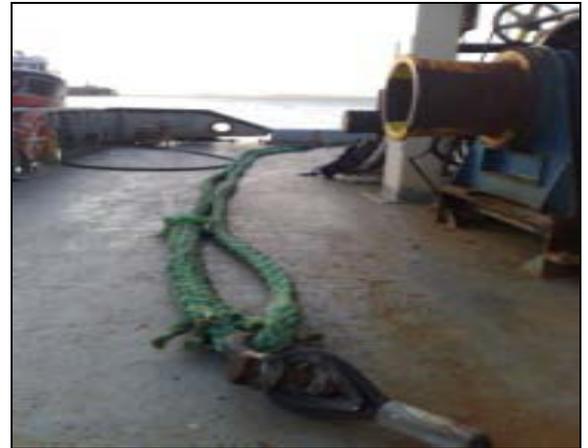
Figure 5 - Mooring rope similar to that used in the operation

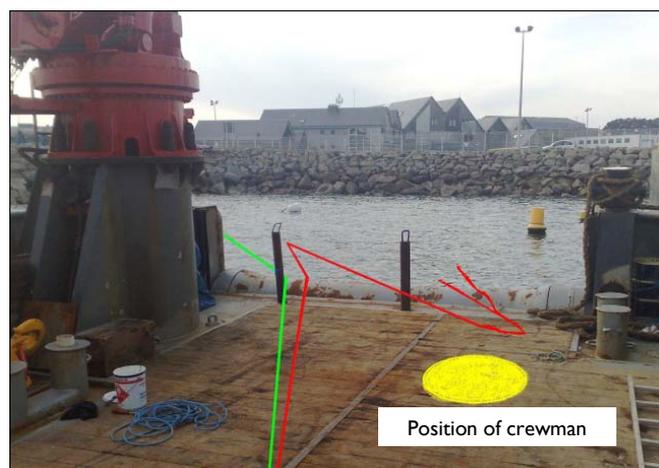
Figure 6 - Scene of incident (green line indicates towing line, red line indicates snapped towing line)

Perhaps the most important point highlighted by our member is that crew should take great care in their movements on deck in relation to possible danger from equipment failure, particularly with regard to ropes, towing and rigging equipment.

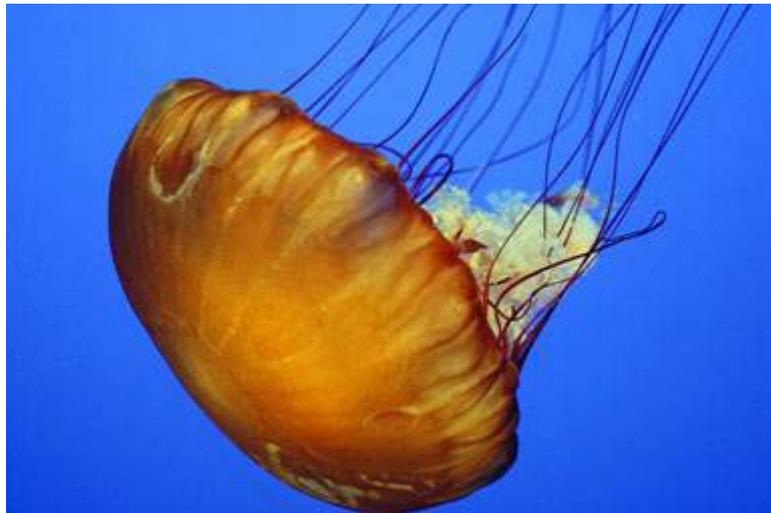
On contacting jellyfish, there is a tendency for particles of tentacles to become attached to the diver's suit. If these particles are not removed during the cleaning process, 'dust' remains on the surface of the suit during the drying process and can become airborne when returned to the diving chamber. Some divers may be allergic to this and suffer ill-effects.

Figure 1 - Jellyfish

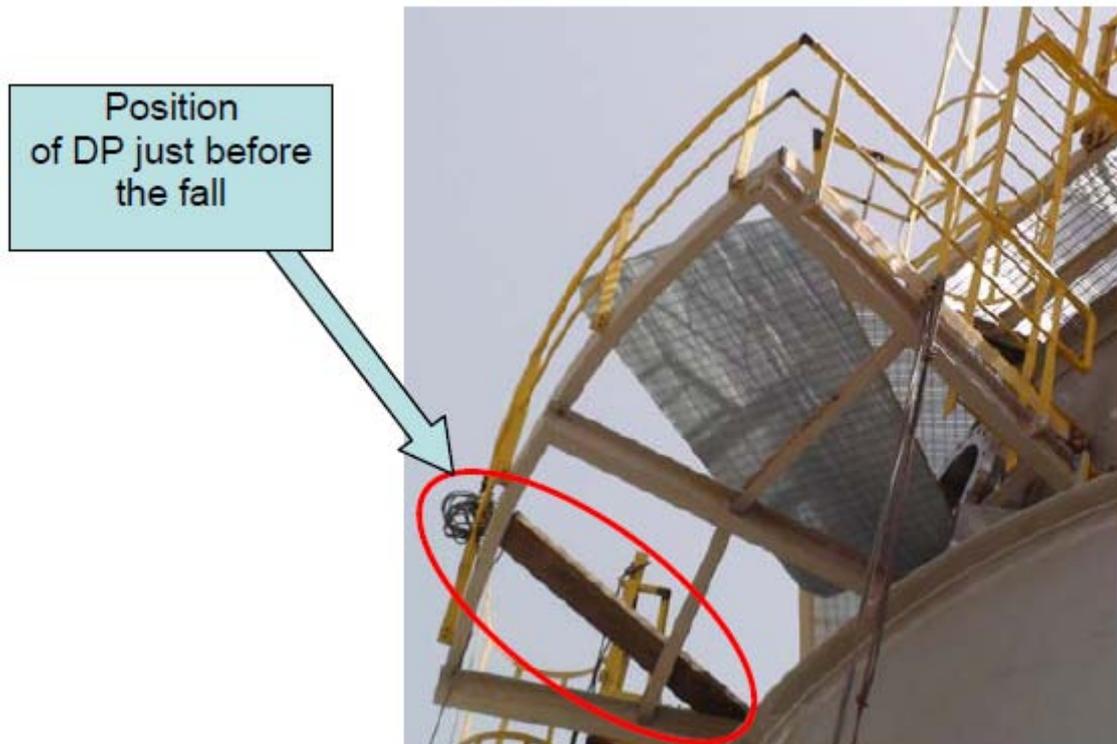
A member has reported an incident in which a worker was killed, falling 19 meters from a column walkway. The person was a fitter putting in place a final piece of grating on an overhead walkway (see Figure 1 below). The worker was standing on a platform made from two planks. As the worker was moving the grating, one plank fell down causing the worker to swing, lose his balance and fall to his death.

Figure 1 - Location from which worker fell

- ◆ When working at height with fall exposure, 100% fall protection should be required;
- ◆ Personnel working at height should be properly trained to use fall protection devices;
- ◆ Personnel working at height should wear full body harnesses fitted with lanyards;
- ◆ Fall arrest equipment should be carefully inspected before and after each use;
- ◆ Temporary platforms should be properly secured;
- ◆ Platforms and walkways shall be kept free from obstacles such as materials, equipment, tools and rubbish, etc., which might fall or obstruct safe working activities.
