IMCA Safety Flash 07/11

July 2011

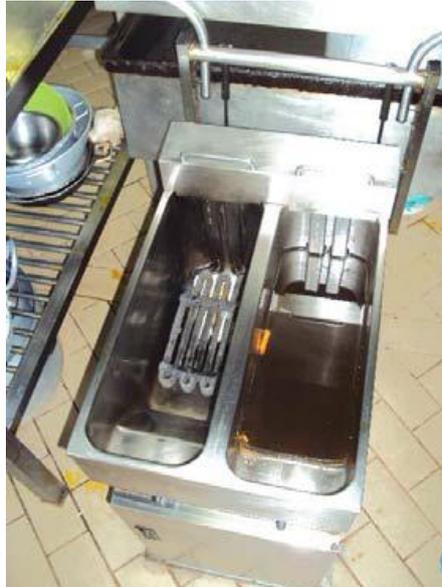
A member has reported an incident in which a fire occurred during routine cleaning and operation of a twin vat deep fat fryer onboard a vessel. The night shift galley team were given the task of cleaning a twin vat deep fat fryer. This task was carried out by them, however on completion only one of the twin vats was refilled with oil. This fact was not communicated to the day shift galley team. The day shift team were required to use the fryer shortly after starting work, and it was switched on by one of the stewards without any pre-start checks being carried out. Shortly after the fryer was switched on a small fire started in the left-hand (empty) vat, which was quickly extinguished by the cook. There were no injuries and little damage occurred.

Galley deep fat fryer

- ◆ No procedure existed detailing that the fryer should be refilled after cleaning;
- ◆ The risk assessment did not identify the risk of fire if the unit was switched on without oil being at the required level in the vat;
- ◆ The galley team shift handover was inadequate;
- ◆ The galley team had inadequate knowledge of the fryer operation;
- ◆ The unit was routinely being switched on at the main isolation point, despite there being two thermostatic controls to operate the vats independently of one another;
- ◆ Not all galley staff had the confidence to tackle the fire, and had not attended recent emergency drills;
- ◆ This was the second deep fat fryer fire on a company vessel in the previous six months, both having similar causes.

It was noted that a fire risk with deep fat fryers will always exist where personnel are not adequately trained in the correct operation and maintenance of such equipment. It was also noted that key errors were made where the unit was left without oil in one vat and then switched on with no check made that it was functioning correctly, and that there were no control measures in place for the cleaning of the fryer.

- ◆ Ensure that the processes and procedures concerning the fryers are suitable and that sufficient controls are in place for their safe operation and maintenance;
- ◆ Ensure that the risk assessment for the fryers and galley equipment is suitable and sufficient, and understood by all;
- ◆ Ensure that all the galley staff have been fully familiarised with all the galley equipment and fully understand the operation and risks for each;
- ◆ Ensure that all members of the galley team are regularly trained in emergency requirements.

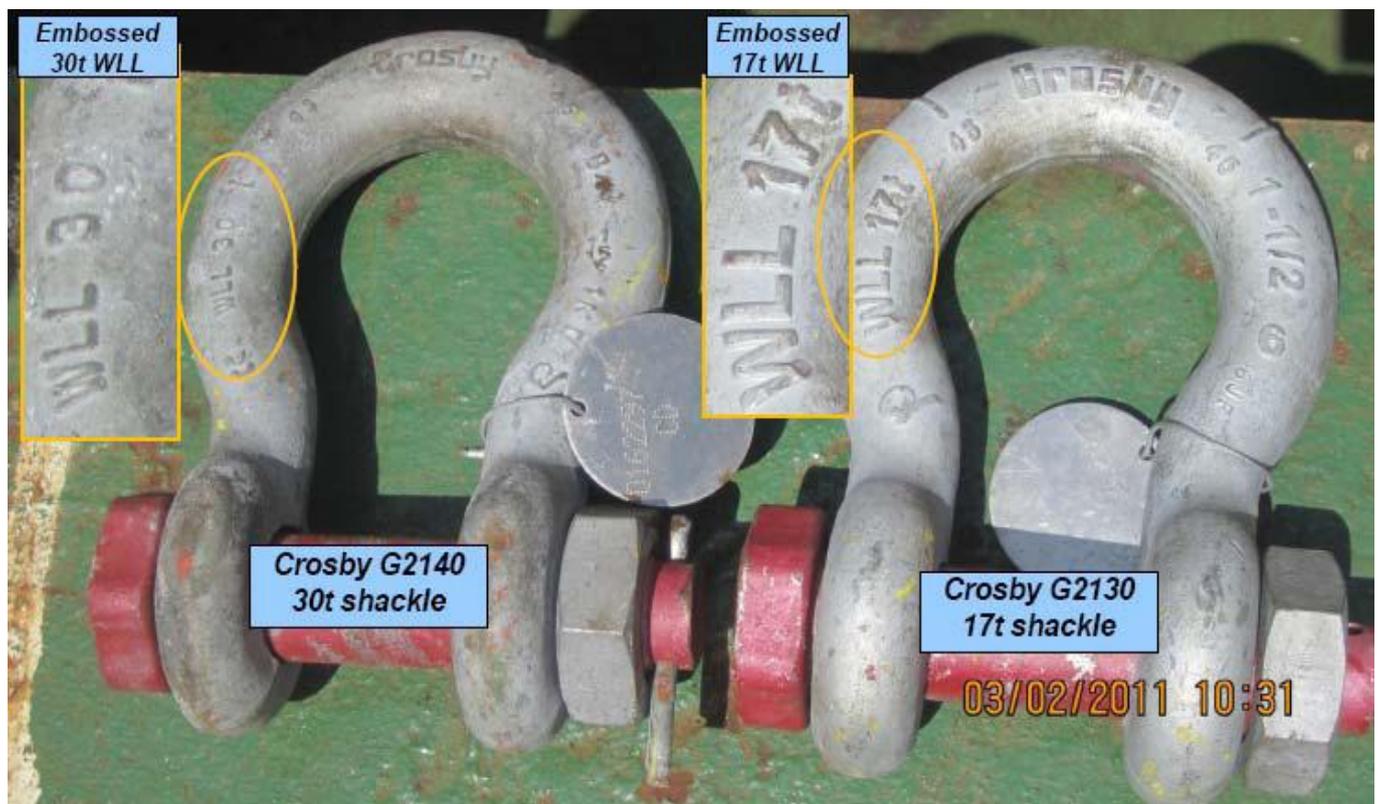
A member has reported that during a recent a recent spot check on a lifting bridle it was identified that a 17T shackle had been fitted instead of a 30T shackle. The preassembled lifting bridle included 3 x 30T shackles (Crosby G2140) and 1 x 17T (Crosby G2130) instead of 4 x 30T shackles. The certificate for the 17T shackle was cross checked against the identification number on the attached tag plate and showed the shackle SWL as 30T. The shackle was removed and replaced with a 30T shackle (30T working load limit (WLL) embossed).

Although the shackles are almost identical in size, differences in the material grades determine the WLL. Both the material grade and WLL are embossed on every shackle. It appears that an error was made during the certification process by the supplier where a 17T shackle had been certified (ID tag attached with common certificate number) as part of a batch of 30T shackles.

Different shackles with working load limits embossed

This unsafe condition reinforces the requirement to conduct a pre-use inspection of lifting equipment prior to commencing the lift.

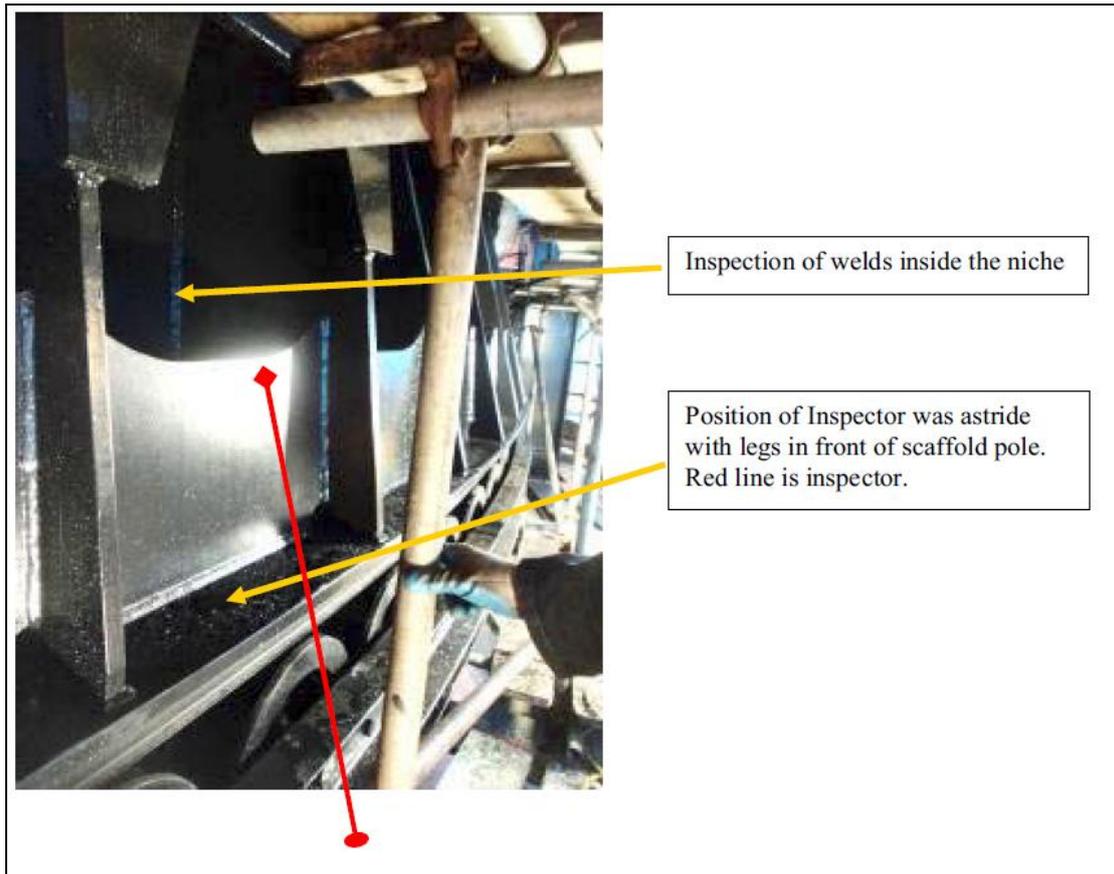
A member has reported an incident in which someone was almost caught between a crane housing and a scaffold pipe. The incident occurred when a non-destructive testing (NDT) inspector was conducting an inspection at the stern of the crane, outside on the roller level. The access was from the scaffold around the crane. The inspector was positioned at a beam, behind a vertical scaffold pole. He had just finished the inspection of the welds and stepped back from the crane housing onto the scaffold platform when the crane started slewing. A deck supervisor spotted the inspector on the scaffold platform and asked him what he was doing. Immediately the deck supervisor ordered the crane driver to stop the crane. Had the crane started to slew earlier, then he could have been caught between the crane housing and the scaffolding pipe.

Site of incident

- ◆ The crane operator was not informed at the start of the work;
- ◆ There were inadequate guards or barriers;
- ◆ Log out tag out procedures were not applied.

- ◆ A 'last minute risk assessment' by the NDT inspector did not reveal the actual risks owing to his lack of experience, and he did not notice that in case of crane slewing the scaffolding would rotate independently from his work spot;
- ◆ There was inadequate initial instruction, and information was not communicated properly to all the involved parties;
- ◆ The toolbox talk process was not conducted in accordance with established procedures – the work process was discussed without involvement of all parties (deck crew/crane operator);
- ◆ The wrong crane operator was informed before the operation took place – this was done during an accidental encounter in the accommodation.

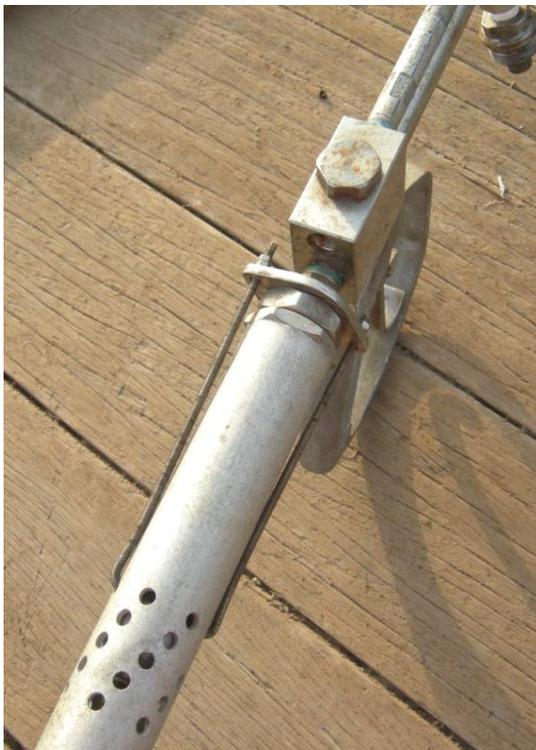
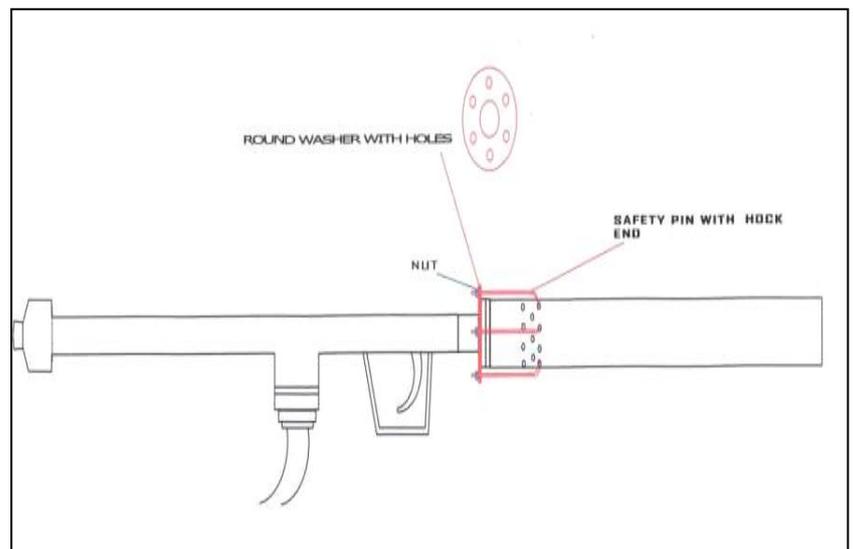
Following publication in [IMCA safety flash 05/11](#), which reported an incident where an injury sustained by a diver after the subsea failure of a high pressure (HP) water jetting gun, a member would like to draw attention to a similar earlier incident. Whilst using an HP water jetting gun underwater, the rear barrel of the gun became unscrewed and fell causing minor injury to the diver's left arm. There was no injury or damage caused by the HP water jet. Upon closer inspection, it was noticed that the threads on the barrel were worn.

- ◆ The rear barrel of the gun is a protective cover designed to be screwed onto the gun, to protect the diver from the (equalising) HP water jet at the rear during work;
- ◆ It is possible that due to constant handling, the barrel may have become loose at the screw end;
- ◆ Failure of pre-use inspection to check the tightness of the barrel may also have contributed to the barrel falling off.

Modifications made to HP water jetting gun

Subsequently, modifications were made to this and all similar HP water jetting guns, in order to prevent recurrence of the incident.
