IMCA Safety Flash 07/13

May 2013

1 Near Miss: Failure of Gas Quad Fitting

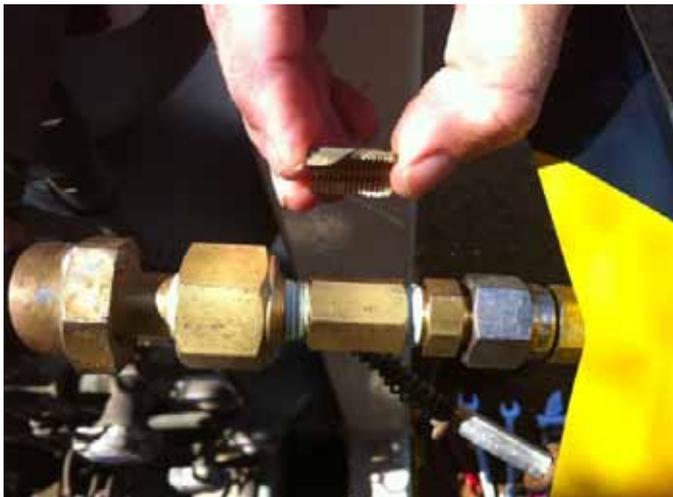
A member has reported an incident in which there was a potentially catastrophic failure of a high pressure fitting on a gas quad. The incident occurred in a yard ashore when crew were carrying out pre-mobilisation equalisation transfer between banks on mixed gas DIV64 quad pack using high pressure (HP) hose. The wrong fitting (incorrect thread and low pressure (LP) rather than HP) was used to connect the HP whip to the king valve on the quad. The fitting failed due to a hairline crack as the gas transfer was being conducted between the HP banks.

The LP fitting failed such that it split into two pieces. One piece was found in the immediate vicinity; the other was found 20m away from the point of failure. It was later discovered that this piece had travelled with such force that it had hit and chipped an internal brick wall within a nearby workshop. The trajectory of this second piece would have crossed the main general workshop area in the facility at a height of approximately 3 metres where an estimated 10 other persons had been working. There were no injuries.

Part of failed fitting

- “ In order to complete this task in equalising gas between the mixed gas DIV64 internal banks, use was made of NPTT (tapered) adapter fittings from both the HP king valve stem connection ports and adapting to the HP transfer hose, and in this incident both the thread type and the choice of material were incorrect. Low pressure fittings were used rather than high pressure fittings;

- “ An identical ¼” NPTP brass socket fitting arrangement had been used on the other end of the hose; upon inspection, a hair-line crack was found in the material;

- “ Additionally the first section of the brass fitting had clear visual evidence of heavy condensation, and icing on the exterior of the other associated adapter fittings at the point of the pressure drop which would have further contributed to reducing the structural integrity of material under high pressure.

- “ Pressure of circuit was above the coupler’s capacity;
- “ Crimped swivel fittings not suited to pressure of this level;
- “ Crew were not aware of different thread types;
- “ Whip checks insufficient;
- “ Valves open more then they needed to be;
- “ Regulator not used;
- “ Pressure not monitored;
- “ Over-tightening on coupler resulted in hairline stress cracks.

- “ Equipment should be of sufficient pressure rating;
- “ Improved training and information were required on this task;
- “ Risk assessment for this task needed to be more detailed;
- “ Hose securing – whip checks – should be improved;
- “ Consider increasing size of restricted access area during high pressure work;
- “ Real-time measurement of high pressure should be in place;
- “ Time allowed for this work should be realistic;
- “ Complacency is to be guarded against.

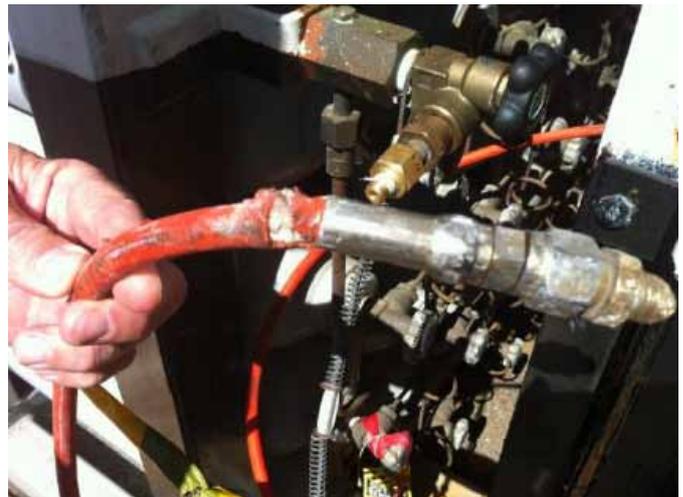
Hose damage resulting from inadequate whip check

- “ Whip checks had been installed at each end of the transfer hose and secured to the DIV64 frame prior to equalisation operations being conducted. However, the hose end at the point of failure did not adequately choke or restrict the hose to a point where by it should have prevented the uncontrolled movement. This resulted in the hose also being damaged and ripped at the section where the stainless steel hose crimp is machine fitted (see photo);

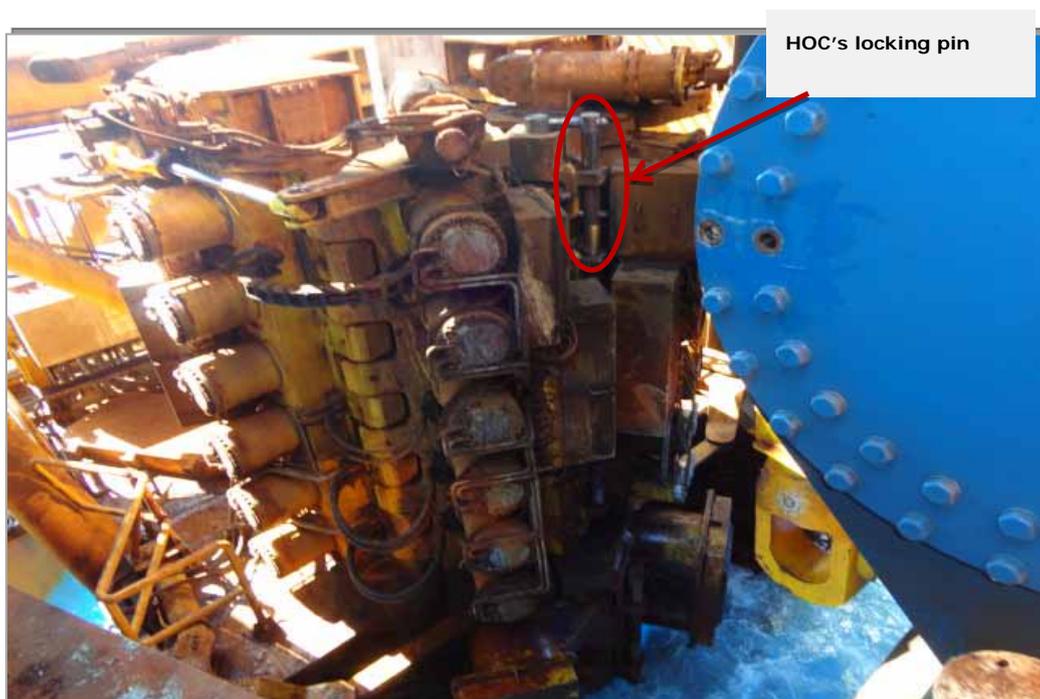
A member has reported an incident in which a rope access technician suffered a serious injury to one of his toes, leading to partial amputation. During J-lay pipeline operations, a malfunction was discovered in the locking pin designed to lock off the hang-off clamp (HOC). The pin would move down, but not up. Maintenance of the equipment was arranged. A crewman was assigned to clean the hang-off clamp using a water jet, and during this process he was supervised, from the deck level, by the Chief Engineer and 1st Engineer. When the cleaning was complete, he confirmed using hand signals to his supervisors that the job was complete.

Showing hang-off clamp locking pin

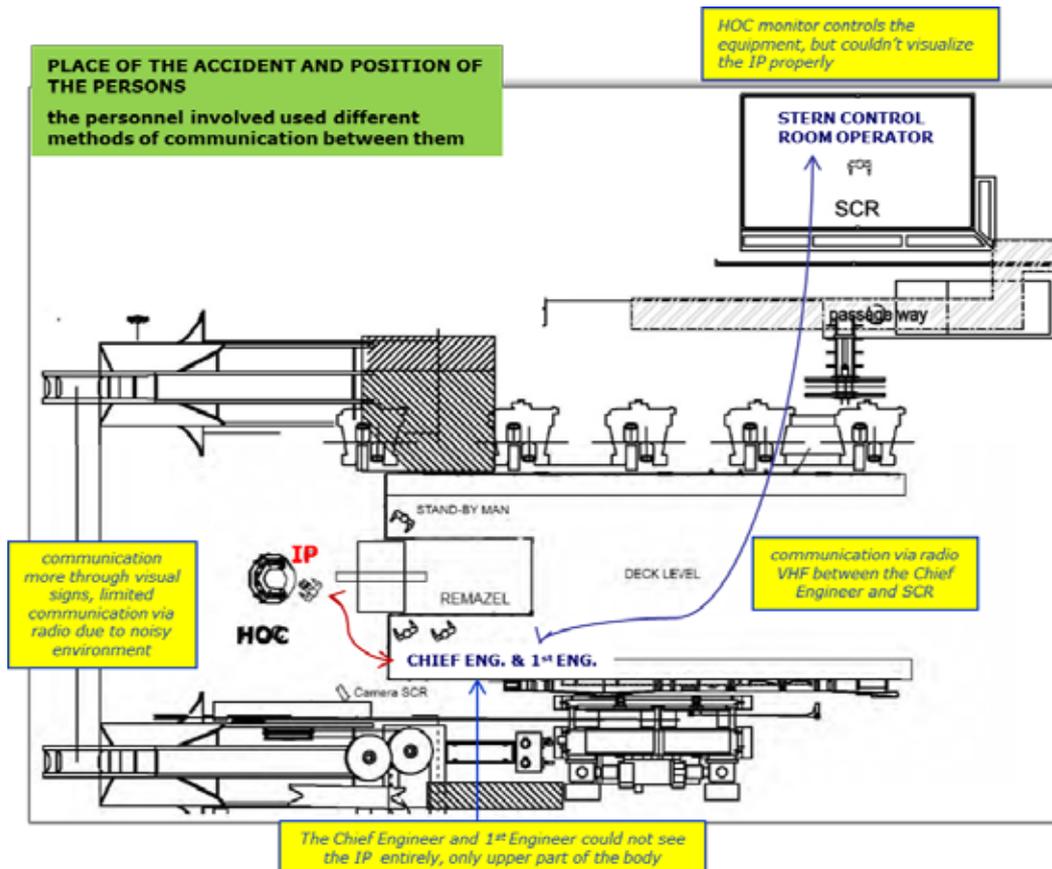
The supervising team alerted the crewman that there would shortly be a test movement of the locking pin in order to test the functionality of the equipment. The supervising team alerted the crewman of the imminent movement of the pin, giving signals that he should move to a safer location. He confirmed visually that he had received this signal, but did not move, remaining with his foot on the pin. The 1st Engineer gave instructions via radio that the pin should be moved. Whilst moving, the pin squeezed the toe cap of the crewman's boot, causing injuries leading to partial amputation of his right big toe.

Line drawing showing place of incident and position of persons involved

- Improper communication between all persons involved:
 - injured person and supervisory team communicated using hand and visual signals and there was no confirmation that the signals were understood as intended
 - 1st Engineer and control room operator communicated by radio
 - There was no communication between injured person and control room operator;
- The control room operator could see the hang-off clamp, but could not see personnel working nearby;
- There was no evidence of any toolbox talk before the operation to agree on proper communication channels or planning of the operation;
- Whilst a job safety analysis and permit to work had been issued, these did not fully identify the task hazards.

- Improved job safety analysis to ensure adequate identification of all hazards and mitigation measures;
- Improved communication protocols and instituted use of common communications channel between crew and control room.
