IMCA Safety Flash 07/14

May 2014

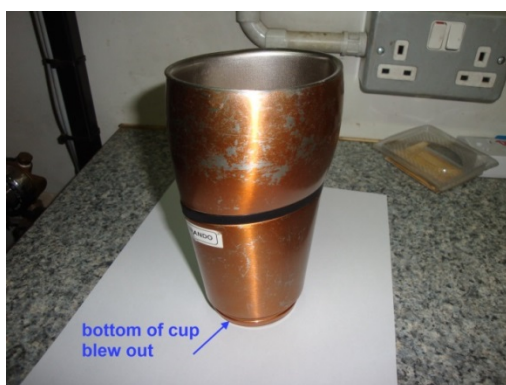
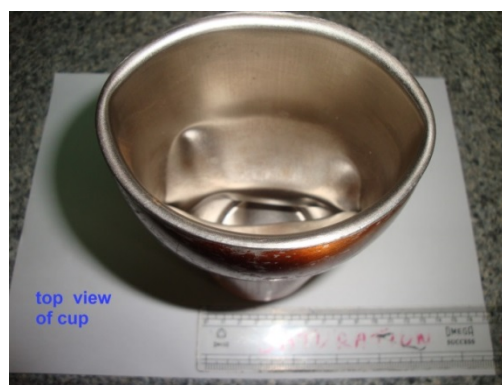
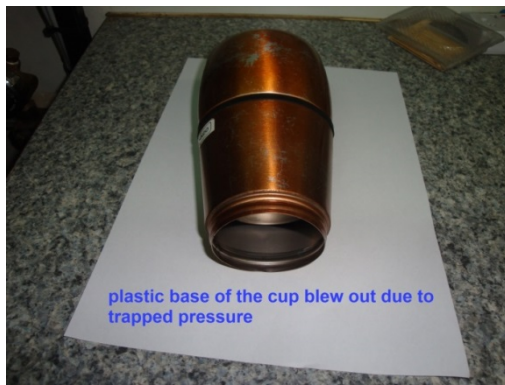
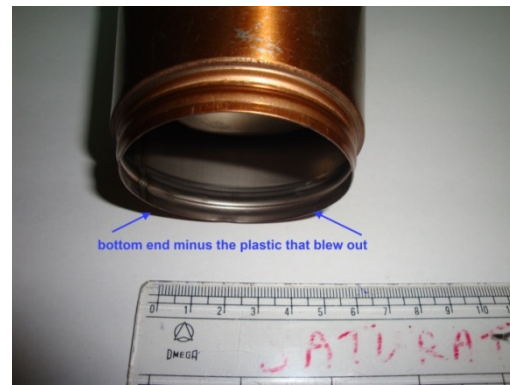
A member has reported an incident in which a brushed aluminium ‘Thermos’ style cup exploded after being taken out of a hyperbaric environment. The incident occurred when the cup – which had been in Sat at -256 fsw with the diver – was placed in the medical airlock and brought to the surface. Once at surface pressure the Assistant Life Support Technician (ALST) removed the cup and placed it under his arm, whereupon a violent separation of the cup from its plastic base occurred. The ALST suffered minor bruising and the cup was destroyed. Immediate medical attention was given, and a proper and timely notification to the appropriate authorities was made. The remains of the cup were retained for investigation.

Our members’ investigation noted that the diver had considered that there was no risk of a pressure differential as the interface between the metal and the plastic base on the cup was of insufficient strength to allow a pressure differential to form.

Figures: Showing thermos cup after explosion

- ◆ Allow this style of cup or vessel in the saturation chambers only if drilled to prevent pressure build up;
- ◆ Add non-venting thermal vessels to the list of items forbidden for use in saturation chambers.

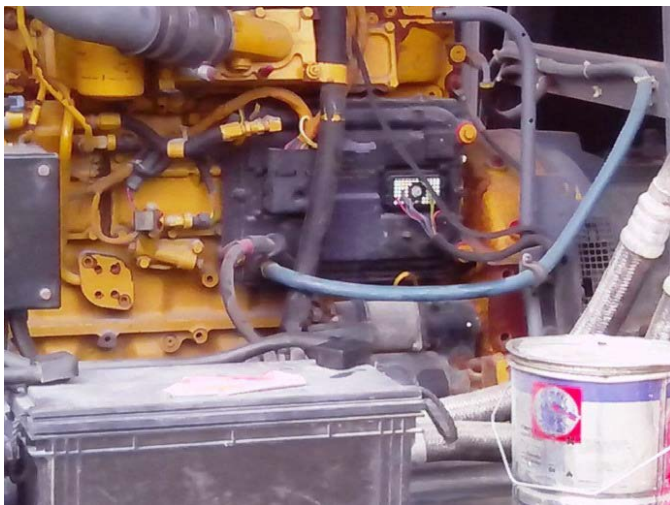
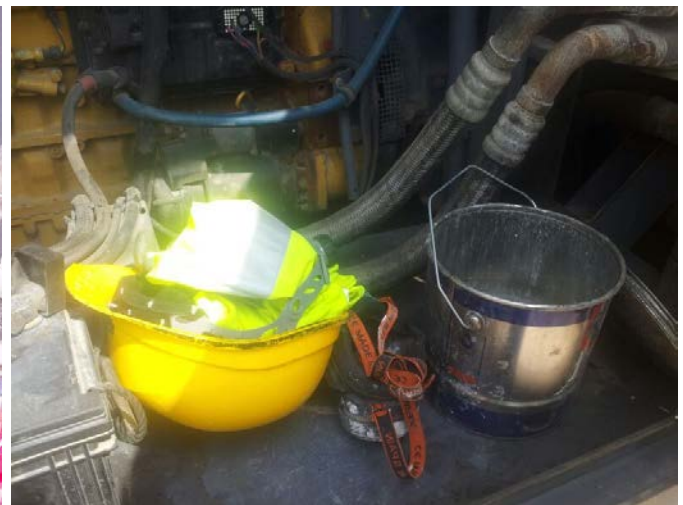
Figures: Compressor unit with PPE and flammable materials inappropriately stored inside

- ◆ Using equipment enclosures as temporary storage can potentially lead to harm of people and damage to equipment;
- ◆ The worker placed his PPE inside the compressor unit. The inside of the compressor unit was used by the crew habitually as a storage area for PPE;
- ◆ There were other flammable materials seen stored inside the compressor unit, which could potentially lead to major fire and explosion;
- ◆ The incident was not reported in a timely way;
- ◆ There was no evidence of new risk assessment being conducted prior to recommencing of the work, and PPE was seen being stored inside the compressor unit the following day – the lessons were not learnt by the crew.

- ◆ Ensure no materials are stored inside any operational machinery;
- ◆ Ensure PPEs/other materials are stored in designated area only.

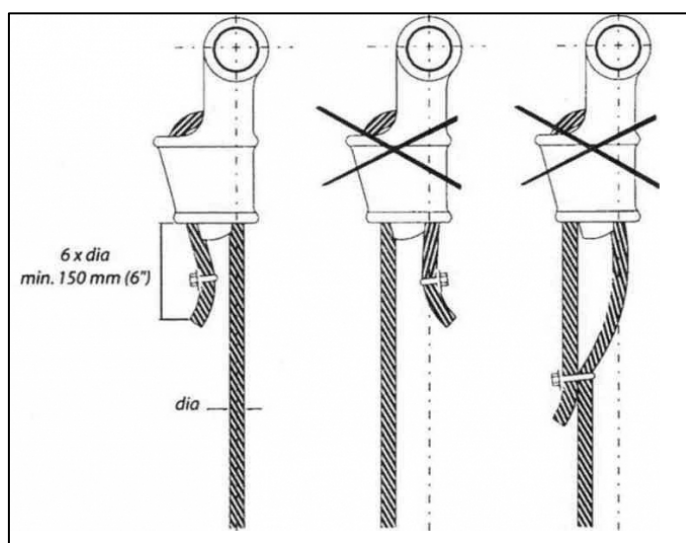
Figure: wedge socket showing right and wrong method of termination

For a wedge Socket, the wire rope grip should NOT be connected to the live rope. It should only be connected to the dead end of the rope. Any clamping at all, bridge or U bolt, to the live end of a rope terminated with a wedge socket can cause damage and crushing and is not recommended.

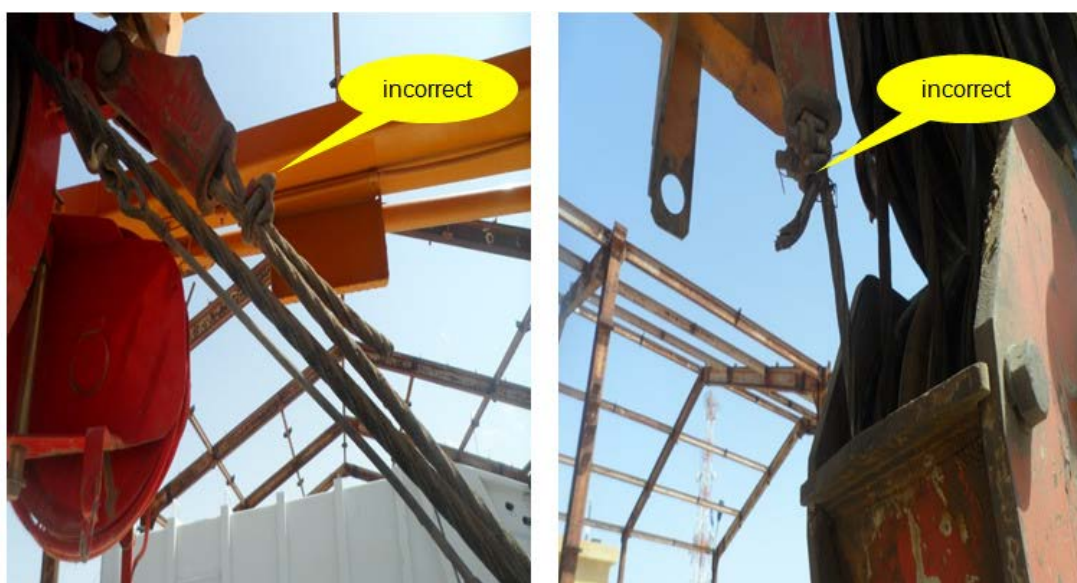
A near miss incident has come to IMCA's attention in which a crane wire rope termination was found to be incorrectly fitted. Before starting work at a land-based site, a 30 tonne mobile crane was inspected, and a rope clamp (bulldog) attached to the hoist ropes 'dead end' was found to be incorrectly fitted causing crushing and damage to the 'live end' of the wire rope (the part of the wire rope that takes the load strain).

The incorrect selection or fitting of wire rope grips drastically reduces the efficiency of the wire rope terminations and can cause the wire rope to slip through the grips, potentially leading to the harm of people and damage to the equipment.

The bridge of the clamp must always be fitted on the working part (live end) of the rope, and the U bolt on the rope tail (dead end) of the rope.

Figure: Showing incorrect fitting of wire rope grips

- ◆ Ensure correct type of wire rope grip is selected when terminating wire ropes;
- ◆ Ensure wire rope grips are correctly fitted;
- ◆ Watch out for signs that may indicate broken wires; e.g. reduction in rope diameter, corrosion or rope deformation.

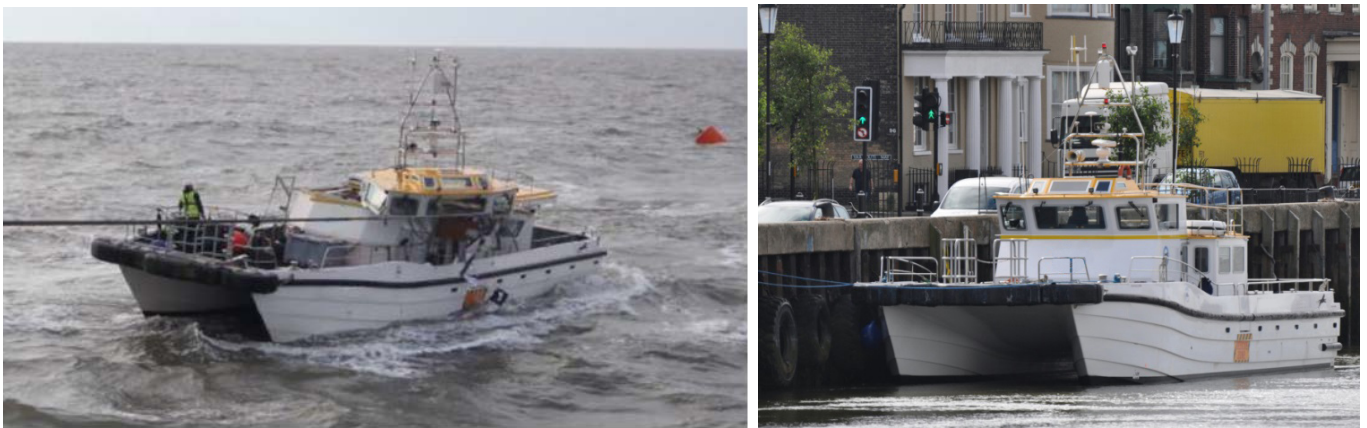
Figures: (L) Showing CTV caught by wire under tension, and damage to wheelhouse (R) Showing vessel undamaged

- ◆ A similar incident had happened with the same CTV earlier in the year;
- ◆ Crew transfers are executed so often that they can be considered as a routine activity ('taxi') leading to risks being overlooked and complacency setting in;
- ◆ Crew transfer is an important activity and should be formally risk assessed on each project since environmental conditions differ for each project;
- ◆ Reporting, communicating and follow-up of incidents and near misses is important since this incident would have been prevented had the previous incident been properly reported, correctly communicated and follow-up had been in place and adhered to.

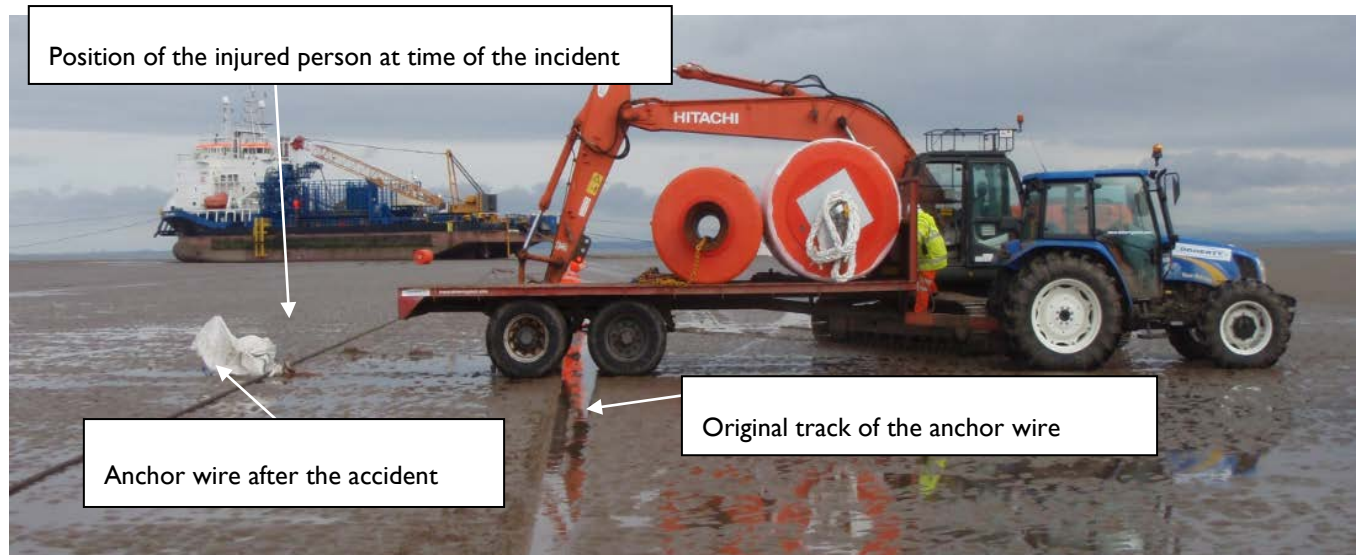
Figure: Showing scene of incident

Our members' investigation revealed one of the root causes was lack of knowledge of what was happening at the worksite: persons involved were not aware of the fact that tension is still in a wire even when hanging slack and lying on the beach for a considerable length (700 meters).

The lesson learnt is that it is in the nature of a wire rope that there will always be stored or residual energy in a length of it. This introduces a range of potential safety issues including manual handling and unexpected release of energy when handling the wire ropes. These issues should be taken into account in job planning, tool box talk and risk assessment before the start of the job.
