IMCA Safety Flash 07/18

March 2018

1 Sustained Load Cracking in Aluminium Manufactured from Aluminium Alloys HE30/AA6082 and AA6351

2 Technical Service Bulletin from Broco/Rankin – BR22 Plus Exothermic Cutting Torch

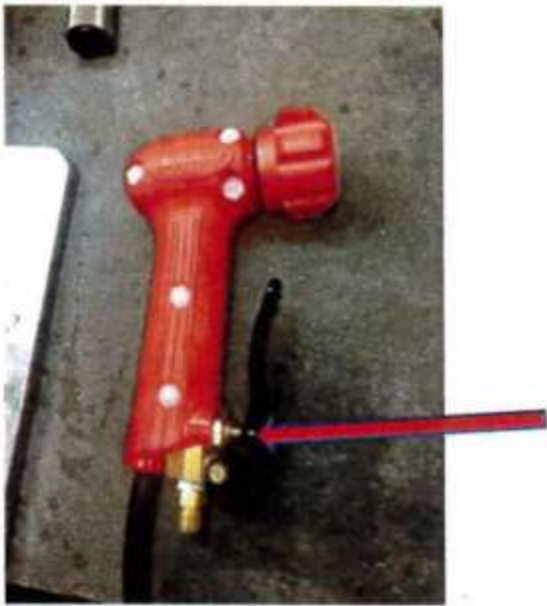
The bulletin, available [here](#), notes that “a recent report of an external oxygen leak from the control valve of a BR22 PLUS prompted an investigation to determine root cause. The result of that investigation concluded that machining debris in the O-ring groove of the Control Valve Nut has interfered with the Oxygen seal in the valve assembly”.

This picture shows what a BR22 PLUS torch looks like and the location of the valve stem leak. If this is not what your torch looks like, do not continue!

Members using this equipment should download and read the bulletin, and take the actions recommended therein.

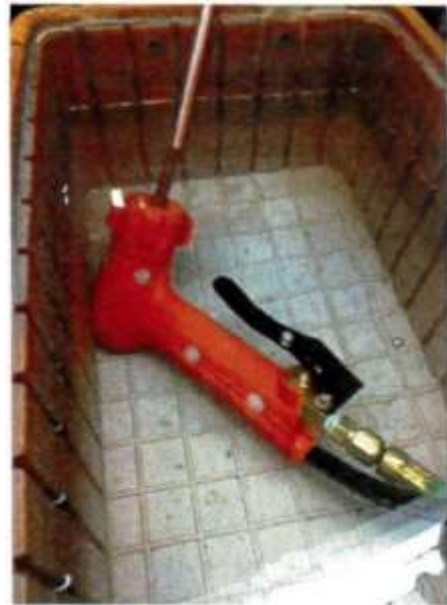
Outfit the BR22 PLUS torch as shown with an 18” cutting rod inserted and the collet tightened
