IMCA Safety Flash 08/00

December 2000

1 Dangerous Transformers

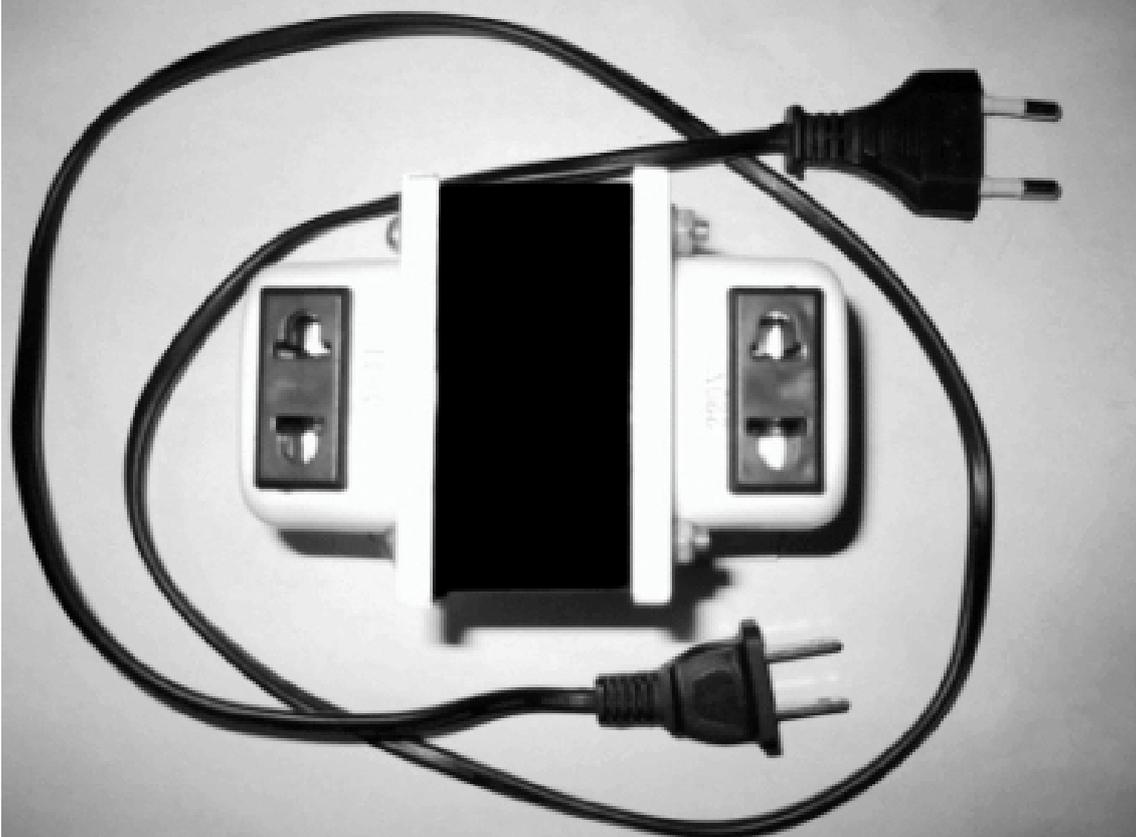
Overleaf is a picture of one of the transformers.

- ◆ The transformers have no earth and thus do not comply with relevant class (class I equipment – earthed) for appliances of this kind;
- ◆ The transformers are not double insulated and in fact have a metal casing. This does not comply with the relevant class (class II equipment – double insulated) for appliances of this kind;
- ◆ The lead has two plugs and the transformer two sockets. It is possible to plug a 220v supply into the 110v socket and produce 440v;
- ◆ If power is fed to the transformer then both sockets become live and there is a high risk of somebody being electrocuted.

DANGER

DO NOT USE THIS
TYPE OF EQUIPMENT
