I Container Door Hinges Failure – Container Door Fell on Deck

2 Fatality – Pressure Build-Up leading to Sudden Release of Mechanical Plug

3 Attempted Service to Microwave Results in Fatal Electrocutation

4 Cracked Fuel Line Results in an Engine Fire

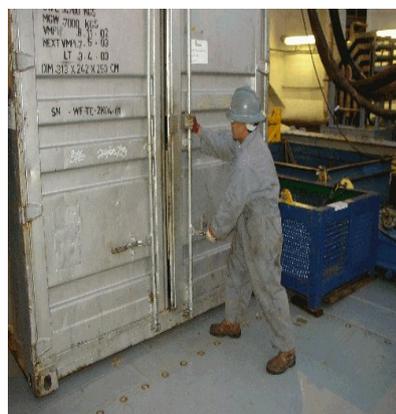
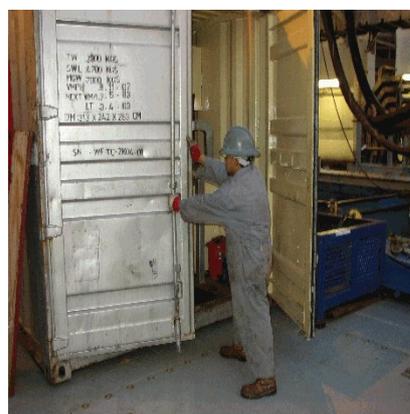
A container was being opened as illustrated in the two photographs below. As the left hand door was opened the top hinge broke, followed by the second and third hinges, and the door fell onto the deck.

The cause of the incident was found to be lack of lubrication between the vertical rod and the hinges, which should rotate on the rod. They had become corroded and jammed intermittently and had suffered fatigue due to opening and closing of the door resulting in cracking and eventually failure.

- ◆ Container door hinges of this design should be routinely checked every time they come on board for signs of jamming, wear, tear, and lubrication applied accordingly;
- ◆ If lubrication and corrective actions are required on board, particularly to hinges in containers, then a non-conformance report should be submitted so that appropriate preventive measures can be taken.

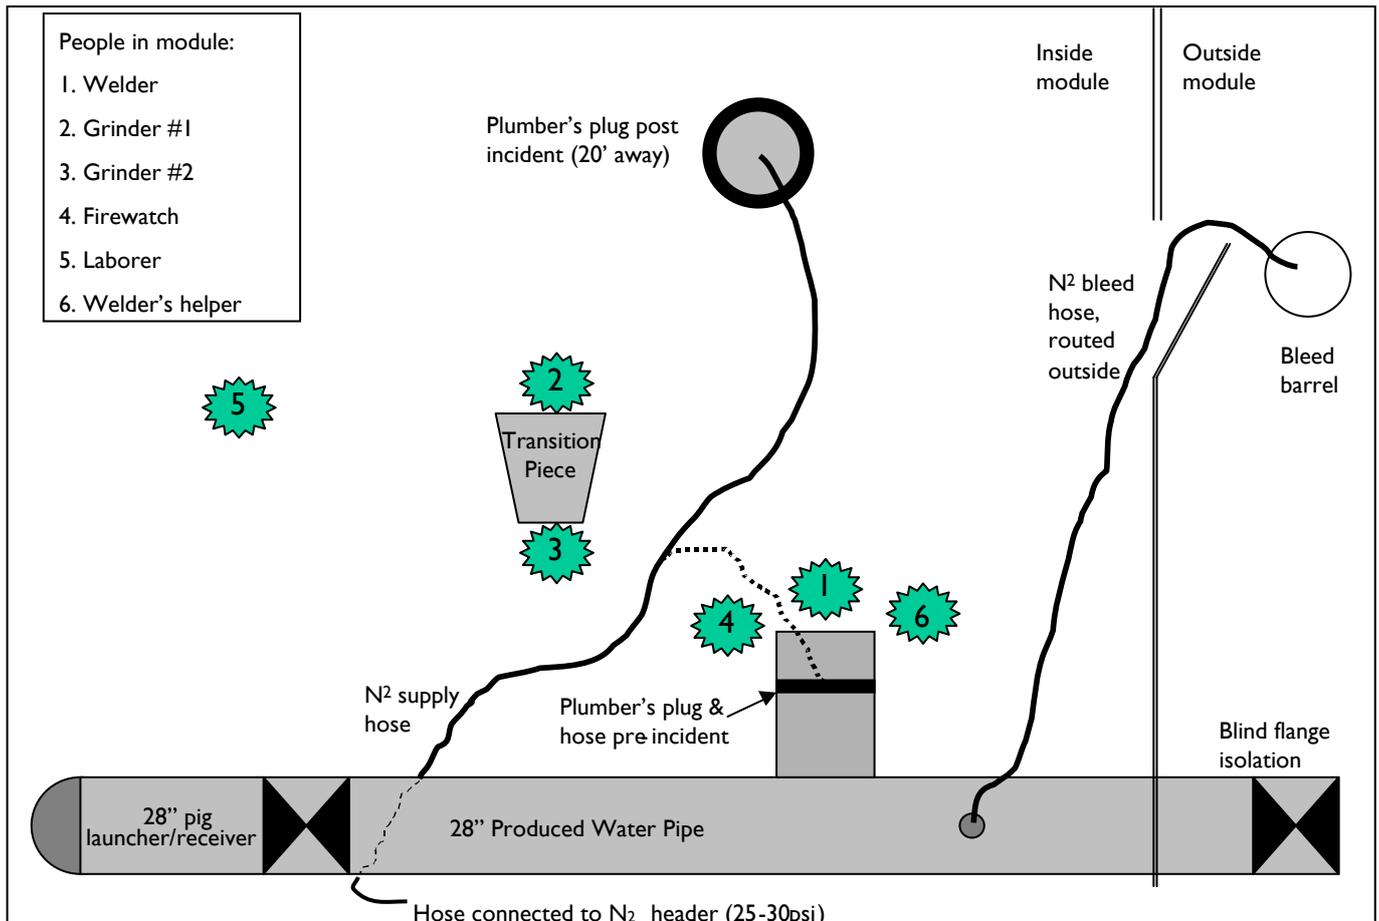
Results from the investigation indicate that the direct cause of the incident was blockage of the purge vent line on the back side of the plug due to freezing water vapour in the line. This allowed pressure to build up and eject the plug.

The work in this incident involved a welding operation on the open end of a 28-inch produced water line that had residual water and hydrocarbons in it. A non-pressure-containing mechanical plug, known as a 'plumber's plug', had been installed about 12 inches inside the pipe, as a barrier against process fluids and purge gas. About three hours before the incident, a nitrogen purge was established through a fitting in the plug to inert the pipe area behind the plug. The nitrogen came from a nearby supply header operating at 25-30 psig. The purge gas was routed to the plug from the header via a ¾-inch flexible hose. Another ¾-inch hose was connected to the top of the pipe behind the plug and routed outside the module to vent the vapors. The ambient temperature was 0°F at the time of the incident. A hand valve was used to pinch the flow of purge gas from the nitrogen header. There was no pressure gauge, regulator, or secondary relief on the purge to allow pressure to be checked or to prevent pressure build-up. A job safety analysis (JSA) recognized the potential hazard of the purge line freezing. To mitigate the risk, the line was checked periodically for flow by placing a hand at the end of the vent hose. This check subsequently proved to be inadequate. When the vent line froze, the pressure build-up behind the plug caused the 63-pound plug to release suddenly, striking and killing the welder and inflicting minor injuries on two other workers.

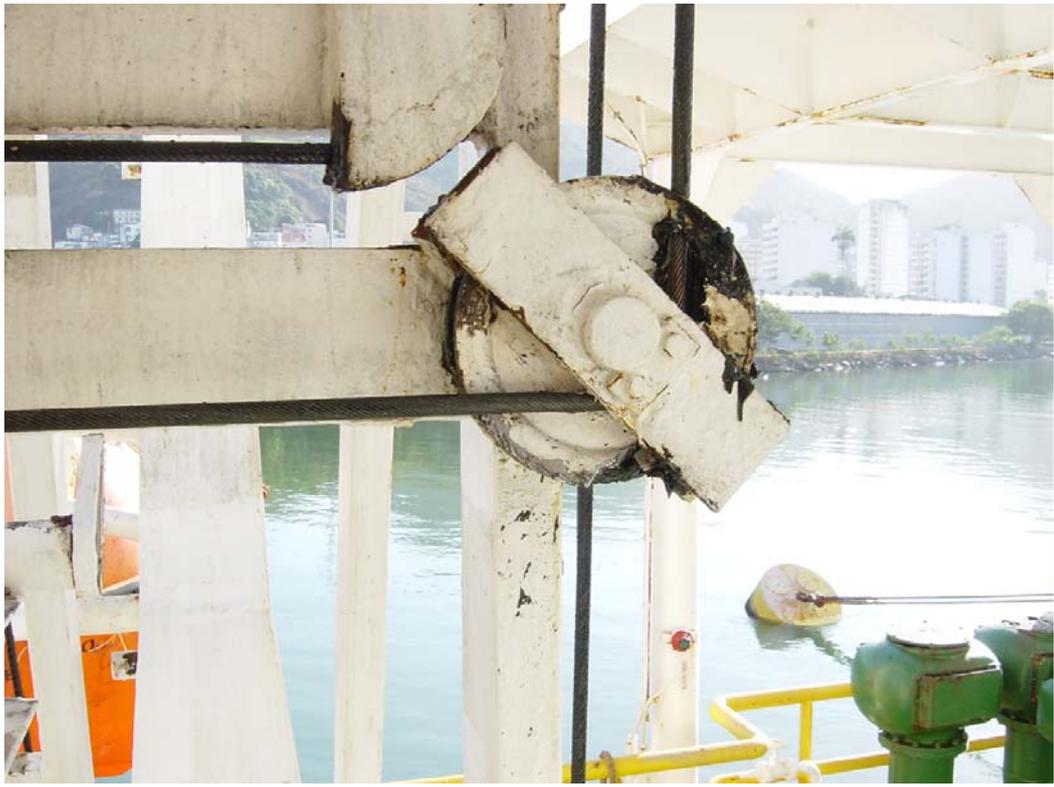
Close inspection revealed that one of the davit sheaves had disintegrated around its perimeter (circumference) and that this, in turn, had caused the falls wire to jump clear of the sheave and become trapped between the sheave face and sheave bracket on the davit structure (see figure).
