## 1 Trapped Pressure Release Incident

## 2 Serious Injury During Pipestalk Rolling Operation

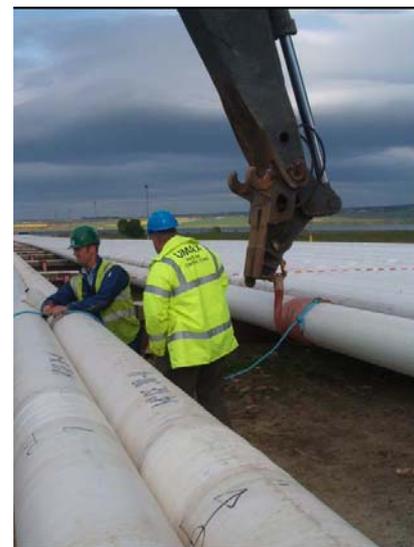
The injured person was assisting with planned pipe stalk rolling operations when he became entangled in a tag-line that subsequently trapped and held him against the rolling pipe stalk. He was carried over the top of the rolling pipe stalk and crushed between that pipe stalk and the one adjacent to it.

- ◆ Although only a minimal amount of lifting at the mid point of the pipe stalk was involved, this activity had not been recognised as a lifting operation and, therefore, the appropriate level of control and supervision had not been applied;
- ◆ There was evidence that, while a safety management system was in place, the procedures and risk assessments used to control the work had not been adequate;
- ◆ The task was being carried out by competent, experienced personnel, who had completed the task without harm many times before. Nevertheless, there was evidence that the personnel involved were unaware of the risk assessments and procedures in place and worked to custom and practice, rather than to procedures.

- ◆ Tag-lines are useful, often essential, attachments to assist in controlling a load. However, all personnel should be acutely aware of the potential risk of snagging or entanglement of themselves or other equipment when using tag-lines and ensure that they position themselves safely away from the load;
- ◆ The same level of compliance with procedures; and awareness and control of risk should be applied to routine work as to higher risk, and non routine activities, particularly where lifting operations, however routine or low-level, are involved.
