IMCA Safety Flash 08/07

August 2007

I Failure of Welding on Hyperbaric Rescue Chamber Medical Lock Door Assembly

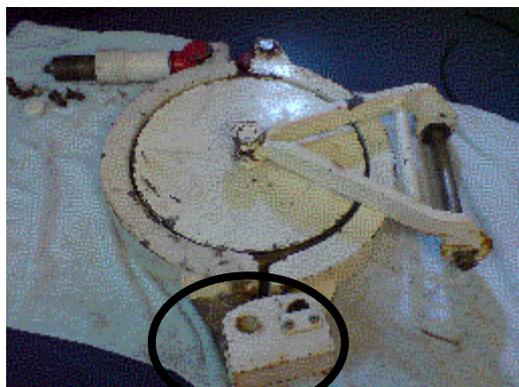
These pictures show the hyperbaric rescue chamber medical lock door assembly and the positioning of the C clamp retaining bracket, the second picture clearly indicating a weld feature that failed whilst in operation.

Medical lock door assembly

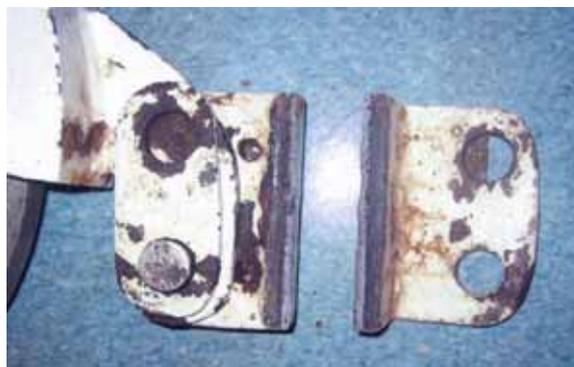
A report commissioned by the company, conducted by an independent metallurgical laboratory, identified that the welds in the bracket could have failed at any time due to there being less than 1 mm of weld remaining. This was partly due to corrosion of the metal and partly due to poor welding.

It was calculated that a downward force of 10-20 kg would have been sufficient to cause the weld to fail. The full penetration weld within the bracket was only 0.8-1.0 mm thick at best and the supporting fillet weld had no fusion along one of its lengths.

C clamp retaining bracket (after failure)

- ◆ The C clamp retaining bracket was never regarded as being a load bearing or critical component and as such was never included in routine checking or inspection of the assembly.
- ◆ At the time of installation of the assembly the engineering, certification or inspection regimes were not as stringent as they are now.
- ◆ It is recommended that all load bearing components within a dive spread are thoroughly inspected for signs of corrosion or damage.
