## IMCA Safety Flash 08/08

April 2008

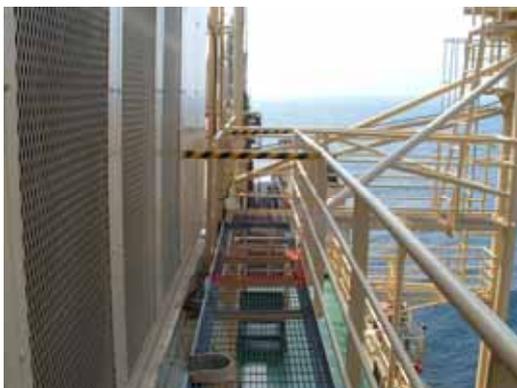
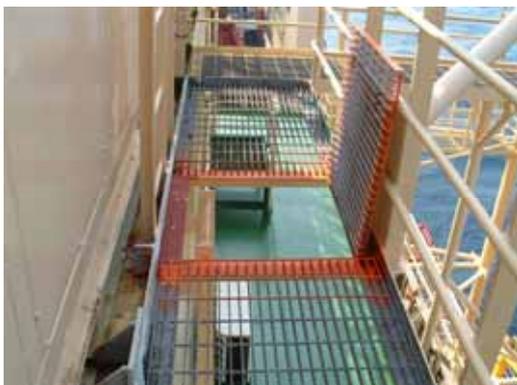
Before

A member has reported a incident onboard an offshore construction vessel in which a crew member fell through an unprotected hatch on a walkway on to the deck below. The injuries sustained were only slight bruising and abrasions to left arm, upper chest and left knee. Whilst the injuries were light, the potential for serious injury was high.

The hatch, which had been installed along with an access ladder when an additional air conditioning (AC) unit was placed on top of the bridge, had been left tied open by another worker. The crew member fell through the hatch after raising a safety barrier on the walkway whilst going to inspect some heating, ventilation and air conditioning (HVAC) air ducts.

- ◆ The addition of the hatch in the walkway should have been risk assessed and a management of change (MoC) process followed.
- ◆ Following this incident the ladder access to HVAC air ducts was relocated to an area outside the walkway, thus eliminating the need for a hatch. The hatch was welded shut.
- ◆ Personnel were reminded never to leave a hatchway open without it being barricaded on all sides.
- ◆ Personnel were reminded never to raise a safety barrier in haste or to enter a danger zone without evaluating potential dangers.

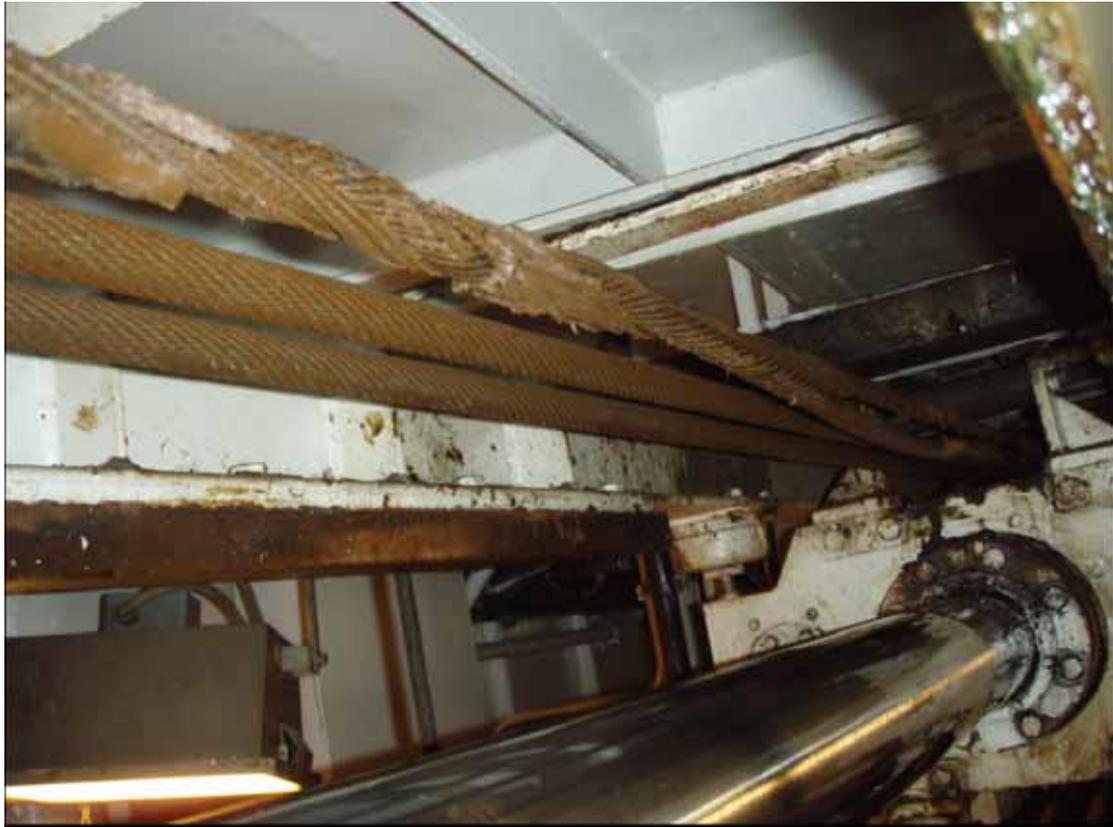
During bell recovery a member of the dive team noticed damage on the bell main lift wire, 48m from the bell.

*Photograph showing partly parted wire*

- ◆ The cause of the wire rope failure was internal corrosion damage where the inner core wires of the rope had been reduced in size by up to 50% with no external damage visible;
- ◆ The rope lubricant had been lost internally and the galvanised coating was no longer present. Both of these two factors had accelerated the corrosion of the wires;
- ◆ The local corrosion of the core wires had led to a loss in diameter and strength. The loss in strength had resulted in overload of the individual wires and placed additional stress on the core.

When checking the size of the bell wire (nominally 22mm diameter) approximately 3m each side of the damaged area, the diameter was recorded as 21mm. At various other areas of the wire the readings were between 21.3mm and 21.8mm.

ISO 4309 2004 paragraph 3.5.7 allows for a 3% reduction for multi strand wire making 21mm outside acceptable tolerances.

Members are urged to consider all of the points raised and review their own wire rope maintenance and testing policies as appropriate.

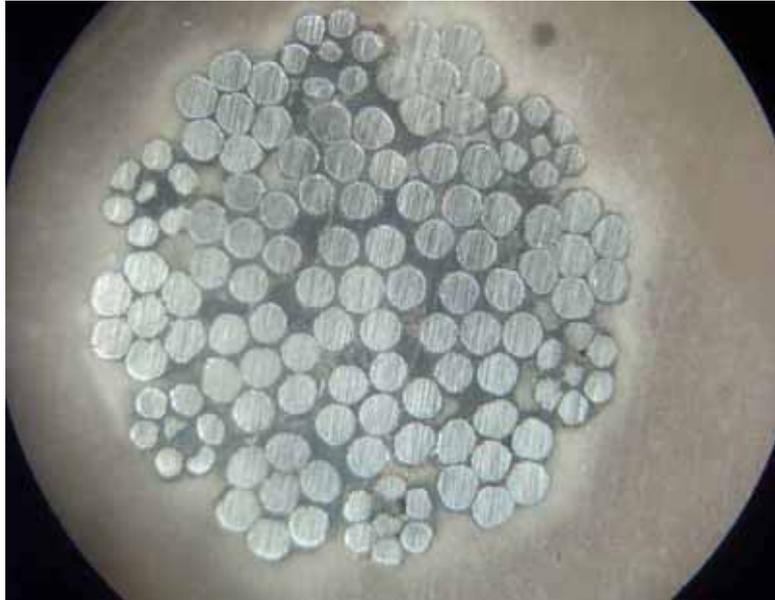
*Photograph of a section taken from the core of the rope close to the fracture*

- ◆ The extent of the detrimental effect of multiple sheaves and sheave diameters in use;
- ◆ The wire rope had, over a number of years, been bent over heave compensator sheaves which could have led to internal fretting taking place within the rope once the rope lubricant had been lost;
- ◆ High peak loads could have been experienced on the system when the heave compensators were fully compressed before the bell and cursor were handled in moon-pool;
- ◆ The bell wire was eight years old which was inside the company's discard policy of ten years which may need to be re-assessed.
