IMCA Safety Flash 08/10

December 2010

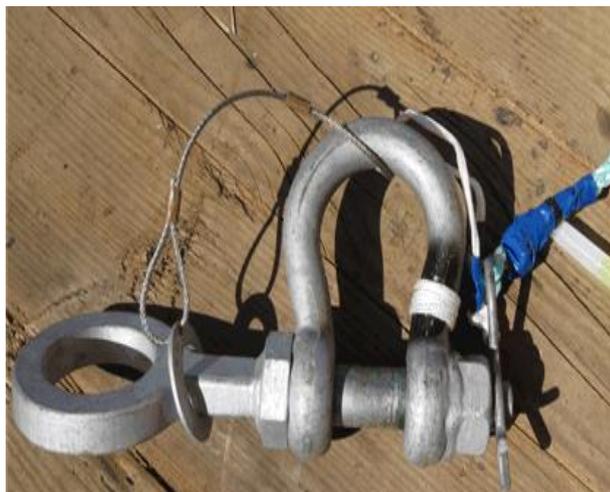
A member has reported that in spite of clear work instructions and procedures to the contrary, shackles and hooks at the worksite were being regularly modified by welding. Rigging suppliers or individual worksites were carrying out welding modifications (mainly to shackles) after delivery from the manufacturer. This practice invalidates the manufacturer's certificate and is potentially hazardous.

The welding of shackles (after delivery from manufacturer) has the effect of adversely altering the material properties and increases the risk of failure by various brittle modes. In addition to this increased risk, the nature of the failure is unpredictable, is not time dependant and cannot be prevented by inspection.

Example of shackle with welded modification performed by supplier

Our member recommends that all shackles and hooks that have been modified by welding should be removed from service. Equipment suppliers should be instructed not to modify or issue modified shackles or hooks for use on any worksite.

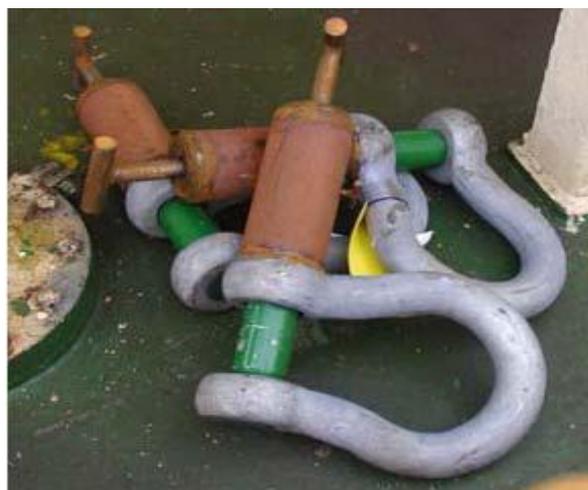
Example of shackle with welded modification performed at worksite

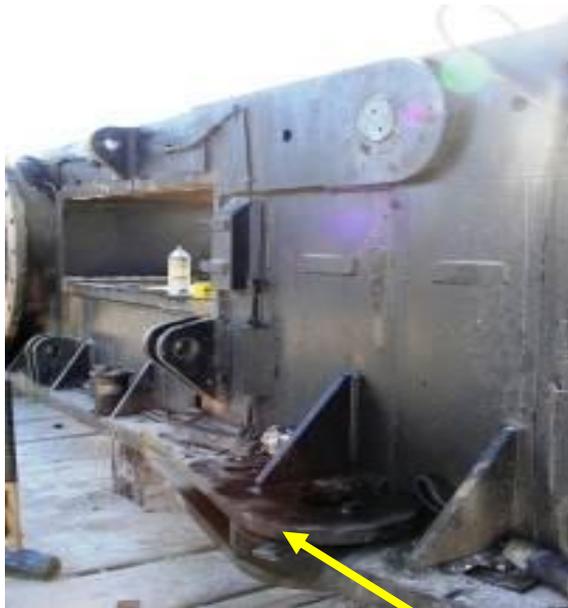
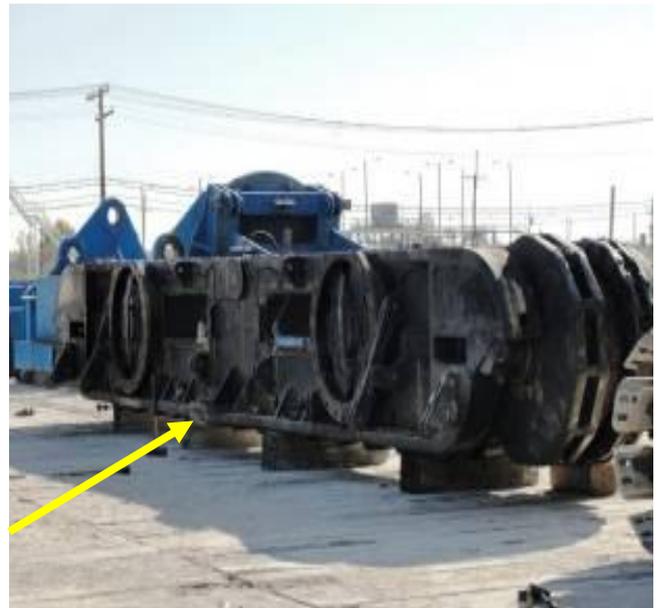
An incident has been brought to the attention of IMCA, in which a worker received a laceration to the chin. A worker was removing a steel wedge from the frame of a crane track during disassembly. The wedge dislodged when struck by a sledge hammer and ricocheted against the frame before striking the worker. The worker was taken to an offsite facility for treatment where he received stitches. He was able to return to work without restrictions.

- ◆ The wedge was in a bind when it was struck;
- ◆ The injured person was 'in line of fire' for the rebound of the wedge after it was struck by the sledge hammer;
- ◆ The injured person was not wearing a face shield whilst removing the wedge;

- ◆ Established procedures did not adequately recognise or cover the hazards for the task being performed.

Showing worksite and position of wedge

- ◆ The use of wedges for this process should be eliminated and the appropriate alternative tools used for pin alignment and removal;
- ◆ Appropriate personal protective equipment (PPE) including face shields should be used for required wedge hammering, impacting and banding operations;
- ◆ More detailed work plans were developed down to the task level, including specific PPE for each task, appropriate tools and body positioning.

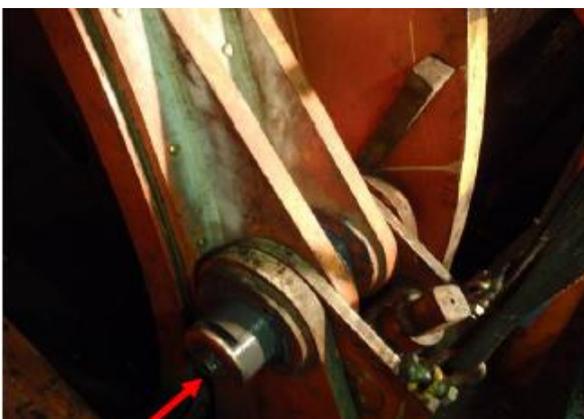
During the insertion of the brake belt pin with the help of a hydraulic jack, a steel wedge (weight 2.4 kilograms) was used to hold the foundation plate in the right position. Just before the pin was fully inserted in the pad eye/hinge-point, the wedge came loose with a lot of energy, and hit the injured person who was not wearing gloves, against his right hand. The injured person received the necessary medical treatment (four stitches) and was subsequently able to continue work under restricted conditions.

Installation of brake pin using hydraulic jack (red arrow)

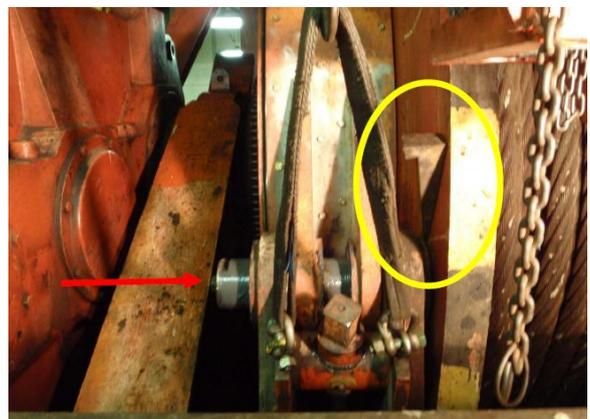
- ◆ There were two direct causes of the incident:
 - the injured person's position with respect to the job he was doing
 - the improper position of equipment used – the steel wedge;
- ◆ The root cause of the incident was considered to be **inadequate experience/supervision** (the injured person had less than three months' experience on this vessel);
- ◆ A significant contributing factor was that the injured person was not using available PPE (gloves) and was performing the task in a tight/cramped working area.

The wedge which came loose (yellow circle)

- ◆ Time out for safety: work was stopped and incident discussed with personnel involved;
- ◆ Further emphasis was given to the importance of safe position with respect to unexpected flying objects;
- ◆ Further guidance and job instructions were given to relative newcomers;
- ◆ Shared lessons were discussed at shift briefings.

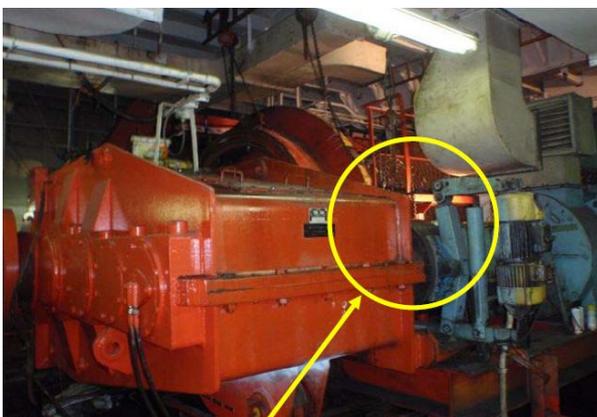
Overview of worksite and position of injured person (injured person NOT shown)
