IMCA Safety Flash 08/15

June 2015

I Near Miss: Hot Work in No Weld Zone

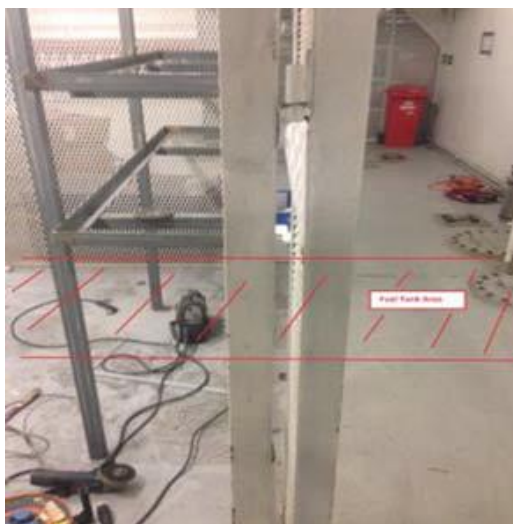
A member has reported an incident in which crew were found conducting welding operations in an area of a vessel where hot work was forbidden. The incident occurred when arrangements were being made for the installation of steel shelves in a storage cage on the upper tween deck. This area 'upper tween deck' is below the main deck, amidships.

A permit to work was raised for this operation and was signed by the rigging supervisor as Area Authority. The welder set up the required equipment at the worksite and was in the initial stages of the task when the Chief Engineer walked by on a routine inspection and stopped the job. The Chief Engineer explained to the welder that he was about to weld onto a fuel tank which is located on the other side of the deck, and called an **ALL STOP**.

Figure: Work site (No Weld area highlighted)

- ◆ Inadequate task plan;
- ◆ Inadequate communication of task plan;
- ◆ Lack of awareness/perception of risk;
- ◆ Inadequate attention to detail;
- ◆ Unclear/conflicting lines of responsibility;
- ◆ Insufficient warning signage;
- ◆ Following usual task;
- ◆ Poor housekeeping.

- ◆ Identified all **no weld** areas on vessels and ensured they were suitably marked/highlighted and **'No Welding'** signage was clear from all directions;
- ◆ Ensured that vessel GA (General Arrangement drawings) were used to show location of open permits and to assist in de-conflicting permits and hot work, had all the **no weld** zones/areas clearly marked to assist in the approval of Hot Work permits and to prevent approval being given for hot work on '**no weld** areas';
- ◆ Ensure that persons responsible for issuing Permits to Work were suitably trained and fully understand their roles and responsibilities;
- ◆ Ensure that those who were "Area Authorities" fully understand the hazards and restrictions associated with those areas.

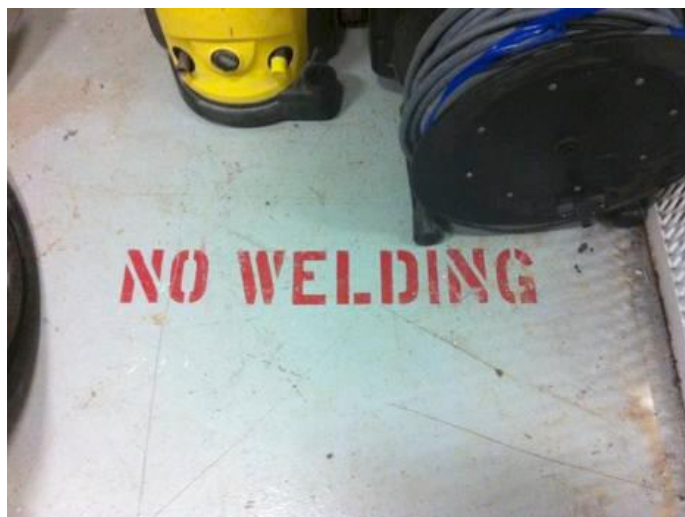
Figure: "No welding" marking which was covered over

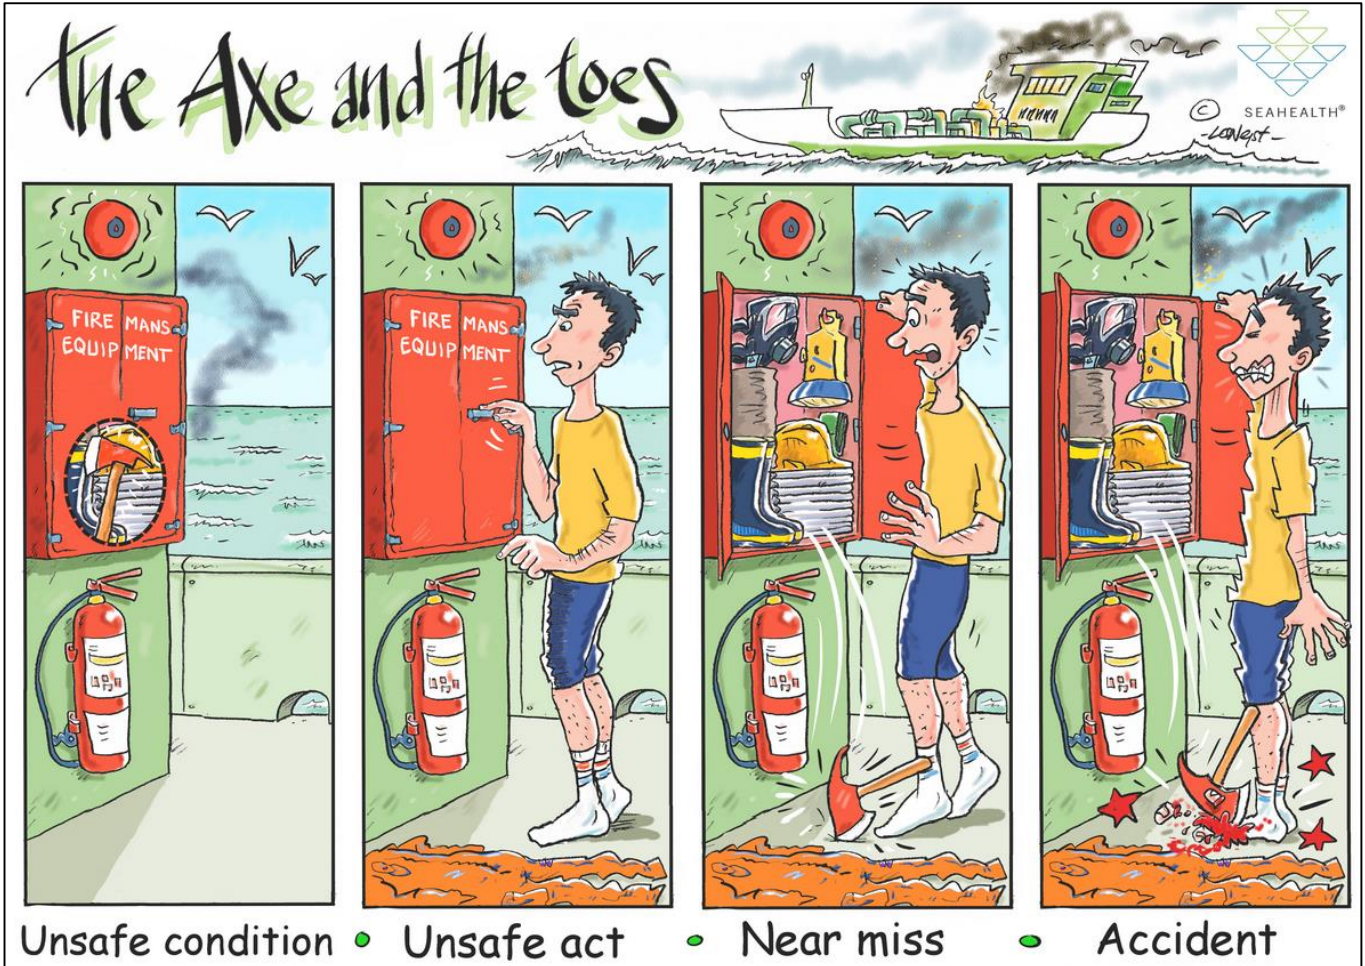
The Danish organisation SEAHEALTH www.seahealth.dk/en has published the following near miss report of how an axe fell from a cabinet, narrowly missing someone's toes. A crewman was preparing to get fire-fighting equipment out of the fireman's equipment cabinet, when the fire axe fell out and fell 1.5m to the floor. The axe landed blade down only a few centimetres from the crewman – who at that moment was in his socks, wearing no toe-cap boots, as he was preparing to don a fireman's outfit.

This cartoon neatly explains the difference between unsafe conditions, unsafe acts, near misses, and actual incidents. Further similar cartoons and explanatory information was available here: <http://uk.nearmiss.dk/knowledge/what-is-what/>.
