## IMCA Safety Flash 08/18

April 2018

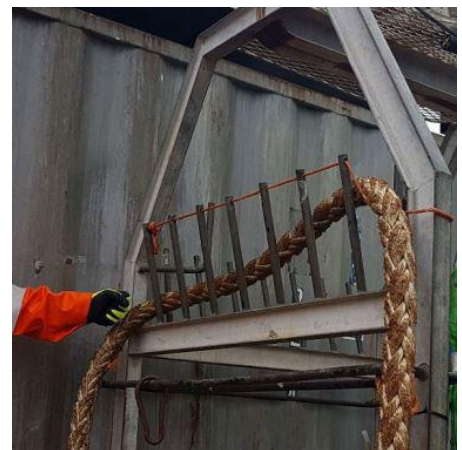
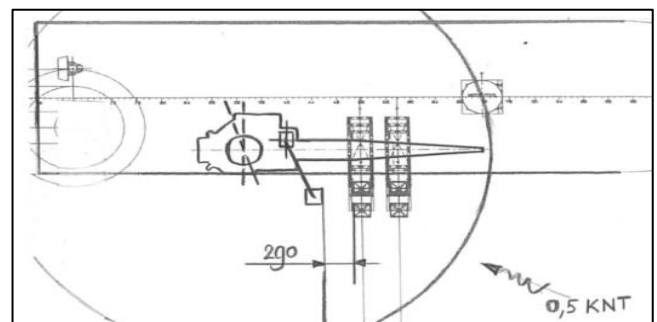
A diver's umbilical became snagged on a tool basket during recovery. An 'all stop' was called, the umbilical was freed and the divers were recovered safely. The incident occurred during the recovery of two divers working from a diving basket at 22m water depth.

The tool basket was recovered adjacent to the diving basket using a small hydraulic crane. Just before arriving at the surface, the hold-back rope broke and the remaining 4m of umbilical started to be pulled through the guiding hole in the roof of the diving basket. When the diver noticed that he was being pulled towards the roof of the basket he immediately called an 'all stop'. At the same time, an 'all stop' was also called by the tender on deck when he noticed that the umbilical was getting too close to the tool basket. The crane operator immediately stopped the crane with the tool basket approximately 2m below the surface. The snagged umbilical was visible on the tool basket. The tool basket was then lowered and the tender pulled the umbilical free. The diver had approximately 0.5m of free umbilical remaining in the basket. After the umbilical was freed, he pulled a further 3.5m of umbilical through and secured it back into the diving basket.

- ◆ There was insufficient horizontal separation between the tool basket being recovered and the diving basket;
  - the horizontal distance during lifting, between the tool basket and the diving basket, was not properly risk assessed. The distance between the crane wire and the diving basket was 2.9m on the surface during the lift which seemed sufficient at that time

- in this case, the slack of the umbilical was pushed in the direction of the tool basket by a 0.5kt current, despite the tender pulling up and tensioning the umbilical “as normal”. The distance between the tool basket and the diving basket was known and visible at the surface but might have been different subsea
- the crane driver did not swing the crane to maximise the distance between the lift and diving basket, as there was no proper risk assessment and associated set of instructions to do so;
- ◆ There was too much slack in the diver’s umbilical from basket to surface;
- ◆ The tool basket had protruding pins which were a snag hazard.

- ◆ The addition of ‘operation of the auxiliary crane’ to the Vessel specific manual;
- ◆ Creation of a checklist/familiarization for an auxiliary crane operator;
- ◆ Thorough check of Diver Supervisor communications with regard to criticality and ‘fail safe’;
- ◆ Provision of detailed instruction, guidance and information on acceptable slack for the tender;
- ◆ Removed the pins creating a snagging hazard from the outside of all tool baskets in use.

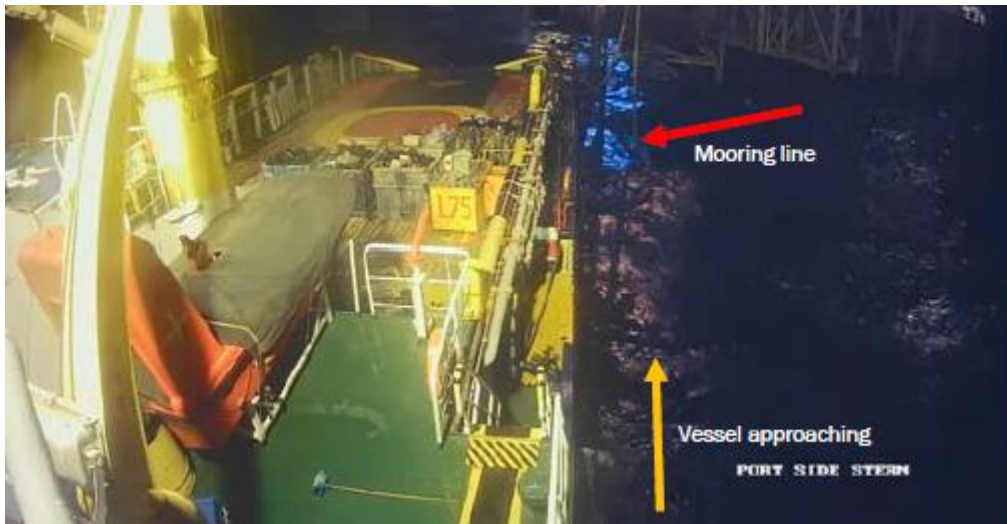
At this time, part of mooring rope was lowered to the water. There was a miscommunication between the crane operator and the deck crew, and as a result the rope was fouled on the port side propeller resulting in a subsequent port side engine shut down and partial loss of vessel propulsion.

- ◆ There was a lack of proper planning and risk assessment during the mooring operation;
- ◆ There was inadequate communication between the platform crane operator and the mooring crew on deck, which resulted in the mooring line being dropped in the water;
- ◆ The deck crew did not notify the bridge in a timely manner when the rope was lowered into the water, and thus the propeller was fouled by the rope.

- ◆ There needs to be adequate means of communication between crane operator, deck mooring team and bridge officer on watch (OOW);
- ◆ Proper attention should be paid to the job in hand during mooring operations to ensure a timely reaction to any unforeseen events;
- ◆ More detailed risk assessment required for this task where the vessel takes a mooring rope from a platform or rig;
- ◆ Stop work authority should be exercised when in doubt.

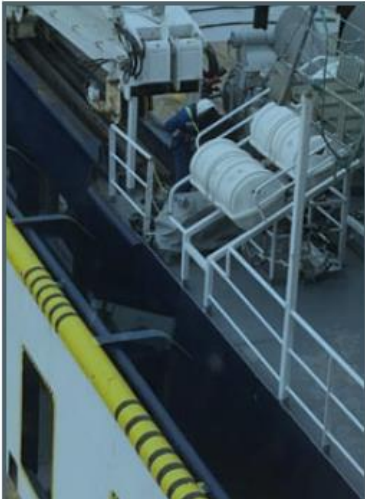
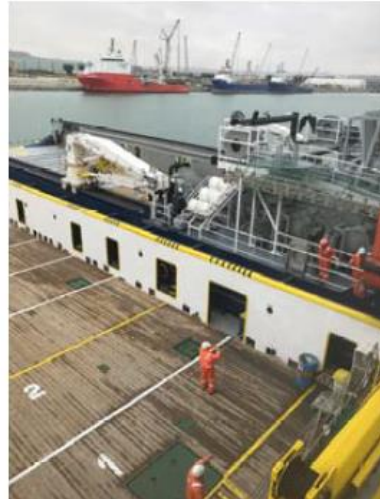
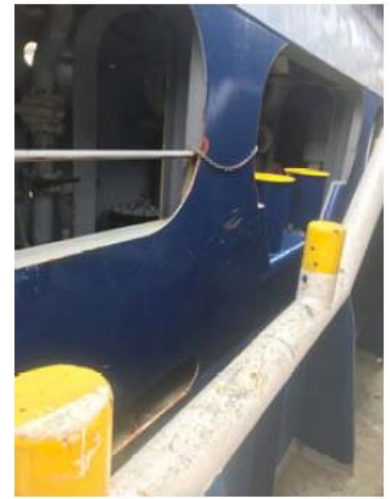
Three people from a sub-contractor were observed trying to move from vessel to vessel whilst alongside, by slipping through the bulwark guardrails. There was no proper gangway in place. The personnel were stopped and company requirements on safe access between vessels was explained to them. The vessel subsequently changed its location and moored to the quayside and a gangway was deployed for safe access. Though there were no injuries, the case was raised as a near miss given the high potential for serious injury.

Company safety management system (SMS) requirements for safe access were re-emphasised to all relevant contractors accessing the vessel. A revision would be conducted of company checklists for visitor/3rd party safety inductions to ensure that the communication of the need for safe access & egress requirements to any visitor when accessing the vessel.

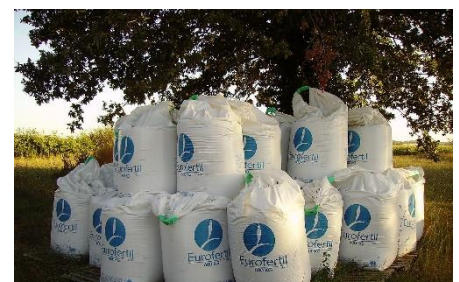
A 600kg flexible intermediate bulk container (FIBC) bag of Ammonium Nitrate fell onto an employee as he was removing pallets from the front of a stack. He suffered multiple fractures, a dislocated ankle and knee and back injuries, and he was unable to work for thirteen weeks.

The HSE investigation found that the company had failed to follow their own risk assessments, by stacking FIBC bags directly on top of one another rather than in the recognised industry standard of stacking in a pyramid fashion. The company had also failed to review their stacking practice following earlier incidents of bag spills and stack collapses on the dockside.

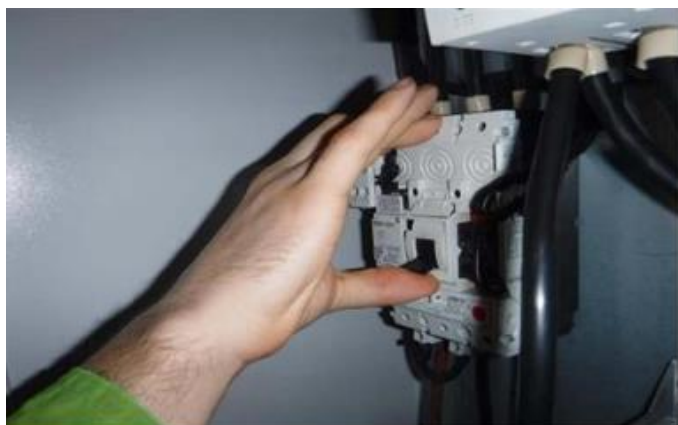
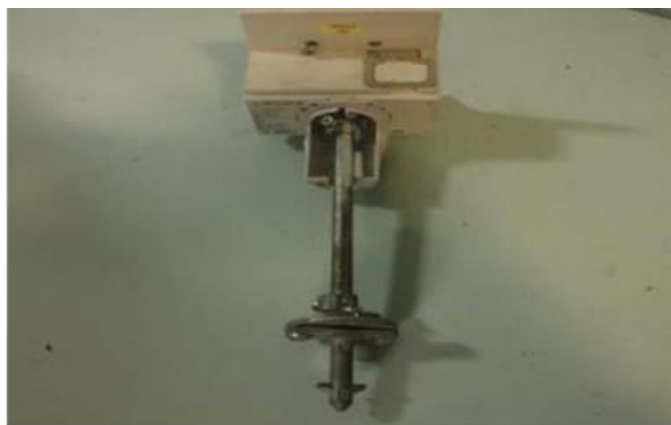
The Marine Safety Forum (MSF) reports an incident in which a worker on a vessel was working on the operating panel for a 690 VAC anti-heeling pump, when he received a burn to his middle finger; he got burnt when he reset the breaker switch. This resulted in a first aid case and he was treated on board.

- ◆ No work or maintenance was being carried out on the inside of the cabinet, so there was no permit to work or isolation (the breaker was the method of isolation);
- ◆ The breaker was never 'live' – the burn was due to the heating of the breaker due to it being of an incorrect rating. This was confirmed afterwards through numerous simulations and calculations.

- ◆ Rotary isolation switch within the electrical cabinet was broken and had been removed;
- ◆ There had been a failure to follow defect reporting procedure;
- ◆ Due to a missing isolation switch, direct contact had to be gained internally to reset breaker;

- ◆ A new rotary isolation switch was fitted to the breaker switch;
- ◆ All similar cabinets on board were checked and rotary switches fitted as required;
- ◆ A full onshore investigation was initiated due to the perceived potential severity of the incident;
- ◆ Upon further investigation, it was found that a change in the cable length after the cabinet from the system design to actual build meant that the breaker was insufficient and had a tendency to heat up. This cable was also replaced.
