IMCA Safety Flash 08/19

April 2019

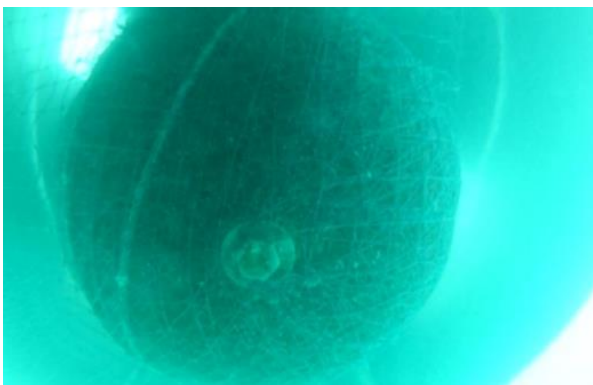
The propulsion system was stopped before completing a visual inspection at the stern of the vessel. Fishing nets were observed on the port side, leading beneath the vessel. It was confirmed that the fishing nets were entangled in both propellers, disabling both and leading to limited vessel manoeuvrability. The bow thruster was used to maintain control of the vessel and slow down to drift towards the shore. In due course, the vessel was able to anchor in a safe location away from seabed assets and await assistance.

Port Propeller (As Found)

- ◆ Suspension of operations until such a time that a review and improvement of the project risk assessment document was completed to fully capture the scenario where multiple propellers and/or thrusters are compromised/immobilised due to entanglement with fishing nets or other floating debris;
- ◆ A proper look-out should be maintained by sight and hearing as well as by all available means appropriate in the prevailing circumstances and conditions, so as to make a full appraisal of the situation and reduce the risk of encountering in/on water debris/fishing activities. If hazards are observed and considered by the Officer of the Watch (OoW) to pose a significant risk to the vessel, consider suspending operations.

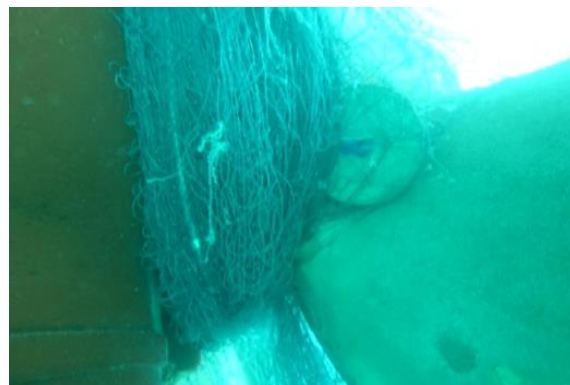
Starboard Propeller (As Found)

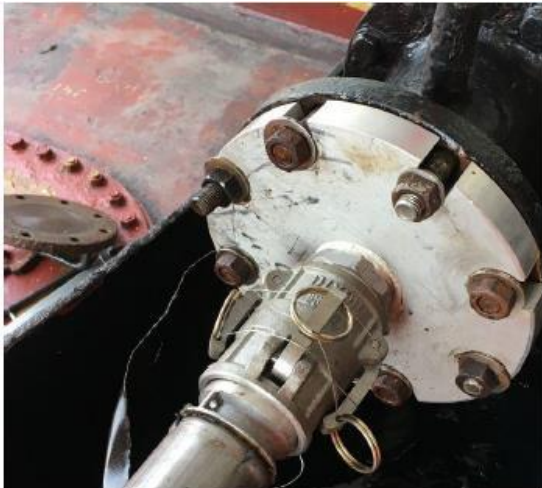
To investigate the reason for the back pressure, suspecting that the manifold valve was not functioning properly, the Chief Engineer instructed the Fitter to open the hose coupling at the manifold. As soon as the coupling was loosened, fuel oil sprayed out onto the pier due to pressure in the pipe. Disconnection was stopped immediately, and the spilt oil was contained in the save-all at the manifold.

Bunker hose connection at ship's bunker manifold

- ♦ The immediate cause was carelessness; without giving the problem much thought the Chief Engineer decided to open the hose coupling without checking if the bunker line was drained properly;
- ♦ Causal factors were inadequate planning and inadequate maintenance/supervision;
- ♦ The root causes identified were:
 - the Chief Engineer was not able to methodically diagnose the reason for the back pressure and did not consider the risks involved in opening the hose coupling without checking that the line was not pressurised
 - there was no check of residual oil in the line by opening the drain dock
 - no instruction was given to the truck driver to open the truck valve to allow the oil to drain back into the truck.

A full review of bunkering procedures took place.

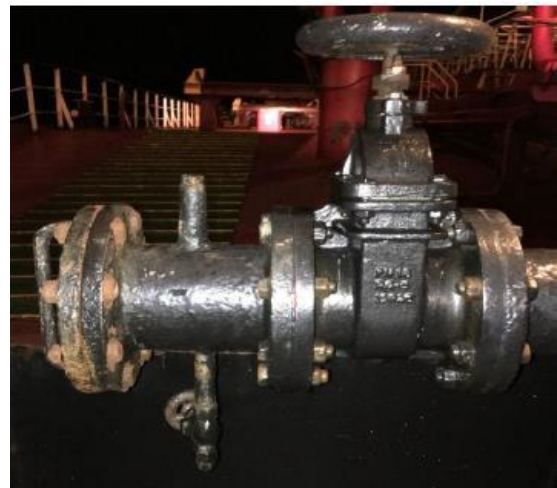
Ship's bunker manifold valve

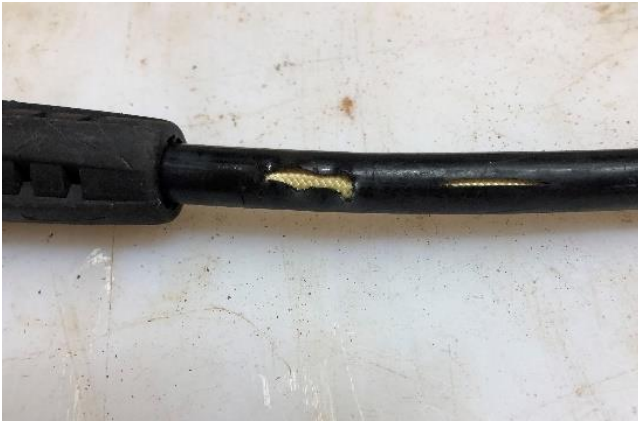
Damaged hose showed cuts in outer skin

- ◆ There were two different types of damage:
 - cuts; most likely caused by sharp mussels and stones (illustration above left)
 - damage caused by bending and overstressing (illustration above right);
- ◆ Both hoses were leak tested and found to be leaking through holes near the ferrule connector;
- ◆ Both hoses were fitted with bend restrictors;
- ◆ The hoses were maintained and tested in accordance with [Code of practice for the initial and periodic examination, testing and certification of diving plant and equipment \(IMCA D 018\)](#);
- ◆ The hoses were subjected to a regular visual inspection before every dive;
- ◆ Both hoses were in use for up to 4 years and were regularly used.

Both hoses were replaced for new hoses.

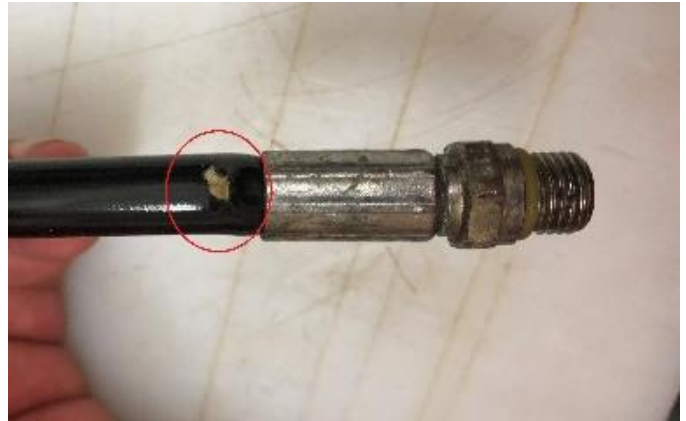
Damaged hose showed a damaged outer skin near the ferrule

Investigation suggested that one type of HP hose is prone to damage near the ferrule connector, caused by bending and stressing, regardless of the use of a bend restrictor present at this location. The damage was not sustained in one single occasion but is believed to have developed over time.

- ◆ Hose type 1: fatigue like damage may occur near the ferrule over time. When this damage occurs, it can lead to loss of the bail-out within a dive. In order to reduce the risk of this type of damage occurring, annual replacement may be required, depending on usage.
- ◆ Hose type 2: does not show the same fatigue damage development as the construction is more flexible and rugged.

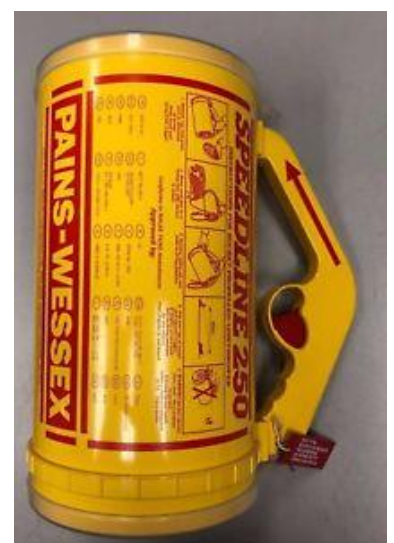
A fire alarm went off; the location of the fire was confirmed, and a team went for investigation. Heavy smoke was observed coming from a spare cabin. The incident occurred on a vessel working within 500m of a rig. The rig was informed, the vessel stopped work and immediately left the 500m safety zone. A fully equipped fire team entered the cabin and it was found that the smoke was coming from an expired line-throwing apparatus (LTA) cartridge, which was being kept for disposal.

- ◆ The expired pyrotechnics were stored for an extended period onboard the vessel.
- ◆ Inadequate work procedure and poor perception of risk.

- ◆ Expired pyrotechnics should be showed in an appropriate, safe and properly marked location;
- ◆ Old pyrotechnics should not be stored on the vessel for long periods.

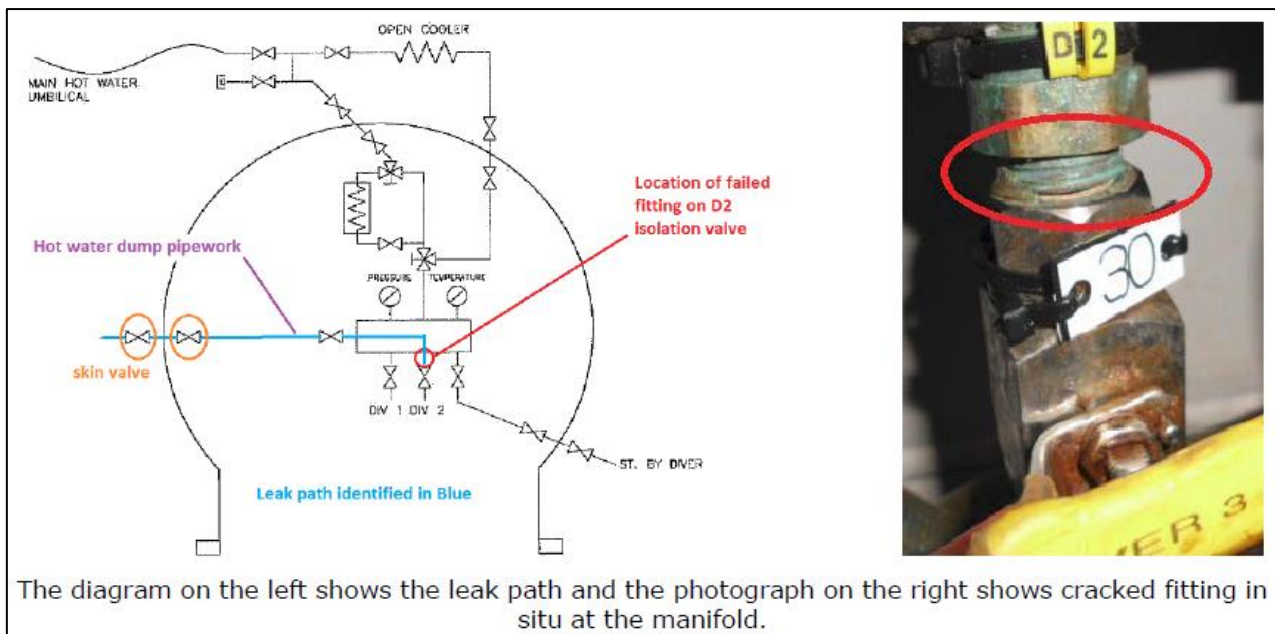
Upon further investigation, it was established that the D2 hot water fitting (see picture below) which connects the isolation valve was cracked. This opened a leak path via the crack to atmosphere.

- ◆ The failure of the fitting is believed to have been caused by the impact sustained from a diver's bail out bottle making contact with the unprotected fittings at the manifold;
- ◆ The bell was completely refurbished during a dry docking in 2011;
- ◆ There were no records of the fittings being replaced in the company planned maintenance system (PMS);

- ◆ Review similar existing fittings to verify if there has been any impact damage and also if there is the potential for impact damage;
- ◆ Ensure all critical components are recorded in PMSs and that they also meet the requirements of [Code of practice for the initial and periodic examination, testing and certification of diving plant and equipment \(IMCA D 018\)](#).
