1 Malfunctions of Kirby Morgan B17 Side Block Non Return Valve

2 Serious Injury During Crane Operations

Safety Notice # 1 of 2005
Defective One Way Valve Recall
July 12, 2005

Subject:
Circle Seal Controls, Inc. One-Way Valve Part P214-180.
Defective Valve Dates 12/04 thru 2/05

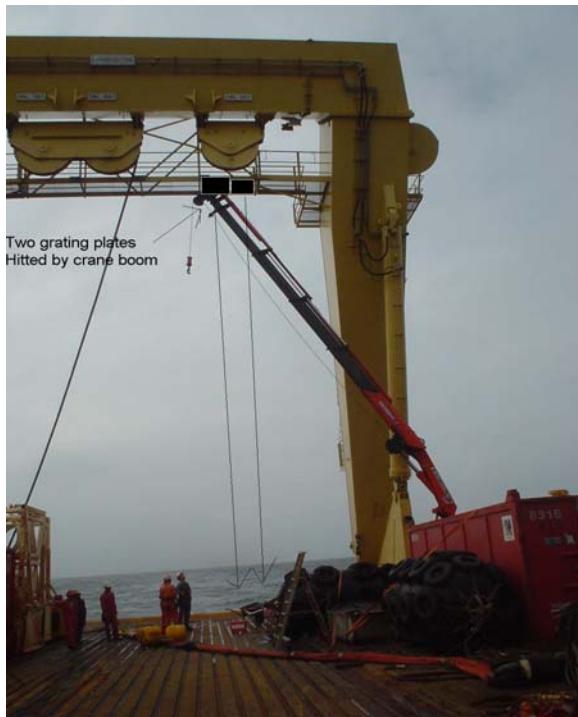
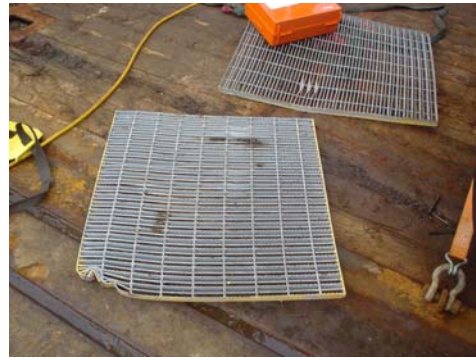
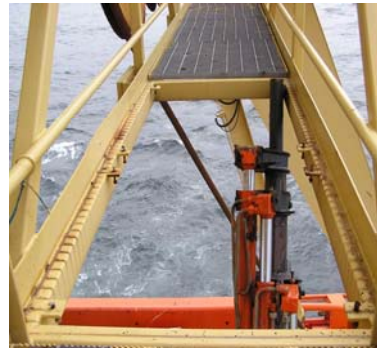
The crane operator, controlling the crane using the remote control flying lead, was repositioning the crane for the next operation when he drove the head of the boom up and into the grating floor of the A-frame walkway, 14 metres above the main deck. The grating came loose due to the force and fell. The crane operator, who was standing directly underneath the grating, was hit on the head and then the left foot by the falling grating, estimated to weigh between 10-12 kg.

Although the injured person suffered four broken bones in his left foot, a wound to his left elbow and superficial injuries to his head (cut/bruising), the company concerned has noted that the potential for a fatality to have occurred in this incident cannot be over-emphasised.

- ◆ Lack of care and attention – This was a routine operation performed by the most experienced crane operator on the vessel. Checks of the height of the crane boom in relation to overhead hazards should have been carried out prior to any crane movement;
- ◆ Incorrect working position – The crane operator had failed to stand in a safe working position and was directly under the hazard. As a result of incorrect working position, he would have been unable to judge the height of the crane boom in relation to the A-frame walkway;
- ◆ Incorrect PPE – The injured person was not wearing safety boots but was in fact wearing backless safety shoes (clogs).

- ◆ During routine work there is the possibility for complacency to arise, so treat every task as if it is a new task;
- ◆ Examine your working position before starting work and ensure you assume the safest position for the task;

Consider industry best practice for lifting, requiring three personnel to be involved in every lift – crane operator, banksman and load handler.

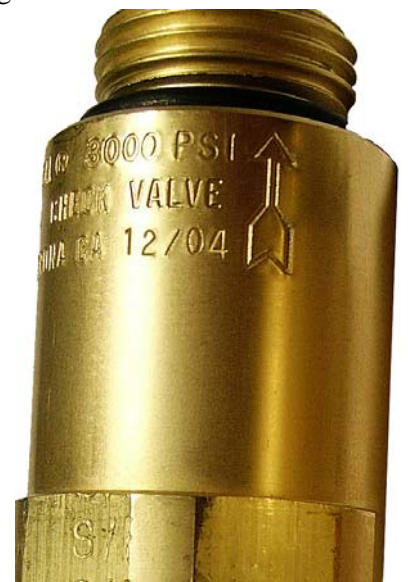
In the defective valves, small slivers of the Teflon wiper (used in these valves as part of the sealing mechanism) may be cut off the Teflon wiper and interfere with the poppet that seals the valve. When this occurs it is possible for air from the helmet or emergency gas supply to be lost through the valve if the diver's umbilical has been severed or umbilical pressure is lost for any reason. This could lead to the diver suffering severe personal injury, known as a "squeeze," or death.

Photo Caption: *Please note the date stamp of 12/04 on the valve shown here. This is where to locate the date on your valve. All valves within the date range 12/04 to 2/05 should be replaced immediately.*

If you have one of these valves on your helmet, or are carrying a valve like this as a spare, **DO NOT DIVE WITH IT!** Please return it immediately to KMDSI, or any of its dealers, for a free replacement. KMDSI can be reached at 1430 Jason Way, Santa Maria, CA 93455. Telephone 805-928-7772, FAX 805-928-0342. Email kirwin@kirbymorgan.com. Website www.kirbymorgan.com.
