1 Near-Miss Involving Hyflex Fire Extinguisher Refill Kits

2 Fatal Accident with Lifting Appliance

3 Small Fire Caused by Toaster in Mess Room

**Hyfex Fire Extinguisher Refill Kits
Part No's SE4816 and SE4817**

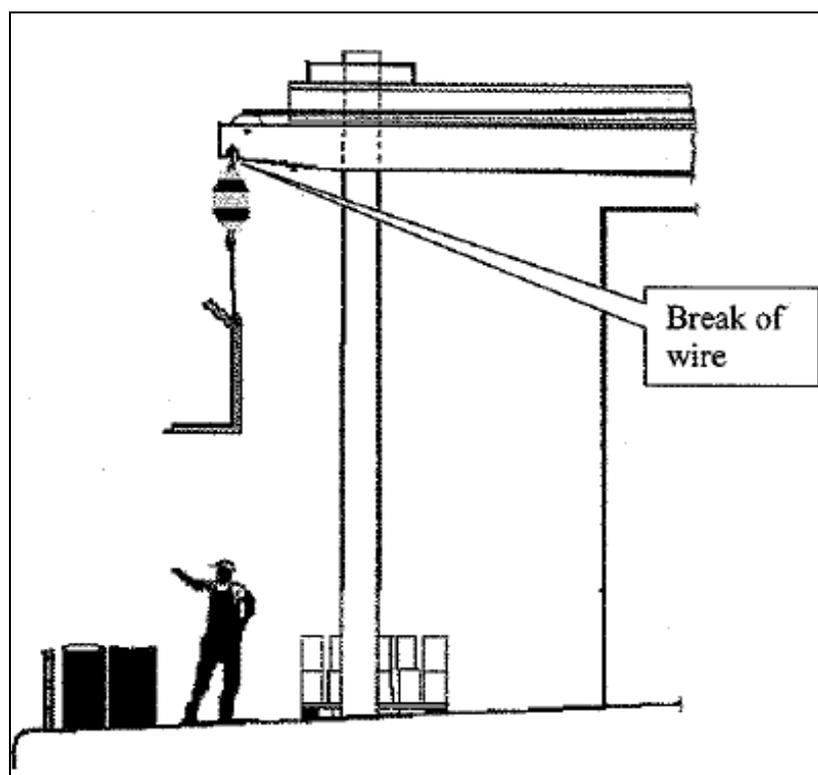
IMCA has received a reports on a fatal incident during a lifting operation. A provisions crane was loading pallets onto a vessel using a pallet fork. After landing a pallet on the deck, the pallet fork was pulled clear and the crane operator moved the crane outward to pick up the next load. During this operation, the crane winch wire snapped. The pallet fork fell onto the deck, landing on a member of the crew, who subsequently died of his injuries.

Sketch of lifting equipment

The company noted the following causes to the incident:

- ◆ a malfunctioning or missing 'upper limit switch';
- ◆ the wire end at the hook side was terminated by means of three incorrectly-applied U-bolt clamps instead of a ferrule and swage (see figures overleaf).

- ◆ Limit switches are important safety equipment that should be tested regularly to confirm their proper operation

- ◆ Winch wire end terminations should be correctly performed.
- ◆ Cranes should be inspected before lifting operations, using an approved check-list
- ◆ Procedures should be established to ensure personnel are properly informed of the hazards involved in crane operations, and do not stand underneath loads

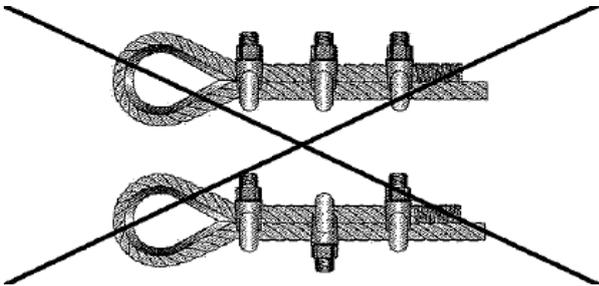
Incorrect method of attaching clamps to winch wires.

Example of a correctly prepared ferrule lock. Other techniques acceptable to classification societies and/or the crane manufacturer may be used.

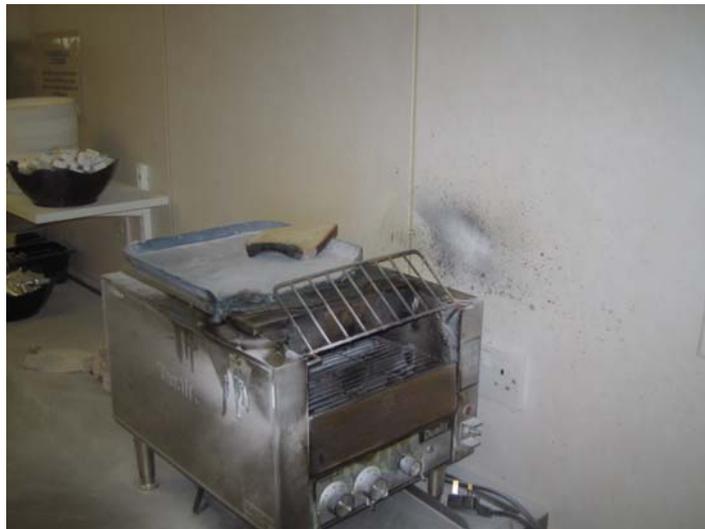
A plastic tray had been left on top of a conveyor toaster. A member of the crew entered the mess room, plugged in and turned on the toaster. The tray was not taken off of the top of the toaster. The person then left the mess room without turning off the toaster. Subsequently the plastic tray holding the bread melted and caught fire.

The fire was successfully extinguished with a dry powder extinguisher and there were no injuries.

- ◆ Ensure that no items are placed on top of this type of toaster even when not in use;
- ◆ Consider the use of guards and/or signs;
- ◆ When this type of toaster is in use, the user should remain in attendance and switch it off before leaving;
- ◆ Consider the suitability of certain types of toaster for a given location;
- ◆ Crew should be reminded about the need for basic safety awareness even when engaged in everyday domestic tasks.

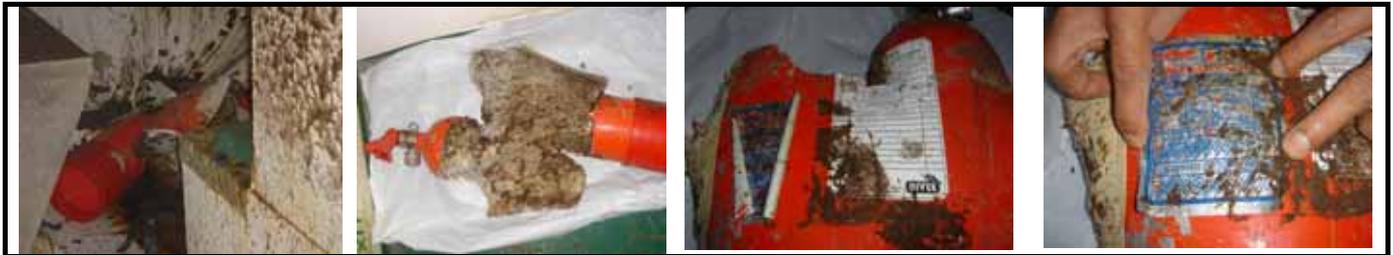
An installed Hyfex Hyperbaric Fire Extinguisher has recently catastrophically ruptured inside a decompression chamber. Fortunately no personnel were injured as a result of the incident and only minor damage occurred to the interior of the decompression chamber. The photographs below indicate the potential severity of the failure:

Investigation has revealed that the interior wall of the fire extinguisher was badly corroded, in places the wall thickness was only approximately **2mm thick**. Typically wall thickness should be approximately **4.2mm and 6.3mm thick based on the type of cylinder**.

The users' contract for maintenance had recently been awarded to a local service company in the country of operation and the maintenance and servicing process was not carried out as per Divex requirements. It was obvious that the Servicing Company did not fully understand what was required of them.

The contents of the ruptured extinguisher seem to indicate that the wrong type of foaming agent has been used and that it has had a significant influence on the high levels of corrosion. Initial appearances are that a "protein based" foam agent such as "bull's blood" with a high level of iron content may have been used. This is difficult to quantify at present.

- Clients (users) need to refill Hyfex Extinguishers with Divex AFFF Refill Packs (SE4816 (3Ltr) and SE4817 (7.5 Ltr));
- Users must ensure their sub-contractors are fully aware of technical requirements and hold the necessary factory / manufacturers training.
- Issue Divex HSE Alert to all trade associations (e.g. IMCA, ADC (UK) and ADC (USA));
- Issue Divex HSE Alert to all known purchasers of Divex Hyfex Extinguishers;
- Distribute Divex HSE Alert to all Divex locations.
