IMCA Safety Flash 09/07

October 2007

I Pinch Points on Winches – Hand Safety

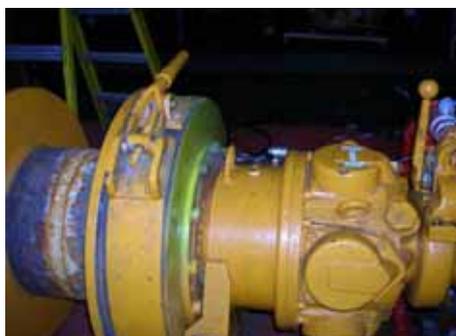
Figure 1 – Typical tugger winch

A member has identified a potentially serious hazard on a tugger winch, temporarily installed on a vessel deck, wherein a hand could be ‘drawn in’ between the winch drum cheek plate and the winch base.

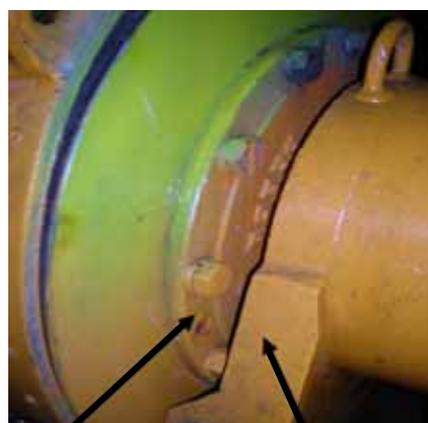
Rotating ring of bolts Stationary winch base
Figure 2 – Detail of gap between winch drum cheek plate and the winch base

The operator for such a winch would typically stand with his right hand on the control lever. It is possible that an operator (or colleague standing nearby) could put his left hand on the winch base, for example to brace against vessel movement. If the winch was pulling in at the same time a hand could be drawn into the gap between the bolts and the base.

These winches or similar models are in widespread use and not all of them have adequate guards. It is recommended that winches with unguarded pinch-point hazards are identified and appropriate actions taken as an immediate measure:

- ◆ Hazard warning signs should be applied to the winches;
- ◆ Personnel operating or working in the vicinity of the winches should be briefed about the potential hazard.
