IMCA Safety Flash 09/08

May 2008

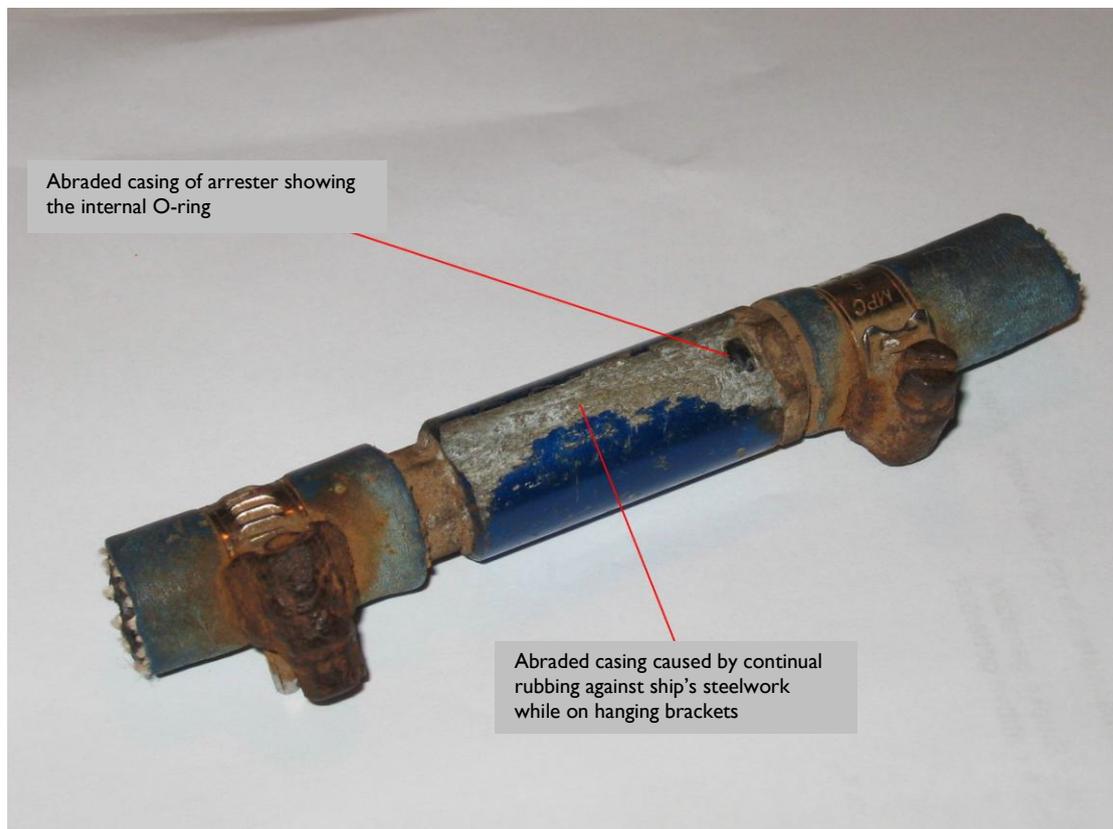
A member has reported a case of serious abrasion on the metal casing of the flame arrester on an oxygen hose. This was discovered during routine replacement of the securing Jubilee clips on the oxygen hose flame arresters.

Where the hose had been left coiled on its storage brackets and had been able to swing freely back and forth with the movement of the vessel, it was noticed that this had resulted in the abrasion of the underside of the metal casing of the flame arrester. The resulting wear on the metal was sufficient to reveal the O-ring inside the arrester, as can be seen in the photograph.

This rendered the arrester useless, and it is evident from the photograph that oxygen would now be able to leak freely past this area and into the atmosphere, thereby enriching it and making it more readily combustible should fire or a cause of ignition occur.

Jubilee clips may be considered inappropriate for such hose connections as they can easily corrode and, due to their small size, do not provide an adequate sealing effect. Members are recommended to check all such hoses and arresters for wear and damage: this equipment is sometimes needed in a hurry and should always be in a serviceable condition.
