IMCA Safety Flash 09/13

June 2013

I High Potential Near Miss: Dropped ROV/TMS Leading to Equipment Damage

2 Failure of Lifting Equipment: Dropped ROV

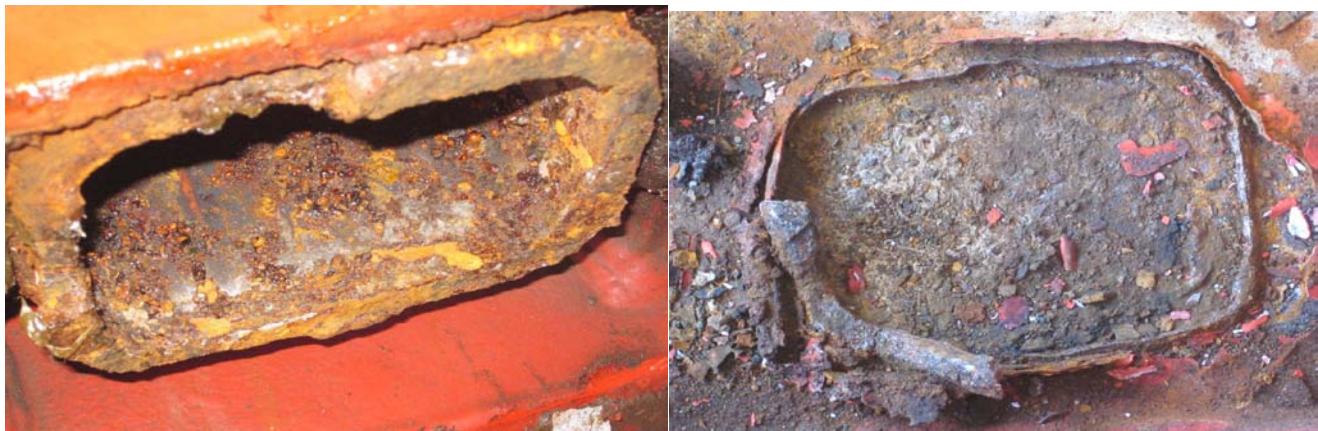
Figure (L) showing guide bar and (R) guide

- ◆ The two snubbing damping cylinder rams had stripped out from their clevis threads on the swing frame;
- ◆ The welds between the sheave guide posts and the docking head had also separated;
- ◆ The initial investigation suggested that the guide post welds had been compromised, allowing movement of the docking head out with the design of this system. This movement eventually transferred through to the damping cylinder clevis points, causing stretching of the clevis points over time until they reached a failure point;
- ◆ The stresses that led to the guide post weld failures were most likely to have been induced over time by operating the A-frame with the damping cylinders in the locked position.

- The preliminary investigation indicates that the stress on the guide post welds is possibly a result of the A-frame being operated with the system in the "locked" position over a period of time;

- ◆ Inspection and Maintenance
 - Inspection of the weld areas between the sheave guide posts and the docking box suggest that these areas had been compromised and possibly separated for some time prior to this incident, and should have been identified already as part of routine maintenance on the A-frame.

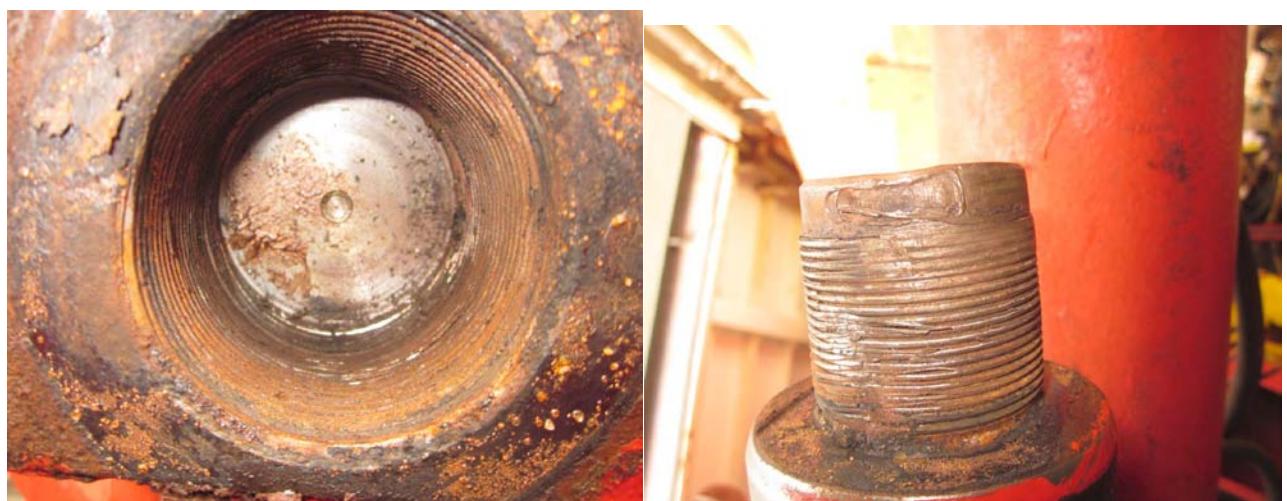
Figure: showing stripping out of threads

- ◆ Equipment
 - A review of the clevis design is required to assess their suitability for the loads to which they can be subjected;
- ◆ Procedures
 - The site-specific launch and recovery procedure called for putting the snubber ring in the "locked" position in marginal sea states to prevent excessive swinging of the ROV/TMS, for both launch and recovery. The manual for the type of A-frame involved in this incident makes specific references warning against moving the A-frame with the snubbing damping cylinders in the "locked" position;

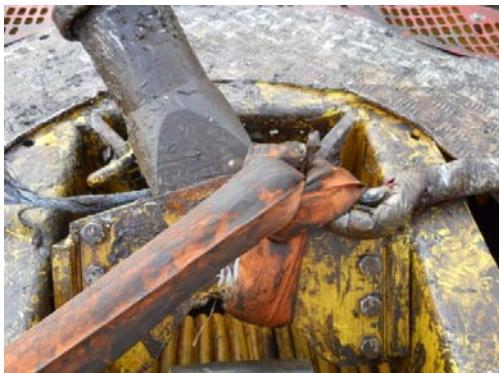
Figure 1: 10 tonne round fibre sling choked around the main lifting eye

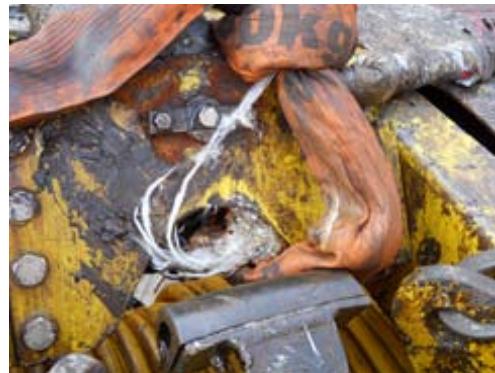
Figure 2: fibre sling was choked around a sharp edge

- ◆ The company's own safety management system was not followed by the involved personnel (watch-keeping officer, sub-contractor's staff and crane operator);
- ◆ No lift plan was conducted before the start of the operations;
- ◆ The on-duty deck foreman was not present on deck to supervise the operations;
- ◆ The adequate rigging equipment and accessories (9.7 tonne four leg assembly and four 4.75 tonne bow shackles) required to lift this particular load was not used, and a 10 tonne round fibre sling was used instead;
- ◆ The fibre sling was choked around a sharp edge, and no protection or "packing" was placed between the sling and the sharp edge.

- ◆ Ensure the rigging and lifting equipment and accessories cannot be damaged by sharp edges, chemicals, hot items etc.;
- ◆ Where appropriate, place protection or "packing" between slings and any identified sharp edges;

- ◆ Remind personnel that sharp edges do not have to be "razor-sharp" to cause failure of rigging equipment.

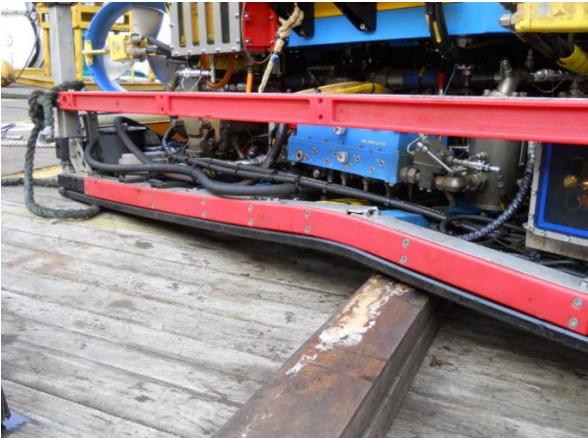
Figure 3: Damage to ROV frame

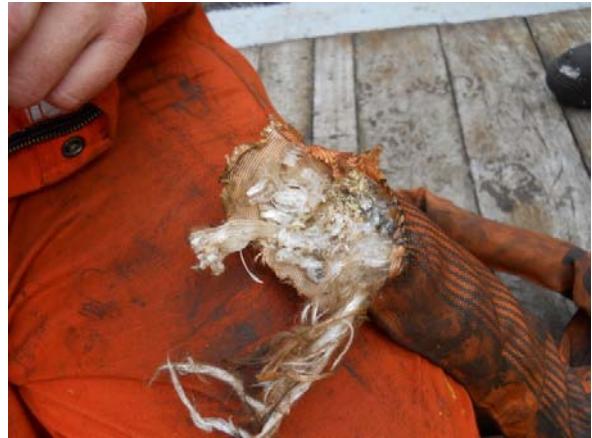
Figure 4: Sling after failure

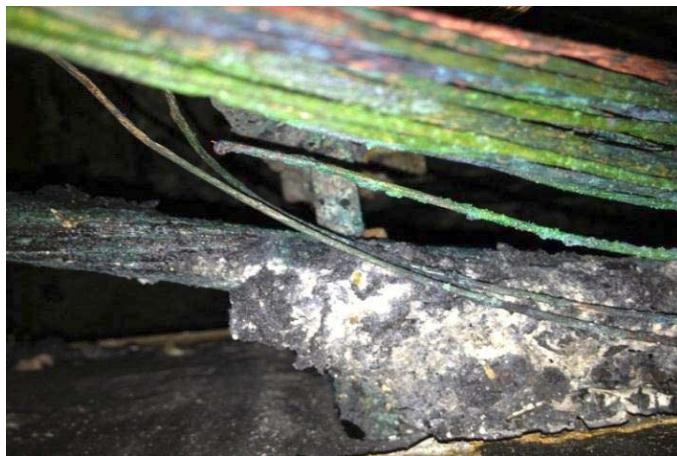
Figure 1: Generator cable caught fire suspected worn wiring over time and lay out cables over the terminal

- On board the vessel, two of three generators have a protection plate above the output plate, above the HV output terminals. This generator did not have that protection plate. There was evidence that the cable retaining bar was rusted and showing no signs of ever supporting cables. This would have meant that the starter motor cable was lying on top of the HV output terminals; over time this cable may have worn through due to vibration and causing a short circuit on phase 2, thus starting the fire;
- On examination, the phase 2 bus bar appeared to be touching the generator casing (see Figure 2). As the bus bar burnt, the heat inside the generator caused the cables on the cable retaining bar to fall. However, the expectation was that the cable retaining bar would be blackened and not rusted.

- Proper maintenance and routine check on generators and make sure no wiring laying across the terminal;
- All generators should have appropriate protection cover to prevent water getting inside the terminal;
- Fire extinguishers stood by near generators;
- Internal nuts and bolts to be checked, fitted with lock washers as appropriate, and tightened properly.

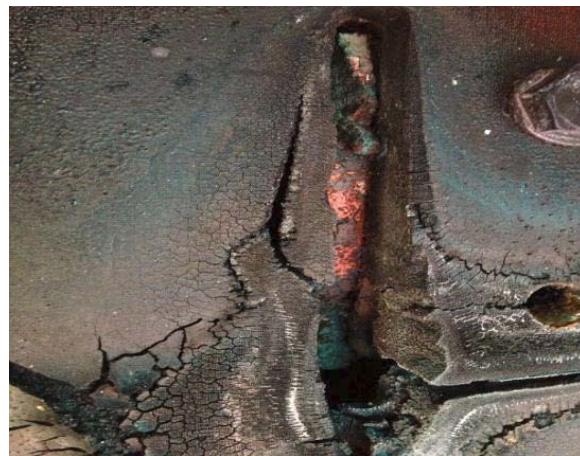
Figure 2: Phase 2 of the generator bus bar possibly contacting the generator casing; thus burning through phase 2 bus bar
