IMCA Safety Flash 09/18

April 2018

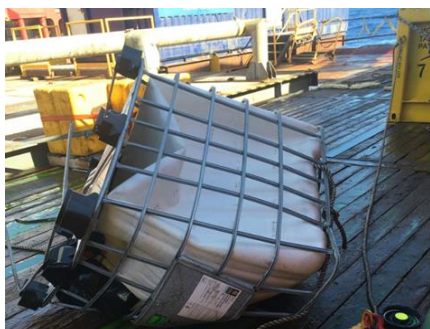
An intermediate bulk container (IBC) was dropped from a crane to deck. The incident occurred when a vessel crane was being used with a certified lifting device to lift and move an IBC containing 1000kg of monoethylene glycol. As the IBC was moved, the liquid inside was sloshed around (owing to the ‘free surface’ effect) which changed the centre of gravity. This change in the centre of gravity caused the IBC to rotate, resulting in the lift rigging device being unable to support the load. Subsequently the IBC fell approximately 3.5 metres to the deck and burst open, spilling the contents. The spill was contained onboard with no pollution to the environment.

Result of dropped object – IBC after loss of load

There was no adequate risk assessment of the effects of the possible combination of:

- ◆ The 'free surface' effect in the liquid within the IBC;
- ◆ Vessel movement in sea states (within limits and minor);
- ◆ Crane movement.

The rigging installed to lift the IBC – whilst certified – was of incorrect selection which created:

- ◆ Minimal resistance to side loading;
- ◆ The lift bars were able to slide under the base of the load;
- ◆ The load was lifted below the centre of gravity.

- ◆ Inadequate risk assessment of the lift;
- ◆ Inappropriate selection of rigging arrangement;
- ◆ Inappropriate design of storage equipment/containers for liquids which require movement in the offshore environment.

- ◆ Review and re-assess the selection and use of liquid storage containers;
- ◆ Review and re-assess the lifting and rigging arrangements in accordance to identified international standards;
- ◆ Lift plans and associated risk assessments should include not only lifting and rigging arrangements but also possible movement of loads within storage containers which may affect centre of gravity.

Our member also prohibited the lifting of IBC's utilising 'pallet' type rigging arrangements, and made arrangements to transfer all IBCs into appropriately designed and certified lifting frames.

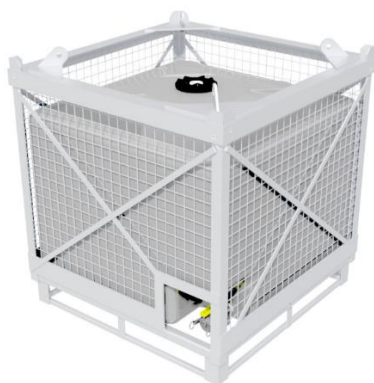
An IBC stored within appropriately designed lifting frame (note lift points at top of frame)

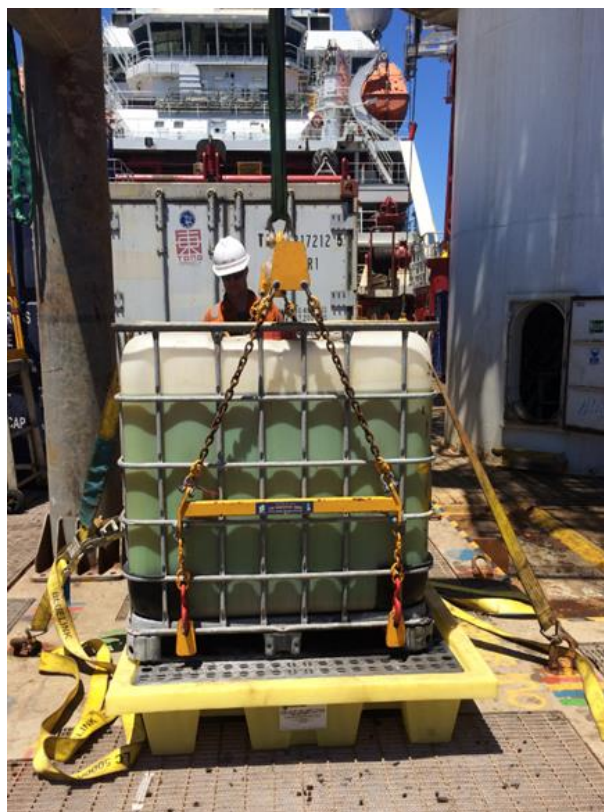
Lifting arrangement used in this incident (re-enactment)

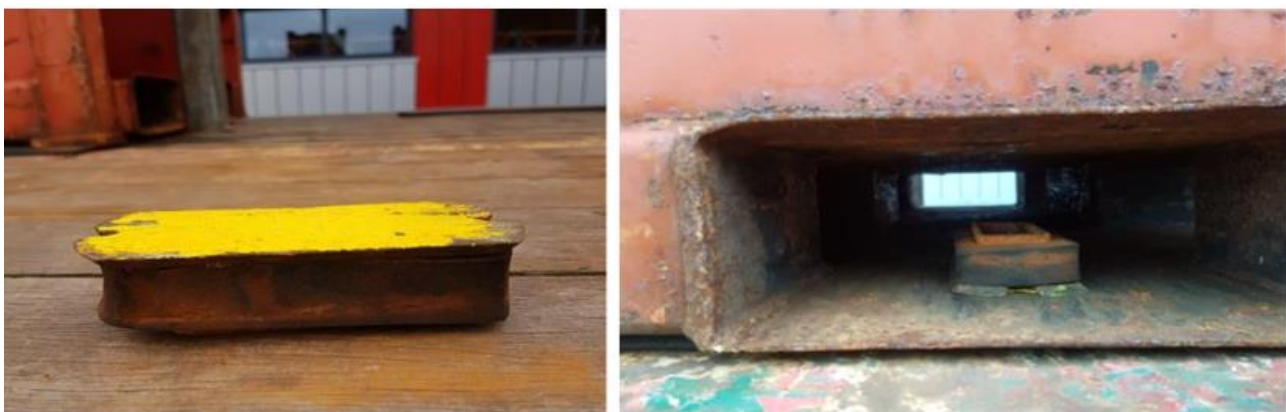
The Marine Safety Forum (MSF) reports a near miss incident in which a small protective cover was lost from the deck of a vessel, and was later found in the pocket of a five-foot container which had been offloaded ashore. This could have been a serious high potential dropped object risk to the crew, shore-side workers and to the general public.

An investigation revealed that the rubber which keeps the deck covers in place was in poor condition and this enabled them to become loose and be washed out during heavy weather. It was also observed that inadequate inspection and maintenance had been contributing factors.

A temporary deck cover was made to remove the tripping hazards created by the missing cover. New covers were ordered and delivered on board. Further recommendations were:

- ◆ Check the condition of the covers on a regular basis;
- ◆ The inspection of the covers should be part of the onboard planned maintenance system;
- ◆ After any heavy weather, deck crew should visually check the deck and if a cover is missing, try to locate the cover before discharging any cargo. This is to help prevent the possibility of dropped objects.

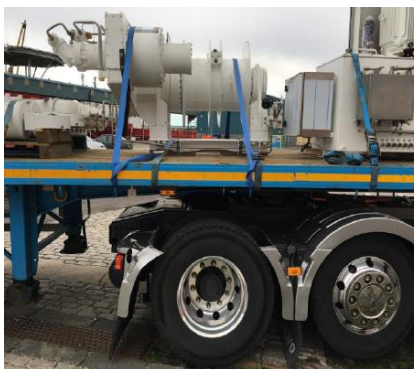
The winch after the incident – shown here correctly secured with ratchet straps

The loads were inadequately secured on the trailer, resulting in a davit winch and two sheave blocks falling on to the road. This incident had potential for personal injury and damage to other road users.

The loose end of the strap securing the winch and blocks was not stowed correctly. The driver took the vehicle out of the shed to allow the second collection trailer to access the shed, and continued to drive out of the front yard area, then proceeded to take a wide arc left over the middle of the port's road. A loud bang was heard as a winch and two snatch blocks fell from the vehicle. A worker witnessed a loose strap flapping on the trailer's nearside, before hearing the loud bang. However, the vehicle was too far away for him to intervene.

The incident area was made safe by removing the fallen equipment from the road to the shed. Other than surface damage, the equipment appeared to be unharmed. Additional ratchet straps were placed on the winch for extra security.

- ◆ The winch was a heavy piece of equipment with a high and offset centre of gravity, rendering it an unstable load;
- ◆ A conventional pallet was unsuitable for the type, shape and size of the equipment. Consideration should have been given to shipping the items in half height containers;
- ◆ There was a failure to effectively secure the load before movement of the truck, and there was poor practice in not securing the free end of a securing strap;
- ◆ A dedicated loader or dispatcher should discuss loading arrangements with the driver;
- ◆ The driver should remain in a safe area during the loading operation;
- ◆ Vehicles with an open flatbed should have their loads secured before entering and exiting the worksite.

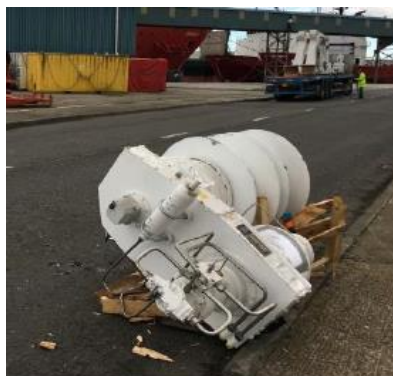
Position on road where winch came to rest

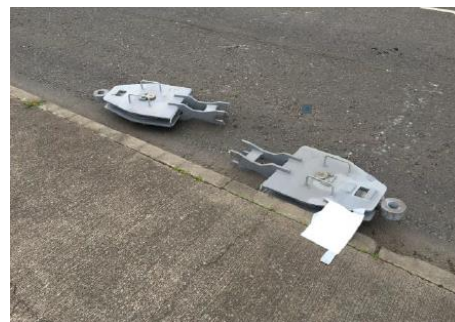
Position where snatch blocks came to rest
