IMCA Safety Flash 09/19

May 2019

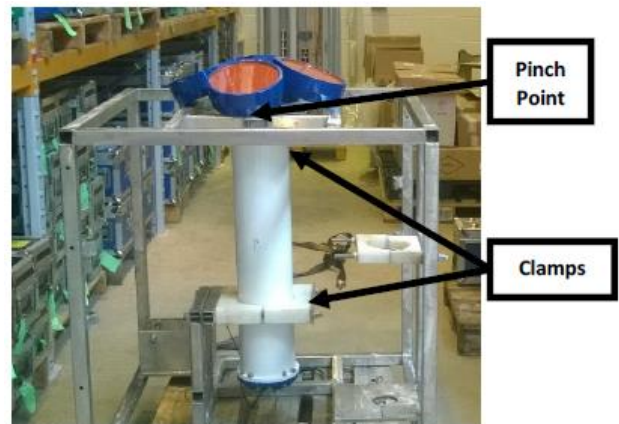
A crewman suffered a pinch point injury resulting in two fractured fingers and a fingertip amputation. The incident occurred when a piece of equipment weighing 86kg was being installed by warehouse personnel into a seabed frame. The equipment was lowered into the frame using a forklift with a lifting attachment, but before the securing clamps were fully tightened, the lifting strops were removed.

It was then observed that the equipment was not aligned correctly, so it was manually turned in the frame. Whilst turning the equipment it slipped through the hand tightened clamps, crushing the injured person’s fingers between the equipment and the frame.

- ◆ There was no risk assessment or work instruction in place for this task. This was found to be the case for many of the routine tasks carried out in the warehouse/workshop;
- ◆ The warehouse team had not carried out this task before without supervision;
- ◆ There were insufficient engineering controls to prevent the incident from occurring.

- ◆ A straightforward modification to the seabed frame engineered out the pinch point. When designing equipment, it is vital that safety during installation, maintenance and transportation is considered, as well as operational safety;
- ◆ Review workshop, warehouse and yard activities to ensure that suitable risk assessments are in place and used:
 - seemingly routine activities should be adequately supervised and subject to suitable and sufficient task risk assessment; in this instance, no risk assessment or instruction was in place covering the task
 - previously the task had always been supervised by a senior engineer, but on this occasion, the workshop personnel carried it out unsupervised.

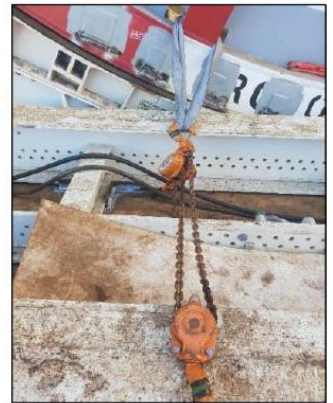
Before unexpected movement

3 x lever hoists used to position reel above cradle

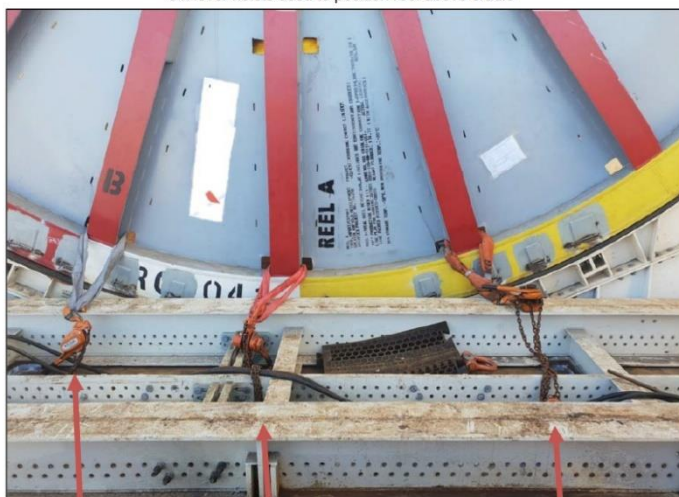
- ◆ The riggers realised what was happening and rushed in to disconnect the lever hoists. One lever hoist was disconnected however, tension on the second lever hoist became too great, resulting in the hook disengaging from its snagging point in an uncontrolled manner and striking the rigger on the hand.

Snagged then released under tension causing injury to IP

Snagged but was successfully cleared by a rigger

Did not snag when reel moved back towards Port

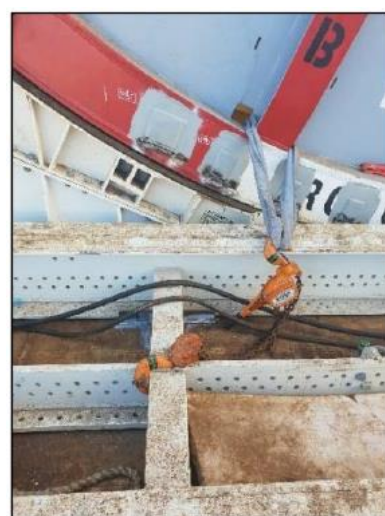
After unexpected movement

- ◆ The reel swung approximately 1.5 metres towards the riggers. This movement caused the 3 lever hoists to lose tension and disconnect. The reel then moved back towards the port side, allowing two of the lever hoist hooks to snag and come under tension;

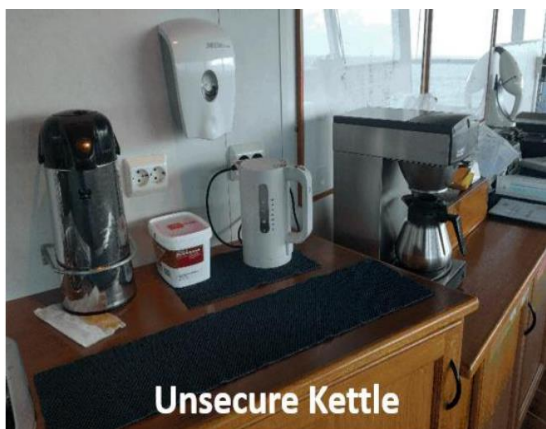
- ◆ The spilled water came from an unsecured kettle in the utility area of the bridge;
- ◆ The water from the kettle had spilled onto the deck and was not clearly visible to the crew member as it was dark.

Unsecure Kettle

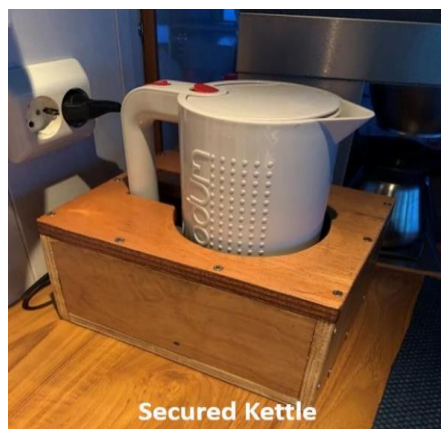
Secured Kettle

- ◆ The kettle was fitted with a proper securing bracket for adverse weather;

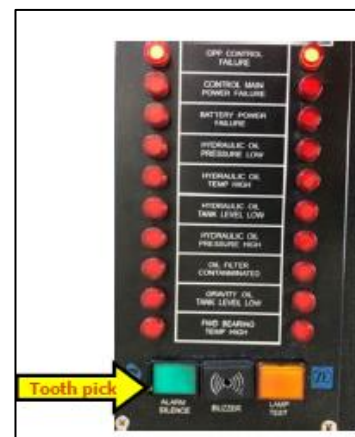
On a vessel safety walk-round, an unsafe condition was found whereby alarm push buttons for acknowledgement/mute were kept pressed using toothpicks and scotch tape.
