IMCA Safety Flash 09/20

March 2020

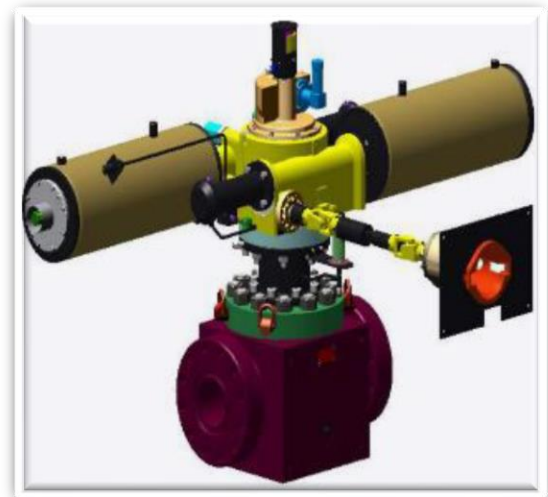
A diver was involved in a near miss that could have resulted in serious injury when he was asked to function an ROV valve override on a subsea isolation valve with a hand-held torque wrench.

A diver was asked to operate an ROV override switch with a hand-held torque wrench. The operation was observed by a third-party technician who intervened and stopped the job. The use of hand-held torque wrench to operate an ROV override on the valve was inappropriate due to the possibility of a sudden uncontrolled unwinding of the spring mechanism; this could have caused the torque wrench to rotate and hit the diver.

- ◆ The warnings on the GA (general assembly) drawing stating that hand-held tools should not be used were ambiguous and were missed;
- ◆ The valves procedure issued by the client did not include a warning or highlight the dangers of using hand-held tools to operate the ROV override;
- ◆ Engineers were not issued with the appropriate installation operations manual which included warnings not to use hand-held tools;
- ◆ The assumption was made that a hand-held torque wrench could be used. Our member notes that similar incidents have occurred within the organisation.

- ◆ Any operation of an ROV override on a double actuated spring ¼ turn ball valve (fail safe) should not be operated with a manual hand-held torque tool unless there is clear confirmation from the client or the valve manufacturer that it is safe to do so.

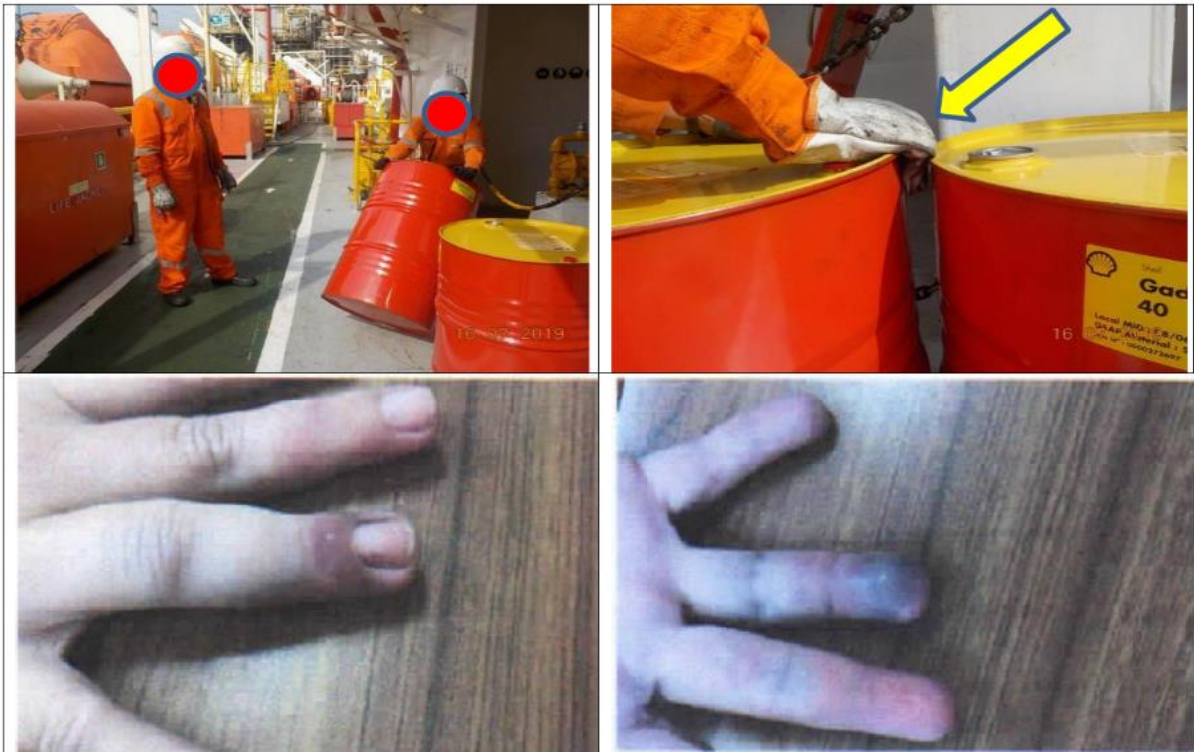
A crewmember suffered a fracture to the right-hand ring finger whilst arranging 200l oil drums. The injured person was moving drums from a container using a pallet truck, assisted by a colleague. During this work, the injured person trapped a finger between the drums. At the time of the incident, there was no pain and the injured person continued to work. Once the operation was over, the injured person went to the medic to report the accident and took painkillers before resuming work. After shift, the injured person removed their safety gloves and found discolouration (purple/black) of the ring finger and returned to the vessel hospital again. The doctor advised to disembark the injured person for further medical examination ashore. It was discovered that there was a fracture of the distal phalange of the right-hand ring finger. The person was considered unfit to work for 15 days.

- ◆ The incident was not reported to shore-based management (the DPA) in a timely and appropriate way;
- ◆ There were no appropriate procedures in place for this kind of work;
- ◆ The risk was seen as tolerable – crew took an incorrect and complacent attitude towards safety;
- ◆ No-one intervened to stop the job;
- ◆ There was no engineered mechanism to make this operation safer or hands-free. Such a mechanism was developed afterwards – see photos below.

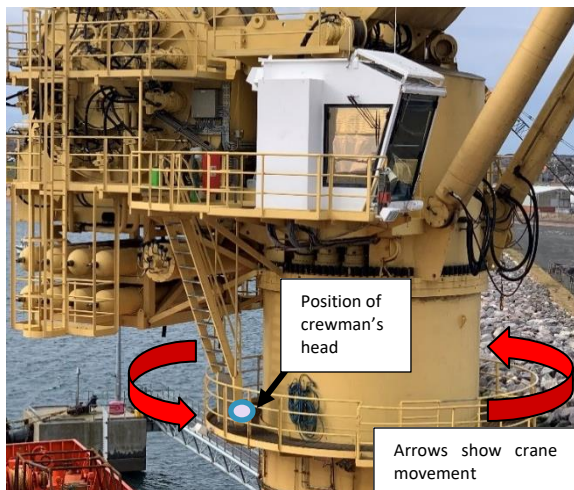
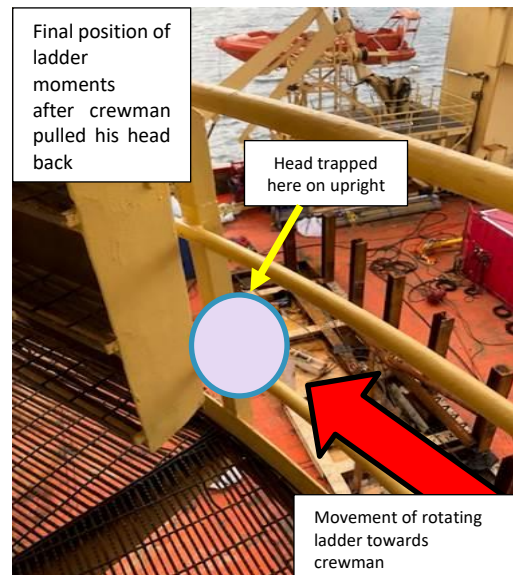
A vessel was alongside demobilising when a crewman went up onto the crane gantry walkway to remove some temporary rigging. In doing so, he kneeled and put his head close to the handrailing. The steel access ladders of the crane cab, which moves with the crane as it slews, pushed his head against the railing upright. As he pulled back hard to free himself from being trapped part of his left ear was severed.

- ◆ Lack of situational awareness/perception of risk;
- ◆ Ineffective communication and coordination protocol between the deck team and crane operator for access control to crane gantry;
- ◆ Ineffective assessment of hazards associated with on-site modification when introducing the temporary rigging;
- ◆ Bypassing warning signs and barriers by the crewman.

- ◆ Standardise signage and barriers around crane structures or other areas with large moving machinery;
- ◆ Ensure lifting procedures outline minimum requirements for communication and coordination protocol for lifting operations;

- ◆ Review of control measures in place around crane access/areas with large moving machinery e.g. guarding, walkways, cameras, alarms, barriers;
- ◆ Consider whether suitable vessel-specific task risk assessments are in place for access to cranes and other areas of moving machinery and that these are well communicated to personnel e.g. during vessel, deck, ROV and dive system familiarisations and walkarounds;

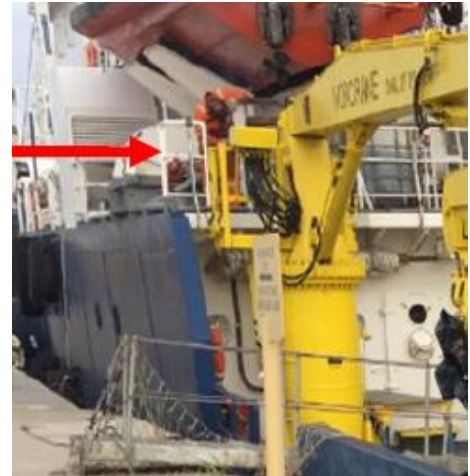
During a crew change handover walk around the vessel hull, the Master observed a welder working close to the open/unsecured edge of a PS davit area. The incident occurred during planned installation of additional access support plates at the port side davit area. A 'hot work permit to work' was raised for completion of welding activities; the work area was agreed, a risk assessment conducted, and a toolbox talk (TBT) signed off by all participants.

The person authorizing the work did not properly assess the work area. Unprotected edge-related working at height hazards were left unattended with no safety precautions considered.

Arrow showing welder working with unprotected edge behind and potential to fall into water

Welding operations were immediately stopped, and additional fall prevention measures installed.
