I Pipe Stacking Fatality

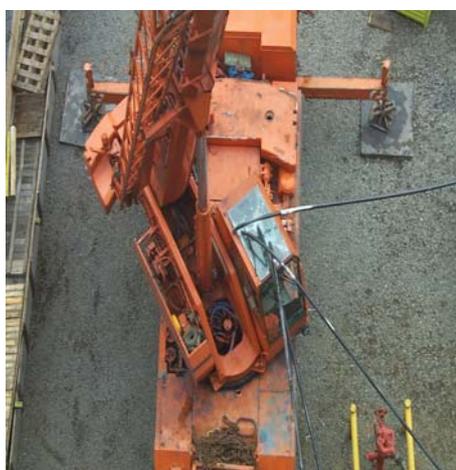
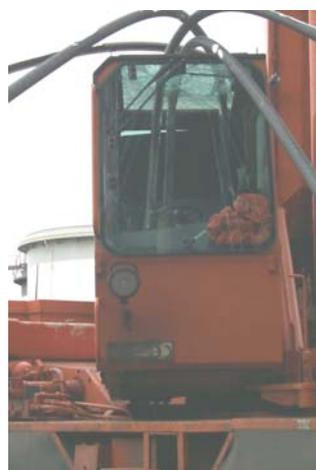
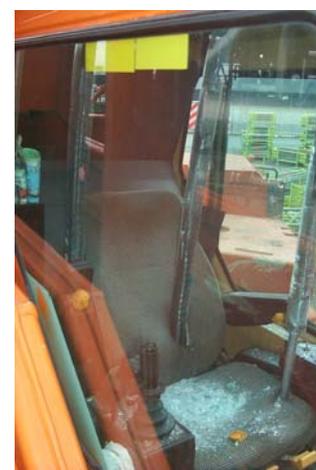
A rigging crew, made up of one crane operator and two riggers, had been assigned to removal several 24-inch diameter steel tubulars from a random stack in a warehouse stock yard. The pipes had been stacked and chocked to be no more than three layers high. During the operation, a tubular in the middle of the bottom layer needed to be retrieved. To gain access, the crew began rearranging the other tubulars. The two riggers were positioned on each end of the stack to assist the crane operator with hook-up and to guide the tubulars out using tag lines.

When the required tubular had been removed, it left an open slot with two unstable stacks either side of it. For reasons that cannot be verified, one of the riggers then stepped into the slot – it is believed he was either placing chocks or following the tag line on the tubular just removed from the slot.

While his foot was in the slot, the force of a tubular on the second row pushed down, causing the tubular to one side of the slot to roll into the slot. The rigger was caught between the two pipes and received severe crushing injuries to his pelvic area. He was transported to the local hospital, but later died from the injuries he had sustained.

- ◆ The warehouse stockyard, not being an area of regular production activity, had not been regularly inspected to ensure the proper storage of tubulars;
- ◆ On the day of the incident, the entire rigging crew, including those involved in this incident, had met to conduct a pre-shift 'toolbox talk' meeting and job safety analysis (JSA), but the JSA had only covered work being done at a project site in another part of the yard, which at the time had been considered a higher risk – this task had been considered routine;
- ◆ Best industry practice is to remove all pipe from upper layers before removing a tubular from the bottom. This had not been routine at the yard prior to this incident.

- ◆ All areas are to ensure that detailed rigging procedures, coupled with a comprehensive rigging training programme, are developed and implemented, to cover best industry practices of handling, stacking and storage of materials;
- ◆ Existing field safety assessment programmes are to be reviewed to ensure all areas of the yard (and of vessels) are covered, including non-production areas such as warehouses and stock yards;
- ◆ All areas are to ensure, through proper training, that employees (particularly supervisors) know how to conduct task risk assessments/JSA's for all of their daily jobs, including inspections of work areas as part of the JSA and identification of adequate controls for lowering risk to as low as reasonably practicable;
- ◆ Each area's management is to stress to its employees the company's expectations that any unsafe work be stopped immediately.
