IMCA Safety Flash 10/03

August 2003

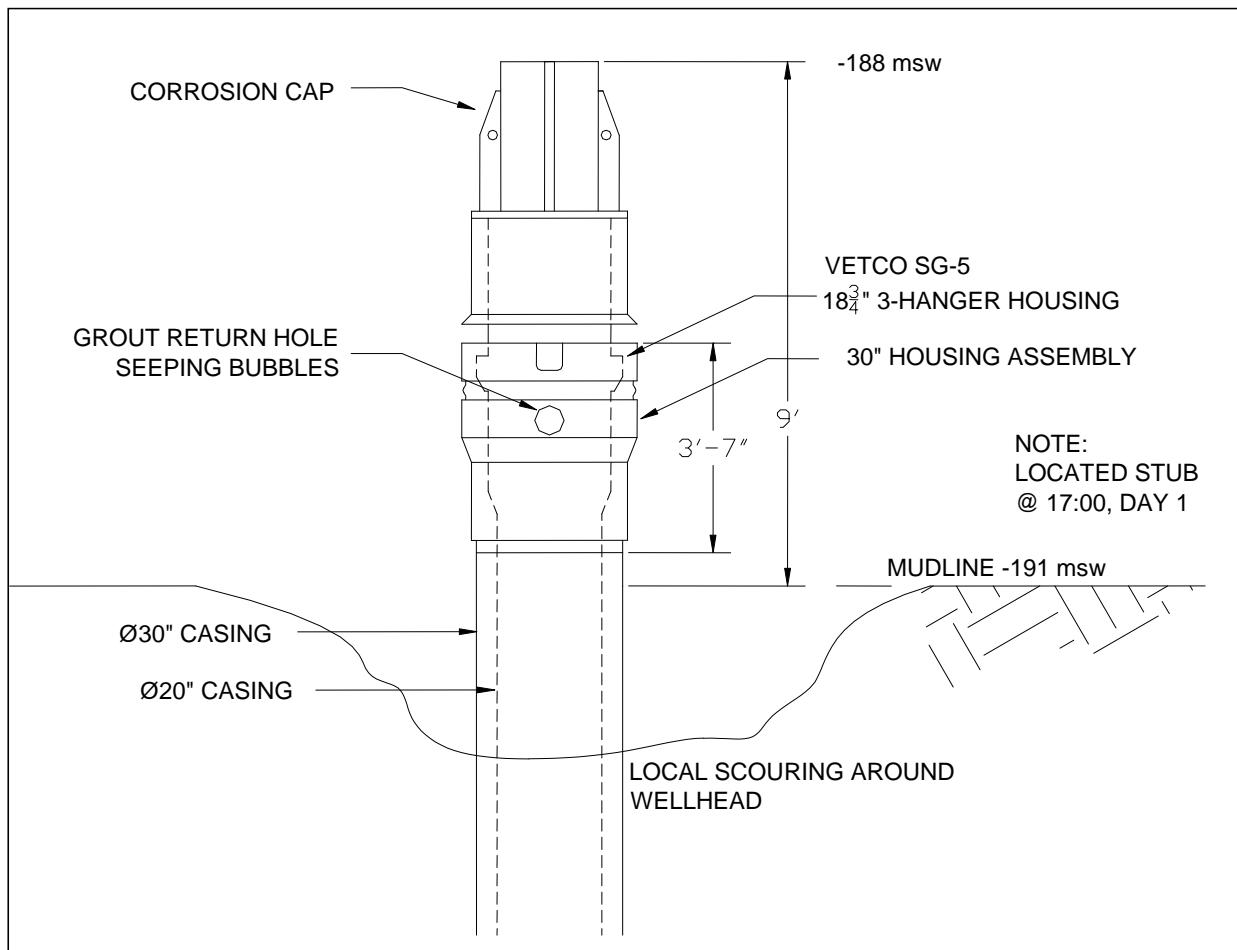
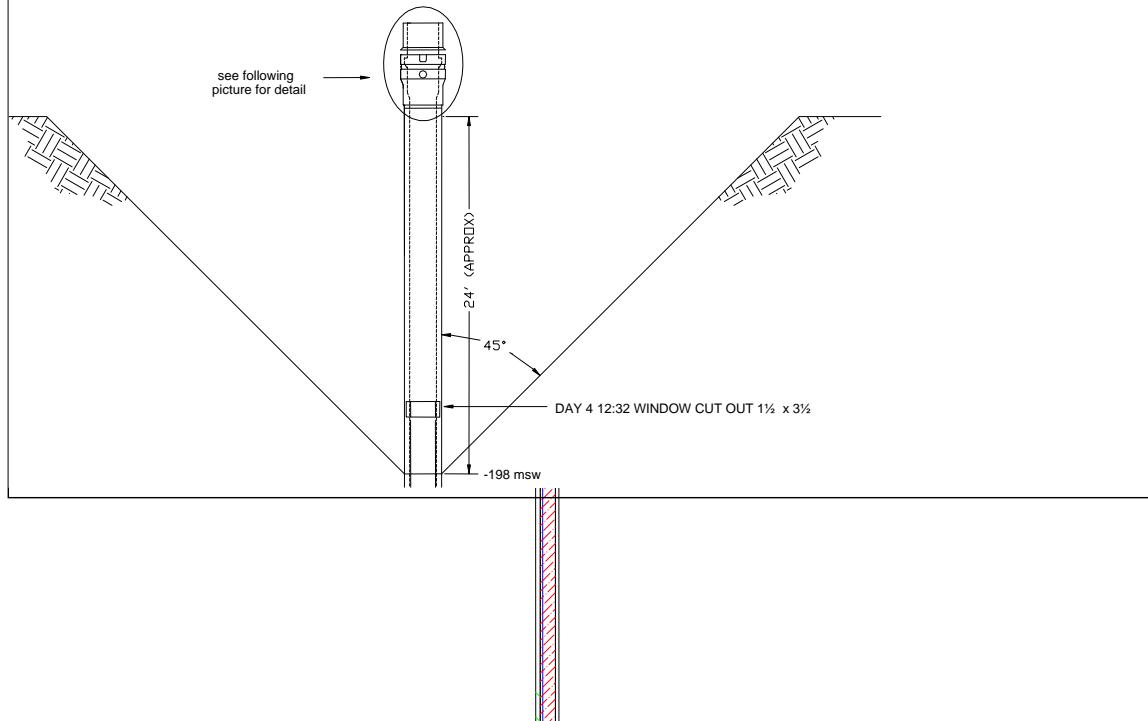
A member has advised of a recent fatality, involving an experienced diver, which occurred during underwater cutting operations as part of a well stub removal project. The site conditions and sequence of events are summarised in the diagrams below.

The company's subsequent investigation has noted the following findings:

- ◆ Site conditions had proved to be different from those represented in the end-customer's drawing, in terms of the wellhead connector assembly, bubbling gas and lack of grout between annuli;
- ◆ Generic procedures had been produced for what had been considered a 'standard' or 'routine' well stub removal;
- ◆ The job safety analysis (JSA) had focused on excavation as the primary risk;
- ◆ A 'can do/will do' attitude can be prevalent among dive teams and in the wider industry, which may have caused some resistance to halt operations;
- ◆ The project manager only had limited involvement in this operation;
- ◆ The on-site procedure, developed by a widely experienced team of diving superintendent, supervisor and diver, proved to be not adequate to avoid the fatality.

The company has noted the following actions:

- ◆ It has instigated a 'formal request for information' procedure for retrieval of additional information from customers;
- ◆ It has reiterated that salvage and burning jobs are never routine and are potentially hazardous. It has noted the need for detailed procedures and project risk assessments to be prepared, as per its project management procedures;

- ◆ It has noted the need for project management procedures to include formal job handover procedures and project risk assessments;
- ◆ It has pointed out the need for formal project risk assessments and work site job safety analyses (JSAs) to identify all potential risks before commencement of operations;

- ◆ It is aiming for a better implementation of its 'safety stand-down' system through reinforcement training, in accordance with its management-of-change procedures, to bring about a 'can do/will do safely' culture embraced by all employees;

- ◆ Again in relation to a better implementation of its management-of-change procedures, the company has noted that, whenever appropriate, project managers, senior and/or onshore management and the customer are to be involved in and to approve all significant changes to procedures.
