## 1 Uncontrolled Decompression of Diving Bell

## 2 Fatality – Fall from Scaffold Opening/Breakdown in Co-ordination/Communication

### 3 Lightning Strike

# SAFETY CIRCULAR ON A FATAL ACCIDENT DUE TO BREAKDOWN IN COORDINATION AND COMMUNICATION < OSD / SY CIR / 04 / 2003 >

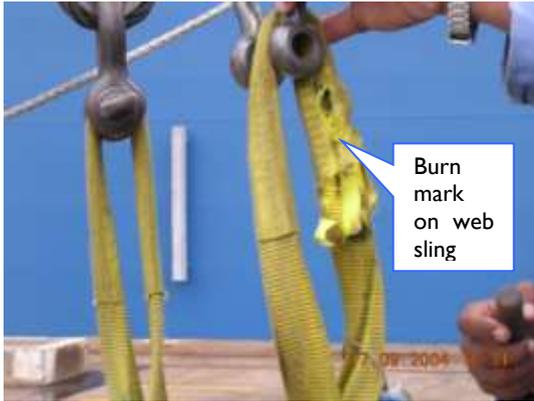
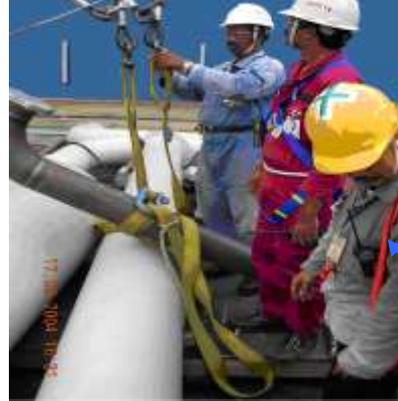
It was observed afterwards that there was a burn mark on the web sling. It was believed that most of the lightning's energy had been transferred to ground through 'earth', but apparently some of this energy had gone through the crane sling and onto the shackle.

Fortunately, no injury was sustained and there was no fire. However, it was observed afterwards that there were minor burn marks on the lifting belt the rigger had been using (see pictures below).

Rigger

- ◆ avoid standing next to tall structures or working at height;
- ◆ do not stay in open areas;
- ◆ do not use mobile telephones in open areas;
- ◆ take shelter in covered areas or buildings;
- ◆ do not use mobile or berth cranes due to the height of crane booms.

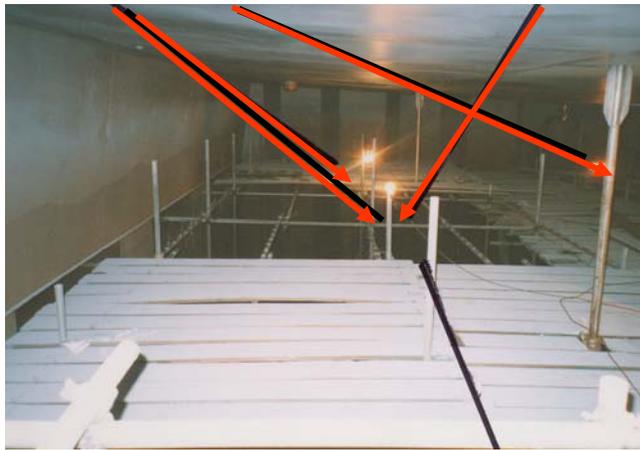
Two hand-held lamps  
& a flood light were  
provided

Opening in the scaffold

- While he was inside the tank, the deceased fell through the opening on the scaffold work platform. The opening was due to the removal of scaffold planks during the dismantling process.
- Although the "NO ENTRY" and "DO NOT USE THE SCAFFOLD" signs were clearly displayed at the entrance to the tank, the deceased still proceeded to enter the tank to carry out the touch up work.
- Illumination (lighting conditions) inside the tank was poor.

- Investigations revealed that the cause of accident was attributed to a lack of coordination and communication between the relevant trades which resulted in the concurrent execution of scaffold dismantling and painting works inside the tank. Coordination of work activities established at the vessel safety co-ordinate committee meeting should be properly communicated to all affected parties, including their foremen and workers.
- Shipyards are reminded to instill their workers on the importance to observe strictly all safety signs such as "NO ENTRY" signs into confined spaces and tanks.
- Adequate lighting should be provided while work is being carried out inside the tank.

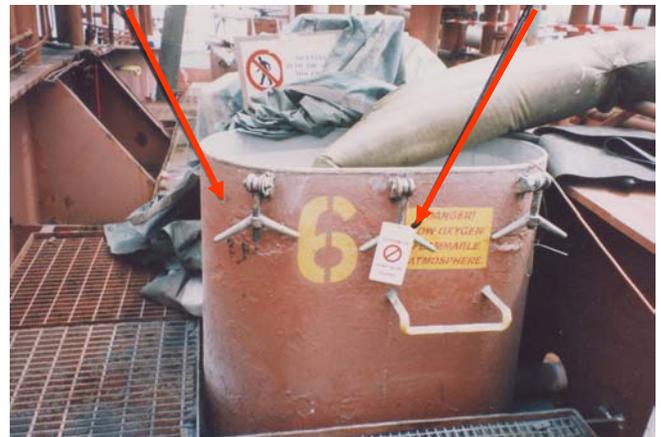
The deceased had  
gained access from this  
manhole

The signage "DO NOT  
USE THE SCAFFOLD"

- The deceased was in the tank to touch up the paintwork for a sensor mounting. While he was walking on a scaffold platform inside the tank, he fell through an opening on the scaffold. The distance of fall was about 16 meters.
- One day prior to the accident, the ship repair manager was informed that the inspection of the paintwork inside the tank had been cleared and accepted by the vessel owner and that the scaffolds inside the tank were ready for dismantling. Instruction was then passed to the scaffold contractor to dismantle of the scaffolds on the next day (the day of the accident).
- The painting foreman, however, was not aware of the instruction to dismantle the scaffold. On the morning of the day of accident, the painting foreman instructed his chargehand to conduct a final check on the tank. The deceased was subsequently assigned to touch up the paintwork inside the tank.
