## 1 Crane Wire Failure

## 2 Engine Room Fire

### 3 Explosion in a Ballast Tank Causing Loss of Life

### 4 Lost Anchor Chain

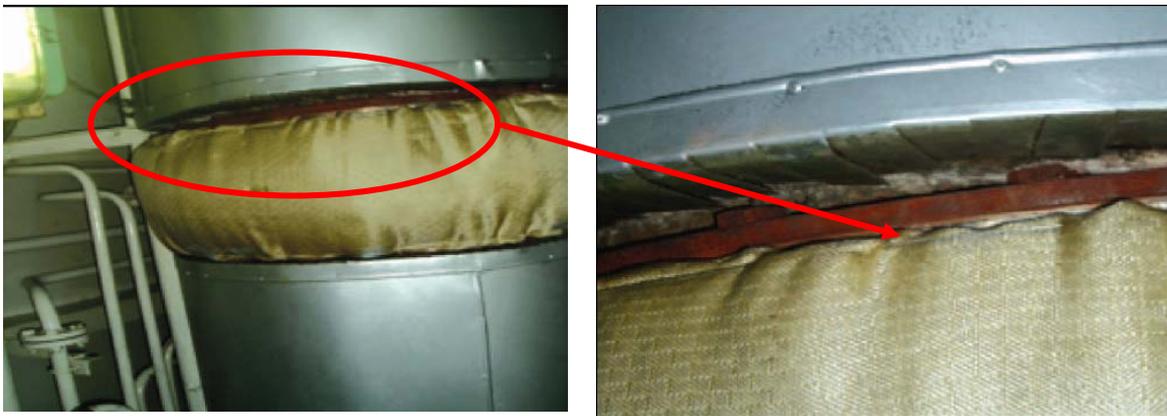
*Pictures 1A and 1B – Main exhaust pipe*

The probable cause of the fire was spraying of leaking hydraulic oil onto an exhaust flange which was not properly insulated (see pictures 1A and 1B). The exposed flange must apparently have reached a temperature above 220°C.

*Such an arrangement may have caused the fire. Note the exposed flange of the expansion joint without insulation.*

*The flange has a temperature normally above 220 °C. Hydraulic oil may hit this flange and start a fire.*

After maintenance and repairs, attention should be paid to satisfactory reinstallation of the insulation.

SOLAS regulations require proper insulation of all surfaces<sup>1</sup> with temperatures above 220°C. See picture 2 for an example of satisfactory insulation of a flange. SOLAS also includes requirements for jacketed piping of high pressure fuel lines and screening of pipe connections on flammable oil systems.

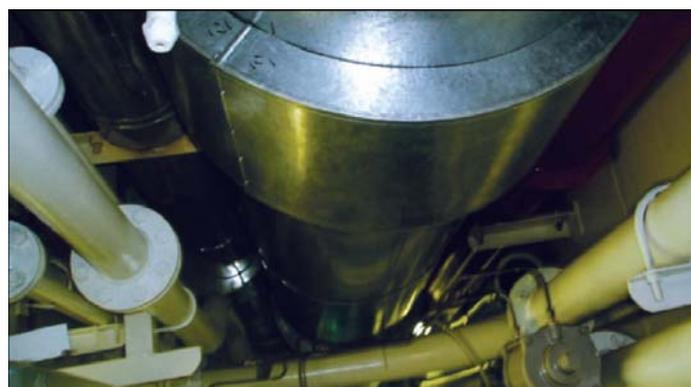
*Picture 2 – Exhaust pipe*

*One example on how the flange can be properly insulated. The insulation and the metal sheath cover the flange completely.*

*The metal sheath protects and ensures proper geometry and location of the insulation material.*

*The sheath cover is only fixed on the upper side since it covers the expansion joint.*

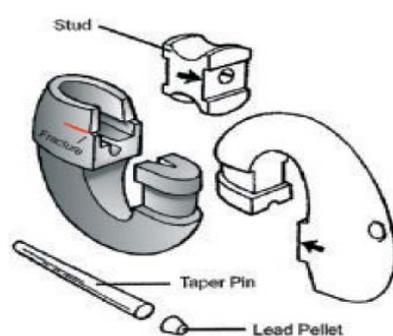
It was discovered on investigation that the probable cause of the damage was the fracture of a Kenter shackle that had not been renewed in the previous dry dock.

Note that the intricate shape of the various parts of a Kenter shackle means that large forces are transferred through relatively small contact areas. Proper design and well machined faces and corners are very important for the durability of such shackles.

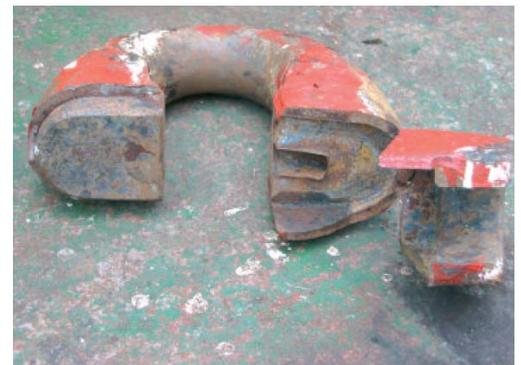
In the above case the failure may be attributed to mishandling of the Kenter shackle during the opening/ fitting operation. Since in most cases Kenter shackles on old anchor chains are rusty/frozen, and opening up and reassembly requires the use of heating or mechanical force, cracks are likely to develop and should result in replacement rather than re-use.

The lesson to be learnt from this incident is, when a chain cable length is replaced due to wear and tear, the Kenter shackle(s) are normally worn as well and should generally be replaced.
