## I Lifting Wire Strop Failure During Air Bag Lift

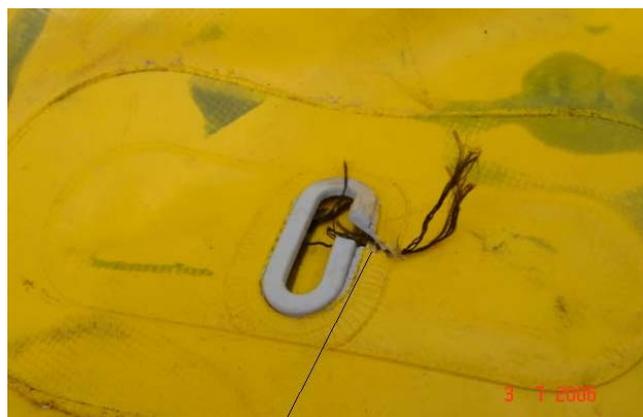
*Inverter ripped out from this location*

On inspection of the air lift bag, it was found that the inverter line attached to the top of the bag had pulled out, resulting in the lift bag failing to spill the air contained and the bag reaching the surface. The diver reported that the bag was only half to two-thirds full in capacity at the time of the incident.

- ◆ The less-than half inch wire rope strop passing through the flanges and attached to the air lift bag had not been certified;
- ◆ The inverter line pulled out of the top tab (the tab burst) and thus the air bag could not be inverted;
- ◆ The suitability of the rigging had not been thoroughly checked prior to lowering the air bags to the seabed.

- ◆ The incident was discussed in toolbox meetings and the potential effects were discussed by the diving superintendent and OCM;
- ◆ The dive team has been reminded of the importance of checking all rigging prior to attachment to loads and of following proper lifting procedures;
- ◆ The rigging gear onboard the vessel has been inspected both for any damage and to ensure it is properly certified;
- ◆ The air bag supplier is further investigating the incident.

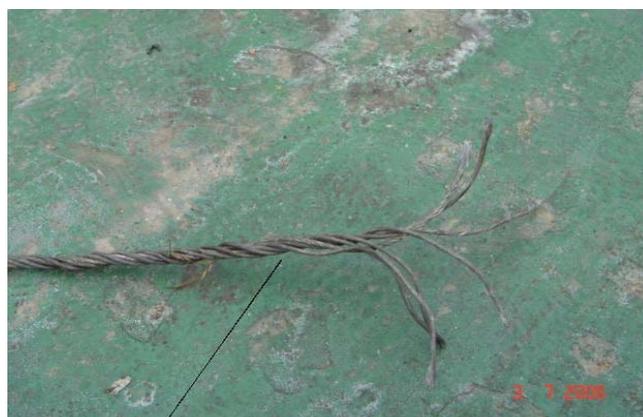
While he was undoing the airline, which was made cold, the wire strop parted, causing the lift bag and airline to come to the surface around 20 metres from port side of the vessel. The diver was on a clear path to the bell with his umbilical and was far away from the air bag rigging attachment, thus averting possible entanglement. The company notes that this avoided what could potentially have been a fatality. The diver was reported well after the incident.

*End of strop cut on flange face*
