IMCA Safety Flash 10/07

December 2007

I Small Fire Caused by Portable Fan Heater

3 Failure of a High Pressure Gas Charging Hose

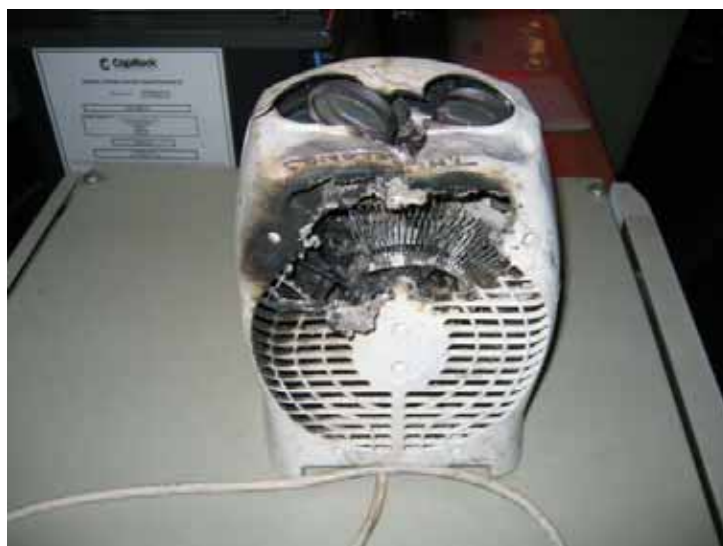
A member has reported an incident in which a small fan heater caused a fire in a cabin. A crew member, on retiring to his bunk, switched on a portable electric fan heater to warm up the inside of his cabin. It appears that he then went to sleep with the heater still switched on. The crew member awoke to find smoke in the cabin and the smell of burning, and small flames were observed coming from the heater. The heater was immediately unplugged and placed in the cabin sink and the water turned on to extinguish the flames. At this point the vessel fire alarm sounded.

Damaged fan heater following fire

The Code of Safe Working Practices for Merchant Seamen Chapter 9.3.10 states that “*Personal portable space heating appliances of any sort should not be used at sea and notices to this effect should be displayed.*”

This was a high potential incident which could have resulted in a major fire within the accommodation of the vessel.

- ◆ Vessel masters should ensure that no ‘personal portable space heating appliances’ are currently in use onboard their vessel;
- ◆ Any such appliances that are discovered should be removed;
- ◆ Only approved and fully integrated means of supplying heat to cabin areas should be used.

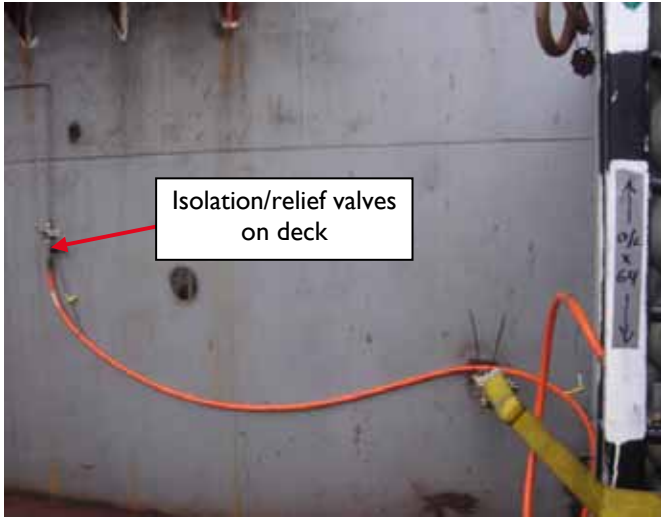
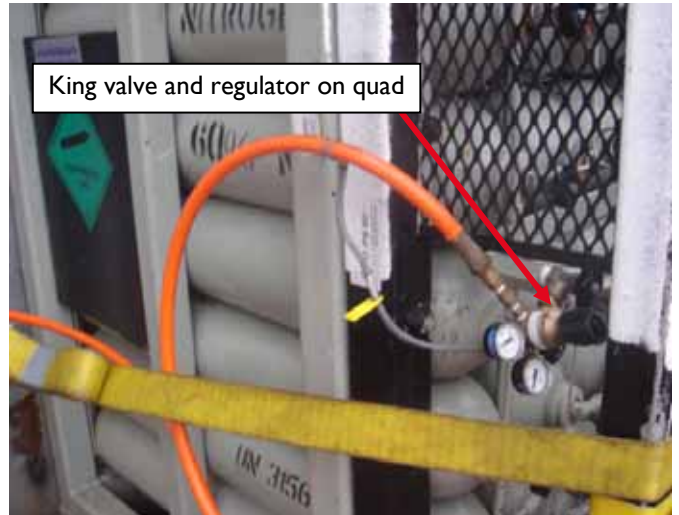
HP charging hose from supply quad used for decanting

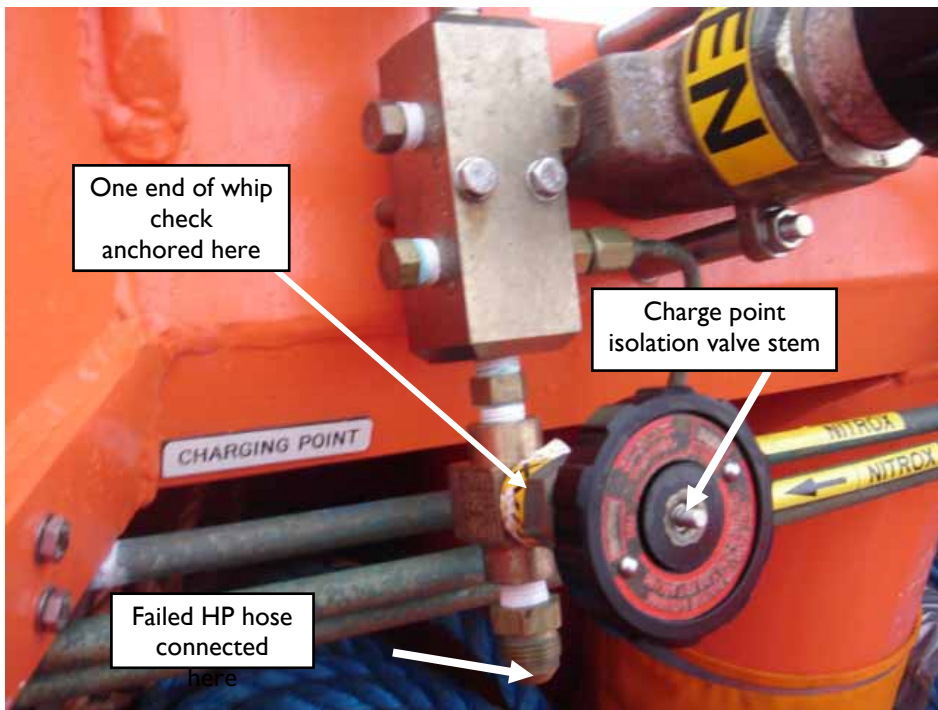
Charging point assembly in small craft

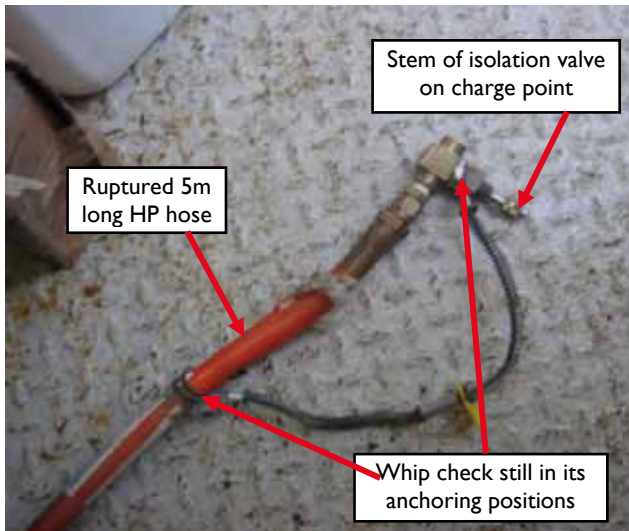
During the gas bank decanting, an HP gas charging hose ruptured and its recoil force caused shear failure of an isolation valve fitting which was serving as an anchor for the HP hose whip check.

Ruptured hose with sheared fitting/valve attached

- ◆ The whip check was anchored on a pressurised valve;
- ◆ There was a failure to recognise the force of recoil and effect on the whip check anchor point;
- ◆ The safe positioning of personnel performing the operation was inadequate.

- ◆ A review of whip check anchoring methods on all HP hoses;
- ◆ An inspection of all hoses for any indication of defect;
- ◆ The use of dedicated anchor connection points for whip checks;
- ◆ An alternative design of whip check that ensures the whip is held at the very end of its length i.e. Chinese finger style;
- ◆ A review of the service life for high pressure flexible hoses looking at the original date of whip manufacture and how many pressurisation cycles the whip has had.

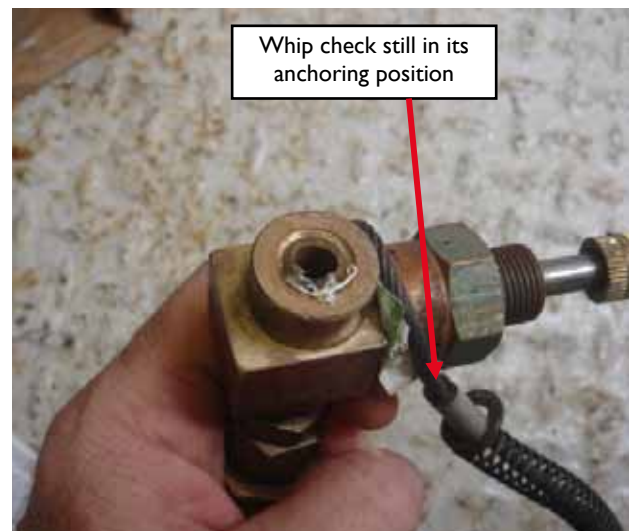
The resulting failure of the valve fitting connection caused a restrained flailing of the hose and valve fitting which became entangled on the structure of the small craft.

1/4" NPT Nipple snapped off from diver charging manifold
