## IMCA Safety Flash 10/08 Rev. I

June 2008

**This flash has been reissued to provide additional guidance in respect of item 3 – GPS Antenna Problems**

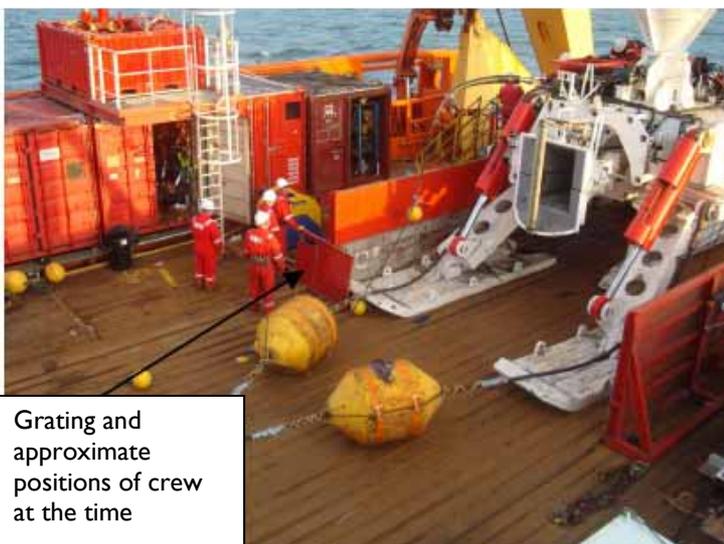
At the time of the incident the weather was flat calm and the vessel was in transit. The deck crew was involved in setting up a rigging arrangement on the over-boarding chute whilst technicians were carrying out fault-finding on other equipment. Four members of the deck crew were on their way to collect rigging equipment from the rigging container. To reach the container the crew had to pass between a deck tigger winch and a heavy piece of grating which had been removed from the top of the equipment being investigated by the technicians. This piece of grating was stowed upright against the plough guards on deck.

Whilst passing between the tigger and the plough guard the grating was disturbed and fell, striking the foot of the injured party. The grating was fitted with fixing lugs, one of which severely impacted the foot, penetrating the safety boot and caused the injuries.

Grating and approximate positions of crew at the time

This incident occurred during routine deck activities when the level of hazard awareness and attention to detail was perhaps not as high as it would be when the vessel was fully operational on project construction work. This highlights the need for the same level of awareness, attention to detail and communications during routine work as there is during project construction operations.

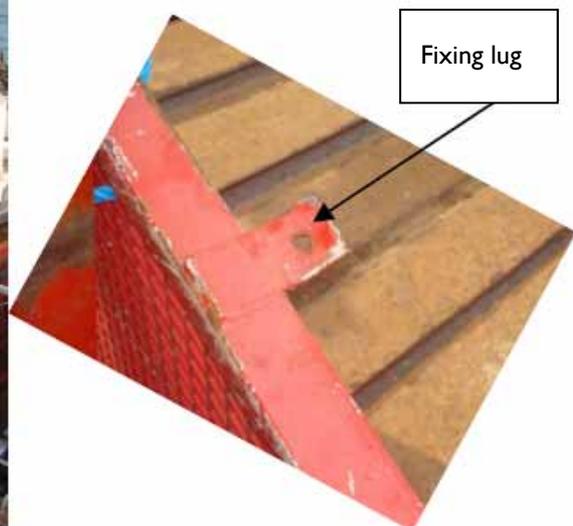
Fixing lug

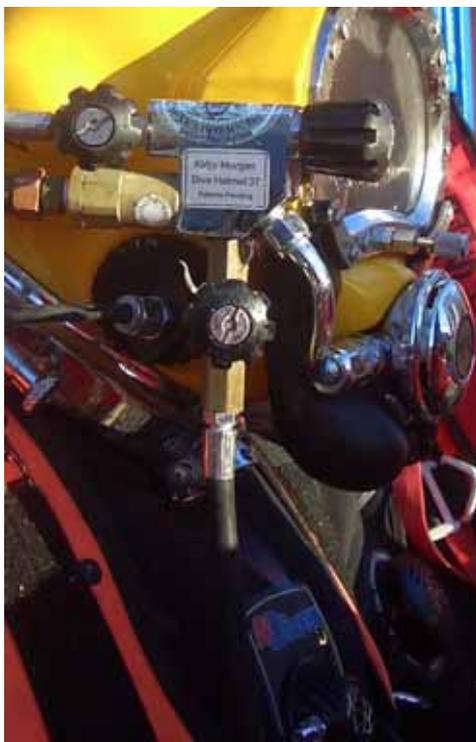
The practice of installing a dry suit inflation whip with modified fittings onto a KM 37 side block has been reported to IMCA.

- ◆ The modification to the side block assembly of the KM 37, shown in the photograph above, is not recommended;
- ◆ The leverage on the brass fitting is extremely high giving a high potential for breakage;
- ◆ The fitting at the bottom of the side block is a 3/8" straight thread fitting with an O-ring seal which is not designed to sustain this kind of leverage.

Members are reminded that an in-line valve is not deemed necessary by the helmet manufacturer, as long as a good quality and suitably approved inflator hose is used or the KMDSI restrictor adapter PN# 555-210.
