## IMCA Safety Flash 10/09

July 2009

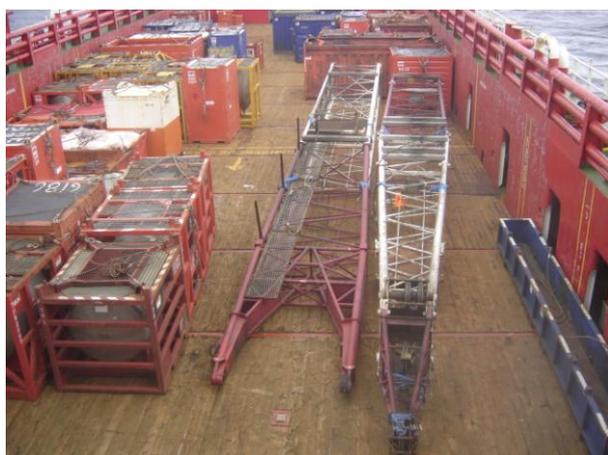
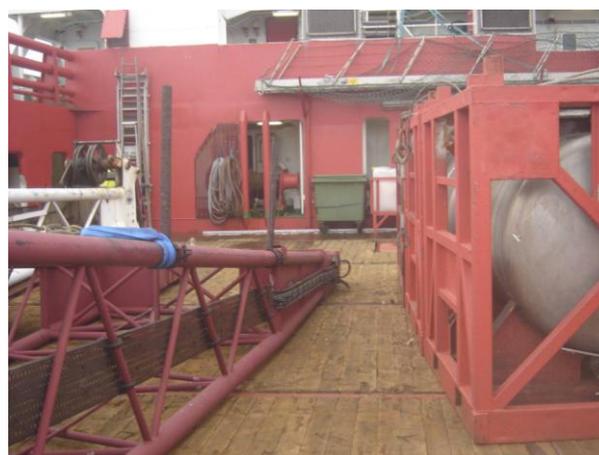
*Crane boom section*

*Crane boom section and tote tanks*

The crane operator then started to heave and raised the back loaded crane boom section by about 1m to approximately waist height whilst personnel were between the crane boom section and the tote tanks. There was very high potential for the two crew members to be crushed between the crane boom section and the tote tanks. A warning was given on UHF radio to the crew members, who were already aware of the hazardous situation and were already moving to a safe position. The crane operator then lowered the crane boom section to deck. Weather conditions at the time of the incident were within acceptable working limits, consisting of wind speed 19 knots and significant wave height of between 1.5 and 2.0m.

- ◆ The crane operator lifted the back loaded crane boom section off the deck but failed to effectively communicate his intention to the vessel personnel;
- ◆ The crane operator assumed that the deck was clear of personnel.

- ◆ Crane operators should:
  - communicate their intentions to all relevant installation and vessel personnel before proceeding with any lifting operation
  - ensure that all communications are fully understood and verified by all relevant installation and vessel personnel before proceeding with any lifting operation
  - avoid making assumptions and verify that the deck area is clear of all personnel before proceeding with any lifting operation

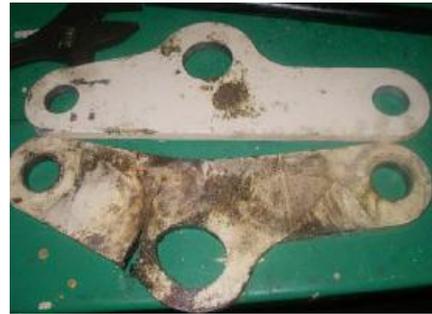
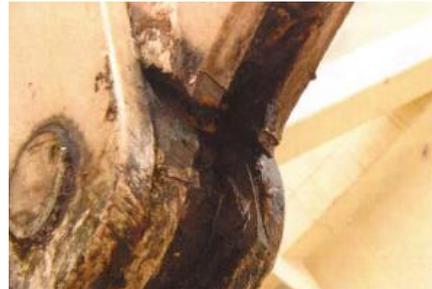
Following a refit, sea trials were being conducted on a member's vessel in preparation for a return to operations. Defects were discovered on the davit tilt arms on both the forward and aft legs of two lifeboat davits. Both tilt plates on each leg of the aft davits were found to be cracked and distorted. It was evident after inspection that the initial defects were historical and may have existed for some time unnoticed. The defects may have been compounded by load tests conducted during the recent refit, during which the davits had been upgraded to allow new lifeboats to be installed.

Following further investigation with the close co-operation of the original equipment manufacturer it was concluded that the defects to the davit tilt arms were caused by the incorrect operation of the davits. The davit arms had previously been brought inboard of the vessel without the required minimum 500kg weights attached to the davit hooks. A clear warning that this should not take place is included in this specific manufacturer's documentation.

*Worn davit tilt plate and parts*

- ◆ The original equipment manufacturer's documentation for the davits should be consulted and appropriate operating instructions verified to ensure existing practices do not deviate from manufacturer-recommended launching practices, nor compromise the safety and operational integrity of the equipment;

- ◆ Davit launch/recovery operators should ensure that the davit is operated in accordance with the guidance provided by the original equipment manufacturer;

- ◆ Warning notices should be posted adjacent to each lifeboat operating station (see the diagram below);
- ◆ A thorough inspection of tilt plates should be included in monthly planned maintenance checks;

- ◆ Since the defects appear to have originated some time in the past, better quality control is required of bi-annual, annual and five-yearly inspections by specialist contractors to ensure that they are conducting the thorough examination of the equipment properly and to an appropriately high standard.

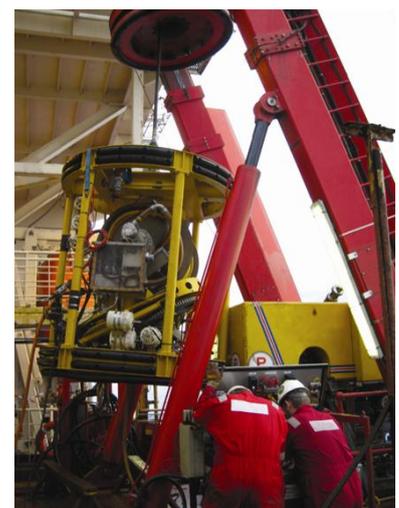
It was at this point that the A-frame started to luff out. Because the winch did not pay out at the same time the umbilical came under tension and caused the TMS to lift approximately 1m off the deck. The technician standing by at the control console immediately hit the emergency stop, turning off the hydraulics to prevent any further movement. As soon as the TMS began to lift the technician on top managed to step off to safety on to the top of the winch frame. There were no injuries or damage to equipment.

*TMS and A-frame*

Subsequent investigation by the company revealed that a proportional valve driver, a part of the hydraulic control system, had failed and was giving a constant output signal to the luffing valve without any input command. This caused the luffing valve to operate in an uncontrolled way, which in turn caused the A-frame to move. The valve driver was replaced and full normal operation was restored.

- ◆ Operating procedures and risk assessments were changed so as to isolate the hydraulics whilst personnel are on top of the TMS with the bullet and lift point swivel mechanically connected;
- ◆ Modifications were made to the hydraulic control system to prevent a recurrence of this incident. The modification included the installation of a relay isolating the proportional valve driver output until the relative joystick is operated. This would prevent uncontrolled operation of the luffing rams if the proportional valve driver unit had a similar failure again.
