# IMCA Safety Flash 10/11

September 2011

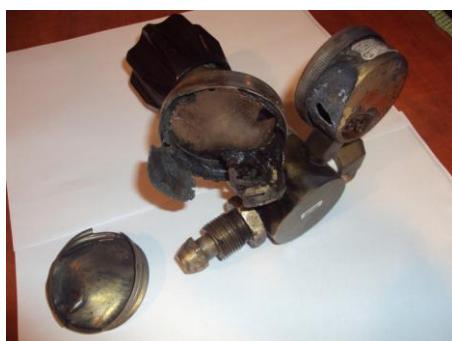
Oxygen gauge

A member has reported an incident in which an oxygen regulator exploded when the oxygen was turned on, causing a second degree burn injury to someone's hand. The incident occurred during the changeover of high pressure (HP) oxygen diving gas quads. The gasman was tasked with going on deck to change over a supply of oxygen from one gas quad to another. Company procedures for isolating the oxygen quad, venting the line, disconnection of the regulator and then reconnection onto the new quad were all carried out correctly. Once the regulator was reconnected onto the new gas quad the gasman turned on all 16 individual bottle valves. He then ensured the oxygen regulator was fully wound back and then proceeded to open the King Valve to allow the oxygen to flow into the regulator. It was during this process of turning the King Valve and releasing oxygen at 200 bar into the regulator that the explosion took place.

- ◆ Unsuitable personal protective equipment (PPE) was worn for the task. A glove which would restrict heat exchange to the skin would have been more suitable, and consideration should be given to the use of a full face mask;
- ◆ Possibility that there may have been some debris or substance such as grease or oil left in the King Valve by the supplier prior to delivery to the vessel;
- ◆ The practice of opening all 16 cylinders at once proved to be hazardous in isolating the flow of escaping oxygen.

- ◆ Ensure all connection points are free from grease, oil and dirt prior to connecting any regulators or hoses;
- ◆ Ensure oxygen storage areas are sited such that they will not be contaminated with oil or grease, for example beneath an ROV platform;
- ◆ Conduct checks of all in use and serviceable regulators used for transfer of oxygen, including those not connected with diving, for example deck welding/burning operations;
- ◆ The risk assessment for the connection and disconnection of gas quads and equipment should be suitable and sufficient, and should be understood by all;

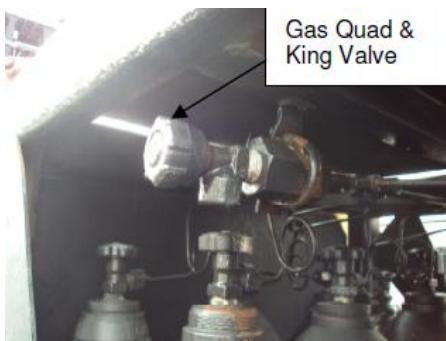
Gas quad and King Valve

After the explosion it was not possible to isolate the escaping oxygen from the King Valve due to possible damage to the valve seat. Each of the 16 individual cylinders then had to be turned off to isolate the flow of oxygen.

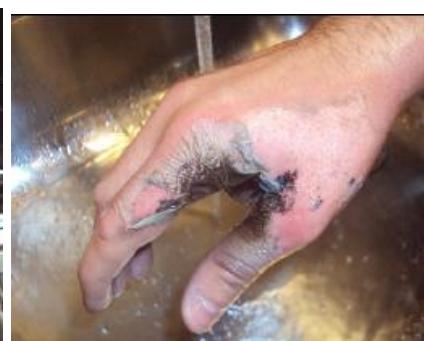
Burn injury to hand

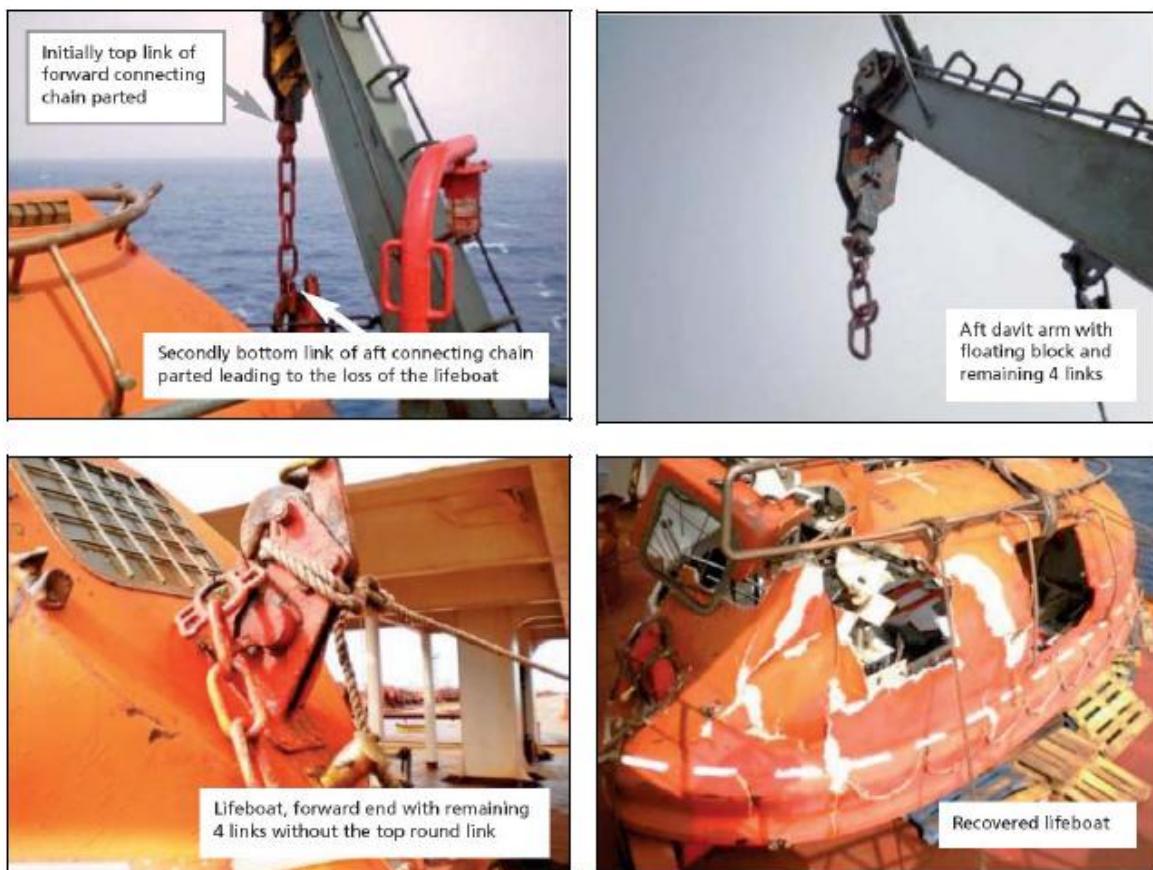
*Sequence of images illustrating the equipment failure*

- ◆ It is likely that the top link of the forward chain parted due to corrosion or damage of the welding of the link such that the load was no longer distributed to both sides of the link. As the links/chain were painted it was probably difficult to detect the fracture that had developed over time.

- ◆ Chains should be replaced at regular intervals and/or tested by DPI/Ultrasonic testing at regular intervals to eliminate/detect parts with potential risk (although not required by the International Convention for the Safety of Life at Sea (SOLAS)), and this should then be included in the vessel maintenance system;
- ◆ The lifeboat chain, hooks and release system should be inspected and maintained according to manufacturers' recommendations, and should be included in the vessel maintenance system;
- ◆ It is recommended that lifeboats are lowered without personnel onboard and boarding then carried out after the boat has been lowered, unless the boat is to be used for an emergency situation as directed by the master.

- ◆ Identification and inspection of all lifeboat equipment using chain links as part of the load transmission from davit or davit block to lifeboat hook;
- ◆ Review of adequacy of inspection level and frequency as part of planned maintenance routines.

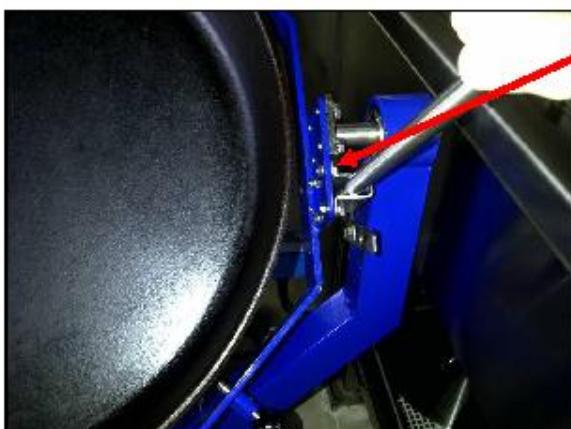
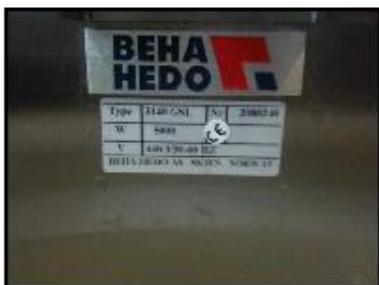
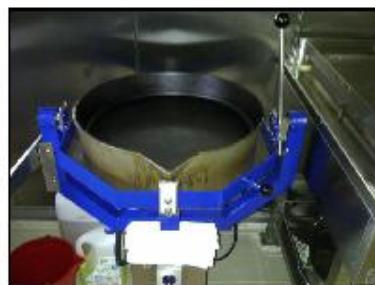
Further to Safety Flash 01-2006 another similar incident has been recently reported. During the cleaning of the Gyro Frying Pan, the handle came away from the fryer as it was being tipped to empty the cleaning fluid as per normal cleaning routine. This caused the fryer to swing uncontrolled and spill water across the galley.

Nut and Bolts sheared  
causing uncontrolled  
swing. These have been  
replaced

All ships fitted with Gyro Frying Pans are to check the gimbal pin and handle assemblies immediately.

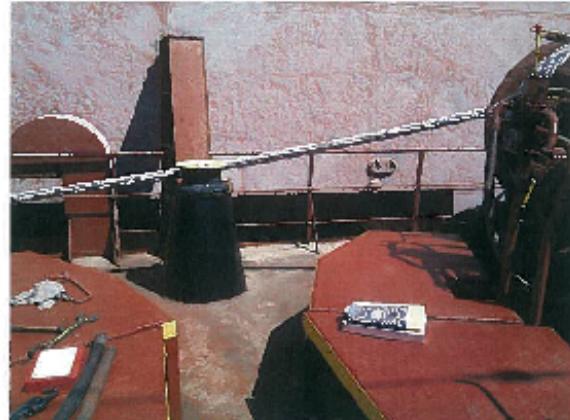
Proper use of deck fittings i.e. buttons, keels, cleats, rollers and bitts provide near unlimited mooring arrangements; they also create the potential for dangerous latent unsafe conditions. Casualty investigations have revealed the improper application of deck fittings has caused mooring lines to spring/slip free off the fitting. Specifically, arrangements lacked a substantial bend and/or had an excessive angle prohibiting the line from holding tight against the deck fitting.  
Image: Note: This line sprung/slipped off the roller. The angle of the line requires a taller roller bit structure for proper fit.
