IMCA Safety Flash 10/16

April 2016

Focus: Incidents during Mooring and Cargo Handling

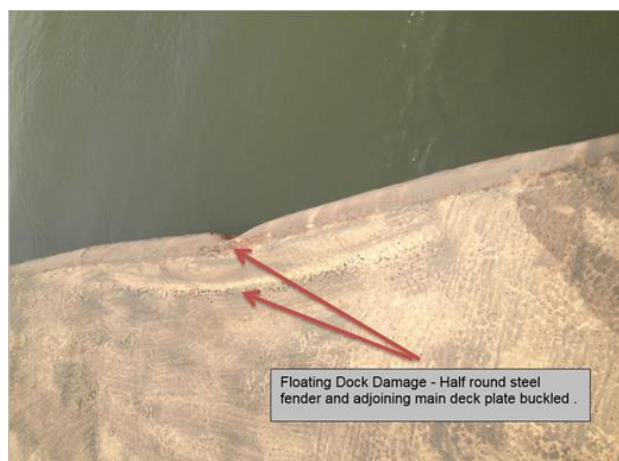
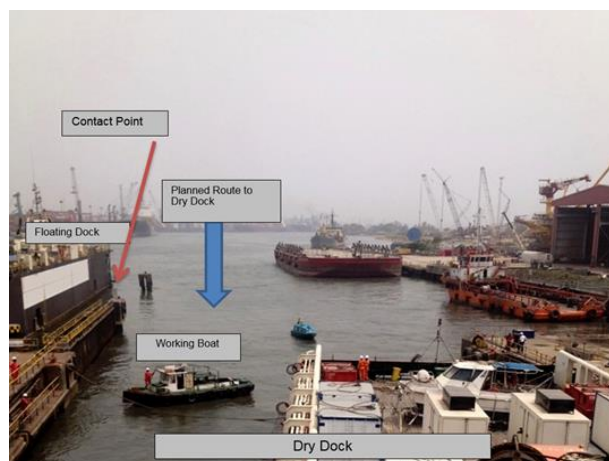
A member has reported an incident in which a multi-purpose support vessel (MPSV) made contact with a section of a floating dock and buckled a steel fender and the main deck forward centre of the dock. The incident occurred as the MPSV was being towed by two tugs (one forward, one aft) to a graving dock.

As the vessel was proceeding towards the dock, the dock master was contacted by the pilot with a request to send two working boats to meet the MPSV, to replace the forward tug. The dock master disagreed with this, as the local arrangements were that working boats were only to assist towing around 200m from the dry dock. The forward tug disconnected and sailed away without prior notification. Efforts made by the pilot to communicate with the master of the forward tug were not successful. The master of the aft tug refused to reposition to push the MPSV from its starboard side, as they were informed that the water was too shallow (8m depth). Thereafter, the vessel drifted to starboard towards the floating dock, collided with it and caused material damage. There were no injuries.

- ◆ A plan was in place to tow the MPSV to a graving dock. The tugs did not arrive as planned and were late. When the first pilot arrived on board, he refused to engage tugs due to the condition of the vessel at the time – only the emergency engines were running;
- ◆ The vessels forward and aft thrusters were non-operational due to ongoing repairs;
- ◆ The deck crew and officers carried out a toolbox talk as well as a risk assessment on towing, mooring and unmooring operations;
- ◆ The MPSV was docked starboard side to quay, before delivery to the dockyard;
- ◆ The pilot was informed about the status of the MPSV. He assured the crew that *'he was familiar with the dockyard operations, and that the proposed delivery will be carried out successfully'*.

- ◆ Better and more comprehensive risk assessment for docking operations;
- ◆ 'Stop work authority' should be implemented and enforced on board if any task is perceived to be unsafe;
- ◆ Pre-task planning meeting with all work parties should be mandatory before start of towing/docking tasks.

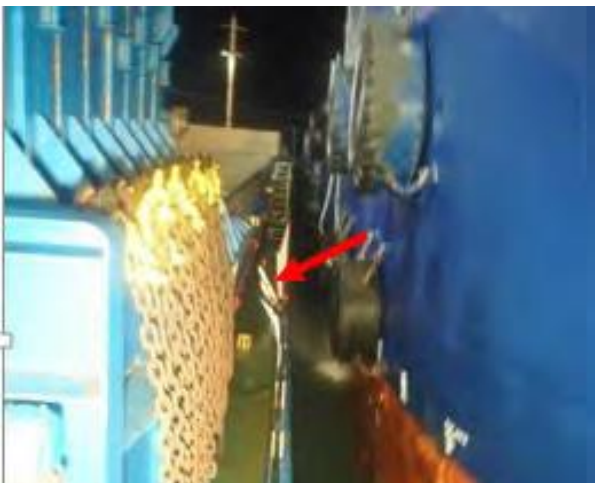
Showing the barge (left) without Yokohama fenders in place

- ◆ The barge master gave permission for mooring alongside the barge without having any Yokohama fenders in place;
- ◆ The vessel bridge team did not identify this and continued with mooring – **no-one stopped the job**.

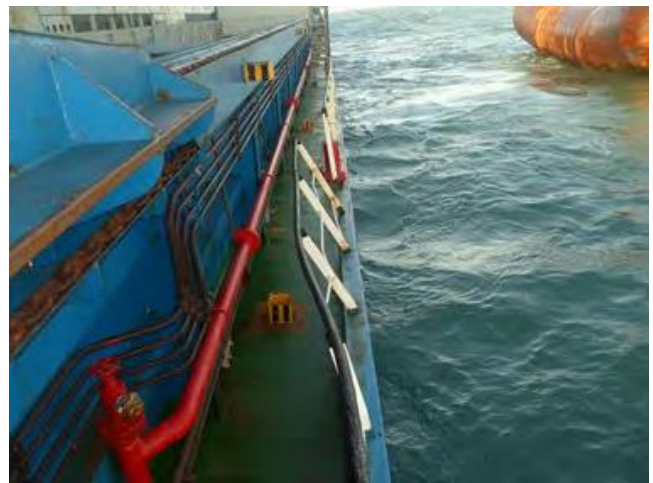
A member has reported a minor vessel collision resulting in damage to hand rails. The incident occurred during mooring operations between a vessel and a barge for the purposes of transferring a passenger to the barge. The vessel started side by side mooring operations and, when approaching the barge, the bow of the vessel came into contact with the hand rails on the barge causing slight damage.

Showing the damage to the hand rails of the barge

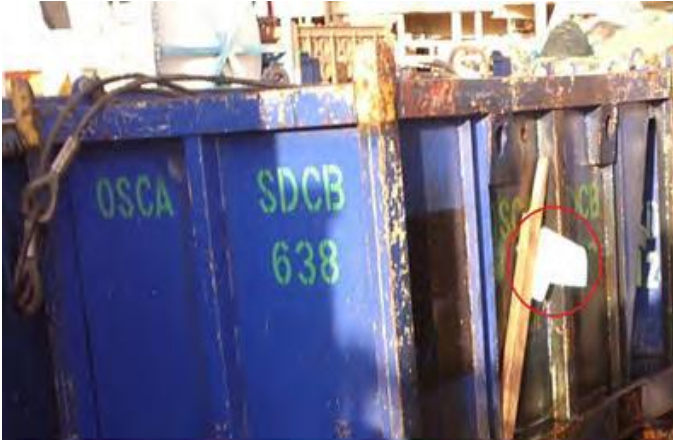
A member has reported an incident in which a filled drilling cutting box (DCB) was punctured during transfer onto the deck of a supply vessel. The DCB was damaged, with the side being punctured from a protruding angle iron bracket on an adjacent container. The DCB contained sand and an amount of oily water. The supply vessel Master decided to backload the container onto the platform and, upon lifting it, the oily water spilled out from the punctured area. This resulted in a minor spillage onto deck.

Showing punctured area of the DCB (circled)

- ◆ The Master has overriding authority to make decisions on the vessel; his action in this particular case, should have been to arrange sealing of the punctured area of the DCB with suitable materials to prevent further spillage to deck;
- ◆ Better communications between the Master and platform Offshore Installation Manager (OIM) should have been in place.

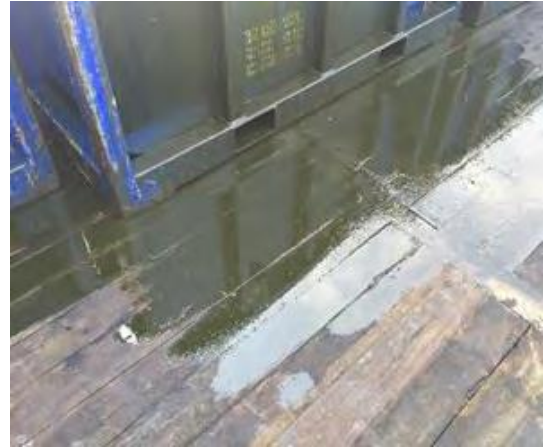
Showing minor spillage on the deck

- ◆ There was inadequate risk assessment for the emergency response to the spillage;
- ◆ There was no consideration given to potential release of oily water to the deck prior to backloading;
- ◆ Returning the container to the platform was against company procedures which state: *“The vessel Master is responsible for the safe and correct loading of his vessel and should liaise with the OIM (client representative on the installation) to ensure that the vessel is loaded correctly. The master should notify the OIM of defective lifts and return these to the installation **only if it is safe to do so**”*;
- ◆ **No-one stopped the job.**
