IMCA Safety Flash 10/20

March 2020

1 Dropped Load and Failed Chain

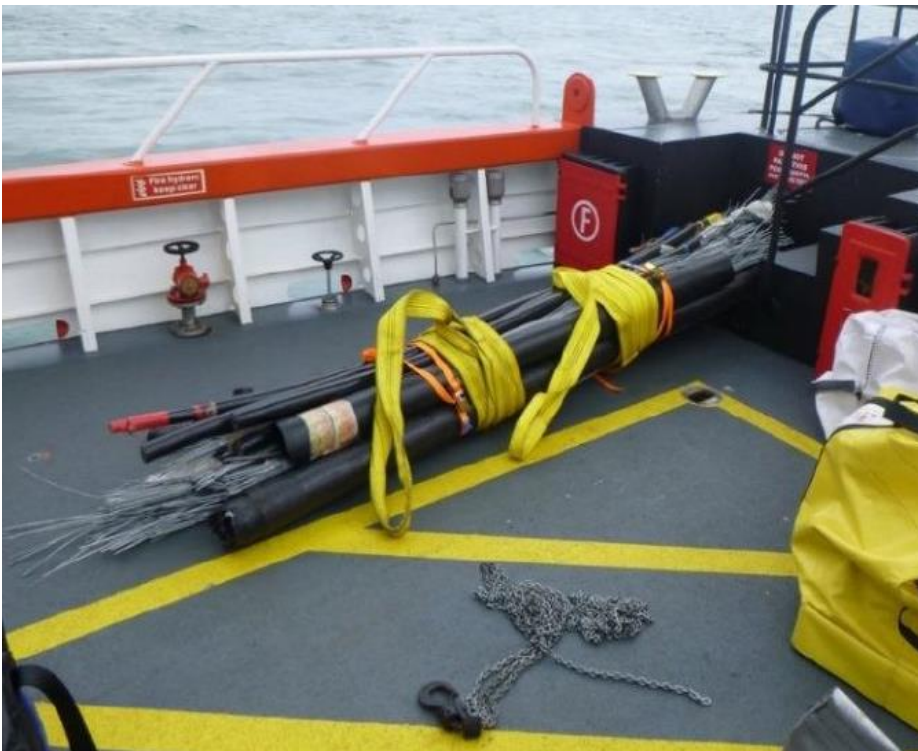
A chain link failed causing a load of over 260kg to fall 1.5m to deck. The incident occurred during transfer of a bundle of scrap cable, when a chain link snapped causing the load to fall the last 1.5m to deck. The load weight was estimated to be between 260 and 390 kg. The failed chain link was approximately 10.5m from the hook.

Dropped load and failed chain

Original link

Link after break load testing

Failed link from incident

- ◆ At the time of the occurrence, the chain link that failed was in the vertical plane and mid-air – the failure was unexpected and not caused by any torque, friction, tension or bending;
- ◆ The chain was at approximately 12% of its theoretical lifetime. Post incident break load testing showed an actual break load of the chain of 3400 kg. Metallurgic and fracture investigation were conducted on the actual chain;
- ◆ The failed link showed to have had an external impact on the weld side, which caused weakening of the structure by approximately 90%. This caused a failure mechanism different from normal overload breaking.

- ◆ Regular visual inspections of your lifting gear;
- ◆ Be aware that any external impacts on lifting gear may have a negative impact on its strength;
- ◆ Any damage spotted on lifting equipment should be reported and when necessary, such equipment quarantined and re-inspected.

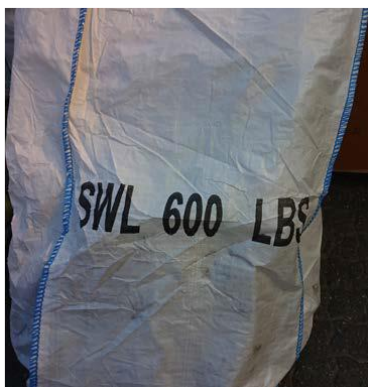
As the FIBC came through the hatch and over the main deck, high winds forced the FIBC into contact with the crane boom resulting in a shock load to the bag and the bottom tearing open. The lift supervisor called an all stop on the radio; however, this was not heard by the crane driver which then resulted in the contents being dropped across the deck and quayside.

Type of FIBC used for lifting operation

- ◆ Inspect FIBCs' prior to use ensuring they are free from damage that can compromise its strength;
- ◆ Post signage next to any FIBC being used as a waste container indicating waste material type to be placed inside;
- ◆ Check FIBC contents (where practical) to ensure correct waste type is inside prior to lifting;
- ◆ Lift FIBC as per the manufacturer and supplier's instructions;
- ◆ Consider the use of tag lines to control lifts where practical;
- ◆ Do not re-use FIBCs or use them for disposal of waste metals, wood, glass or other items than can puncture the bag;
- ◆ Ensure the vessel has the appropriate storage containers for scrap metal;
- ◆ Ensure that suitable lift baskets are available for the transportation or movement of loose items, such as metals, batteries etc.

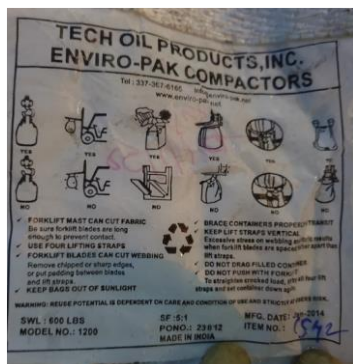
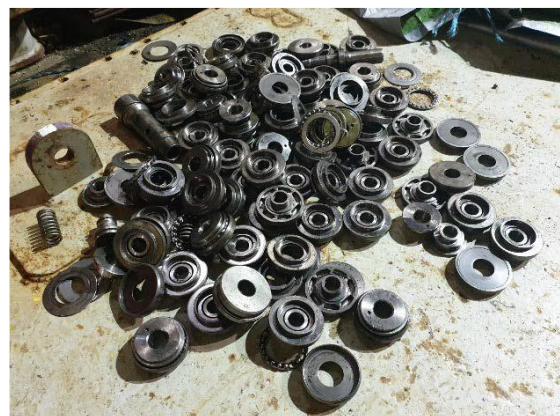
Multiple metal objects were dropped during a lifting operation using a flexible intermediate bulk container (FIBC). It was being used to lift garbage from a below deck stores area. The lift crew were unaware that several metal components ranging from 1.1kg – 2.3kg had been placed into the FIBC and then inadvertently covered over with cardboard and paper.

The distance that the objects fell varied between 8 and 25 meters. The DROPS calculations indicate that multiple items had the potential to cause a fatality.

Type of engine components which fell

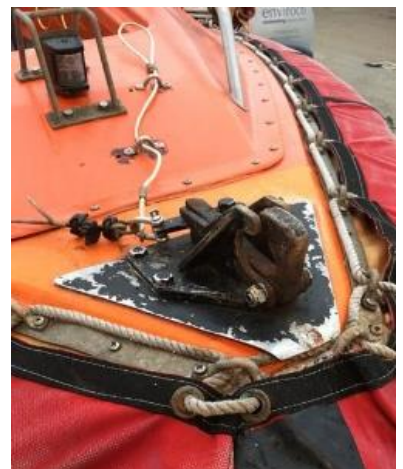
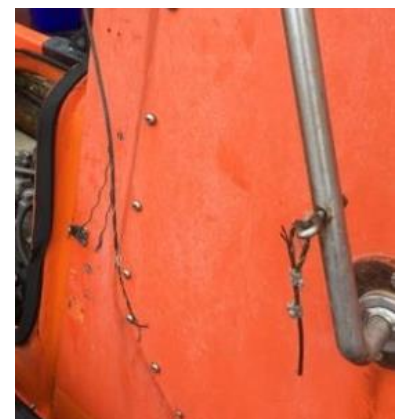
During the launch of a Fast Rescue Craft (FRC) for validation trials, the cable that releases the hook for the fall wire parted, resulting in the coxswain being unable to release the hook. The bowman mistook a gesture from the coxswain and released the bow line. This caused the FRC to turn 90 degrees to the vessel and quickly capsize, resulting in the three crew members falling into the sea. The Safety Alert notes that they were all recovered with no significant injuries. The FRC was righted with the self-righting bag and was recovered, having sustained significant damage. See [here](#) for MSF Safety Alert.

- ◆ All vessels are to hold a time out for safety with FRC/DC crews on launch and recovery, the focus of which is the function/release of the bow line and communications between crews. Also, vessels are to review their launch/recovery procedures and risk assessment highlighting critical points including the need for visual verification of release;
- ◆ Refresher training to be given to all boat crews highlighting the need for clear communication regarding all aspects of FRC operations, particularly during launch with regards to releasing the bow line;
- ◆ Add checks to remote release mechanisms to daily/weekly routines checking for kinks, corrosion and broken strands;

- ◆ Crews to be reminded that regardless of time pressure, launches and recoveries should be conducted in a systematic way that strictly adheres to procedure with clear and concise communications.

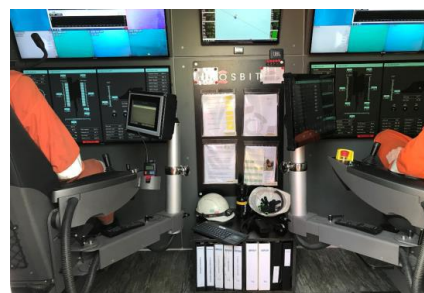
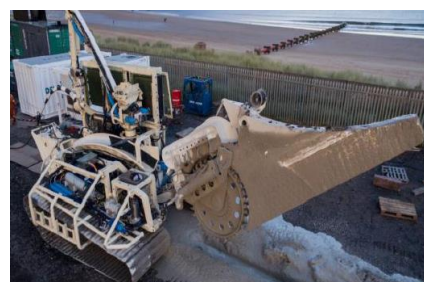
The pilot inadvertently operated the tool tilt function by making accidental contact with the joystick control. The subsea trenching tool was lifted to 4 degrees, which raised the tool depth from 1.17 meters to 1.06 meters, resulting in the depressor depth being reduced. This went unnoticed for approximately 7 minutes while the shift handover was taking place and equated to 27 meters of travel along the product.

- ◆ The pilot inadvertently made contact with the trencher control joystick;

- ◆ The joystick and software design did not include controls to reduce the possibility of accidental joystick activation (e.g. joystick lock, dead-man switch);
- ◆ The tooling alarm tolerance range was set too broad (-0.2° to +0.5°);
- ◆ Trenching operations were not stopped to complete the shift handover;
- ◆ The pilot/s did not notice the change to the trencher angle as they were distracted by both the shift handover and the reboot of a crashed control computer which was underway at the time.

Immediate preventative actions were put in place, which included change in the alarm tolerance with trenching operations ceased during shift handovers and the operating panels being set to maintenance mode, so the joysticks are deactivated.

- ◆ Although this alert focused on a trencher the findings are transferrable to a wide range of equipment; therefore a review of equipment controls (such as joysticks) that could be inadvertently operated, or activated unknowingly, without an audible and/or visual alarm or joystick lock capability should be carried out;
- ◆ Consider carefully your method of handovers during live operations and the implications of reduced focus on the activity during this time;
- ◆ Ensure that personnel involved in operations have access to procedures, manuals and have demonstrable awareness training of associated equipment and processes;
- ◆ Consider change of controls, processes, procedures and physical layout of control systems that would prevent a similar incident.
