1 Failure During Lift Bag Operations

2 Fatality During Lifting Operation

3 Filter Failure in Diver Gas Reclaim Boosters

4 EPIRB Antenna Failures

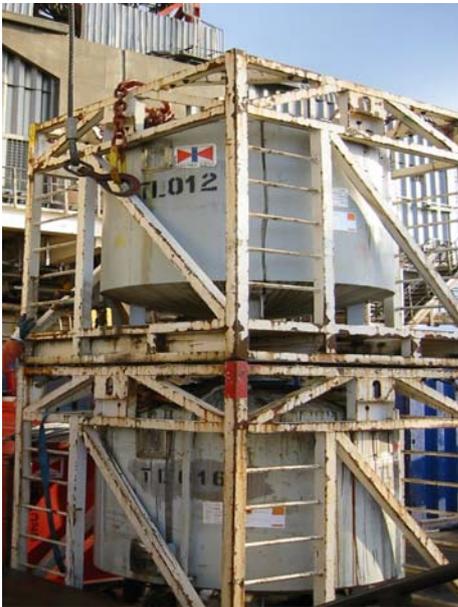
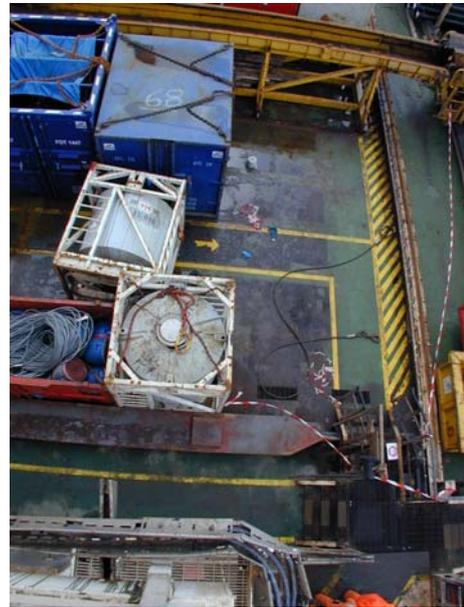
One of the hookmen climbed up the integrated ladder on the side of the pods, in order to hook the chain sling. During this operation, the crane pendant was lowered too much and went inside the frame holding the pod. When the hookman told the crane driver to lift up approximately 20cm, the pendant snagged the frame and lifted one end of the pod. As soon as one side of the tank had cleared the stacking lugs, the tank started to slide.

The hookman had his upper body above the frame and, when the tank toppled, his chest was crushed between the falling pod and an adjacent container, stored approximately 2.6 metres from the pods. The injuries to his chest were fatal and death was immediate.

- i) Inadequate design: the pods were designed for stacking, but the lugs did not properly prevent sliding if subject to external forces (e.g. crane, container). The chain slings were also too short to allow hooking from deck level, which had been required in the company's procedure for stacking to be allowed;

- i) Stacking of these pods and others of similar design to be banned by the company; consideration to be given to banning all stacking of containers;
- ii) A pocket-sized aide-mémoire card to be introduced by the company, to prompt and aid appropriate prior assessment of lifts;
- iii) Existing company rules on working at heights to be properly enforced (working on a ladder above 2m height was already a violation of company rules);
- iv) Company rules on lifting to be clarified/changed:
 - a) 'hooking at deck level' means standing on the deck itself;
 - b) flagman to be the only person communicating with the crane drive; flagman not to touch load; flagman to be identifiable by wearing a bright vest.

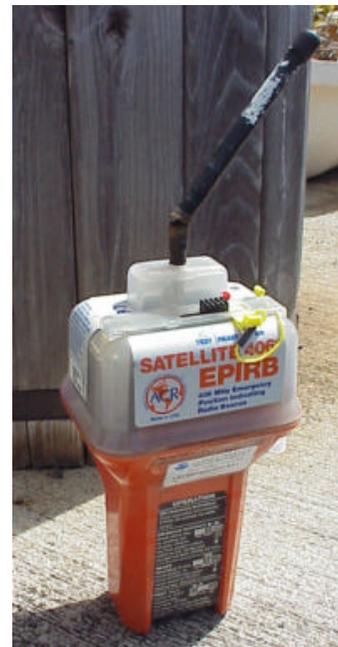
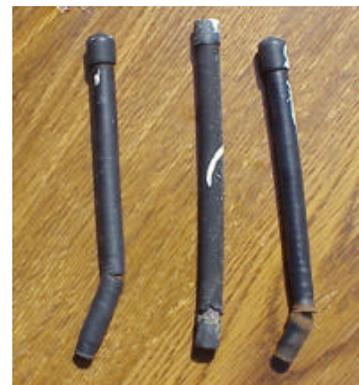
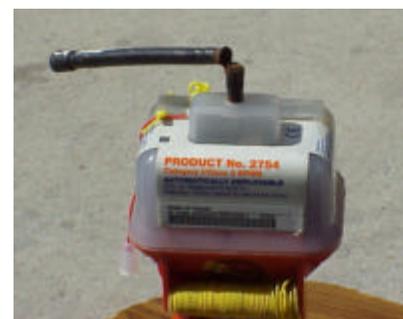
On several occasions the antenna's outer rubber coating was discovered ripped or torn. Closer inspection often revealed extensive internal corrosion. Other antennas showed no perforations on the outer rubber coating but displayed bulges on the antennae near its base. Upon closer inspection when the bulging area was sliced open, total wastage of the antennae interior was revealed.

It is reported that evidence of a corrosion failure may be discovered when the antenna is unscrewed from the EPIRB body assembly. Rusty liquid dripping from the antenna or moisture present inside the threaded section are tell tale signs of failing equipment.

The Coast Guard strongly recommends that vessel operators carefully inspect their EPIRB antennas - particularly if it is manufactured by ACR Electronics Incorporated.

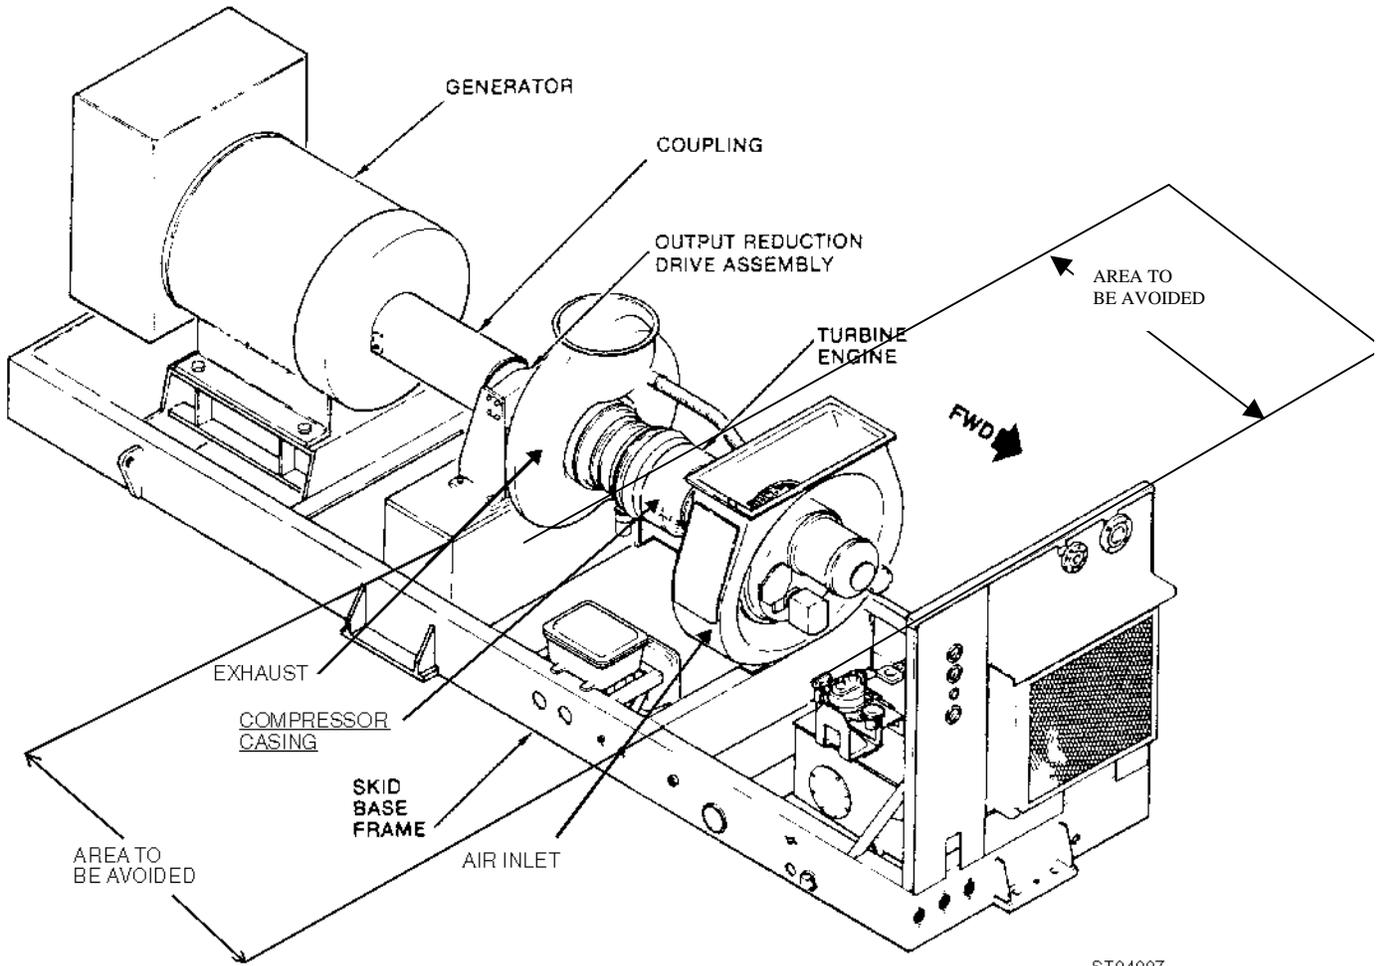
Figure 1. Typical Saturn 10 Generator Set

During March 2002, a Solar *Saturn 10* single-shaft gas turbine experienced an uncontained compressor section failure at a customer site, which resulted in metal fragments penetrating the compressor casing. Initial reports were that this resulted in a fatality. The reported equipment damage was limited to the *Saturn* package.

Solar recommends that in order to avoid possible injury to personnel, users are cautioned to advise all personnel to avoid the area adjacent to the compressor section during an engine start and while the engine is in operation. See Figure 1 for the locations of the engine area to be avoided.
