I Topic Working with Tubulars – Incident Report

2 Airline Coupling Failure

3 Internal Explosion within 12V Forklift Battery

6 Loss of Mooring Chain to FPSO

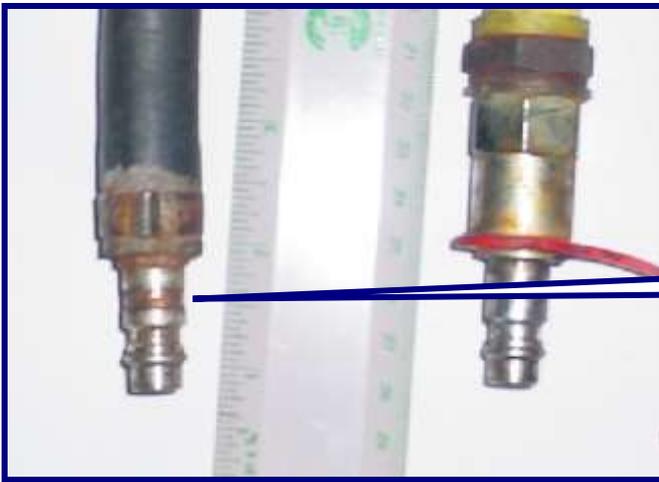
However, on closer inspection the male fitting indicated a slight difference (see below) which appears to prevent satisfactory connection with the female fitting. The pictures below indicate the difference in the appearance of the made up joints. Both joints hold when tested by hand on initial set up, but the dissimilar tubing fitting is not secure if the tubing is flexed, indicating it does not make a tight/locked connection on the make up.

Both 'male' connectors. Both 'female' connections look identical superficially.

Groove present on this one but not obvious on a cursory examination.

- ◆ A system is to be put in place to record that equipment has been fully checked each day before being used on a worksite, to include a supervisor's signature;
- ◆ The contractor is to establish how it was that it was supplied with hoses with 'mixed' fittings with the project equipment;
- ◆ A new set of compatible hoses has been requested of the contractor.

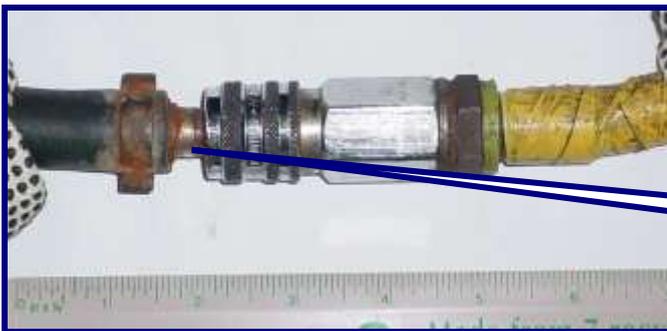
Black 'male' connection to blue 'female' connection. This combination is the only one that would not seat correctly.

Note the gap. NB some pressure is being exerted to push the connection together.

- ◆ Male connections were not stabbing fully into the female connection because of the slight differences in the design of the male connectors;
- ◆ Back up air systems worked correctly;
- ◆ Safety procedures were complied with.

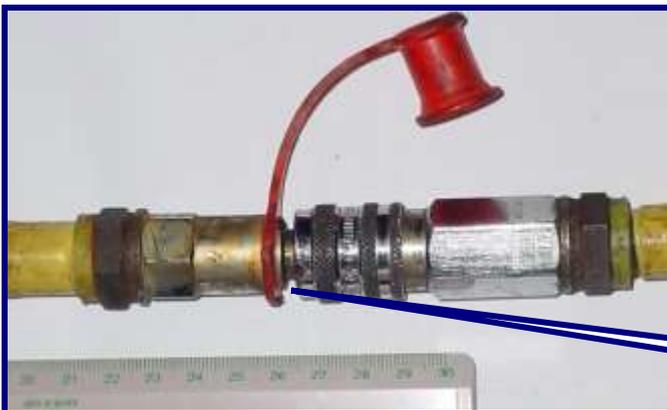
Blue 'male' connection to blue 'female' connection.

A tight connection. No pressure.
