I Parting of Slings Causing Fall of Heavy Object onto Seabed

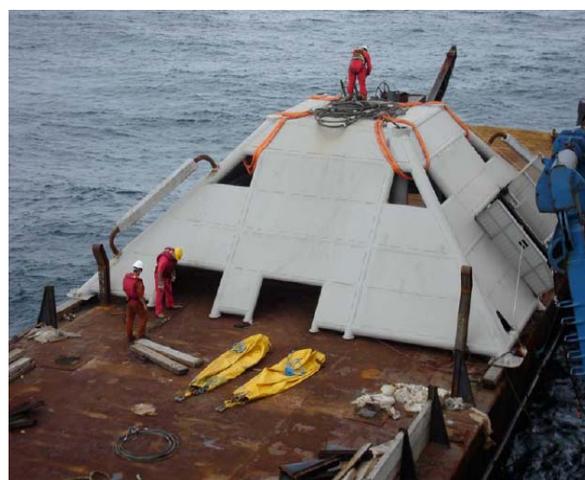
A diving support vessel was installing a 24 tonne metallic cover onto a subsea valve. When this large object was deployed over the side of the vessel into the water, the four 15 tonne round slings used in the rigging arrangement parted and the object fell into the seabed. There were no injuries or damage to equipment or seabed infrastructure as, in accordance with the company's procedures, the lift was made over a seabed area free of any field infrastructure.

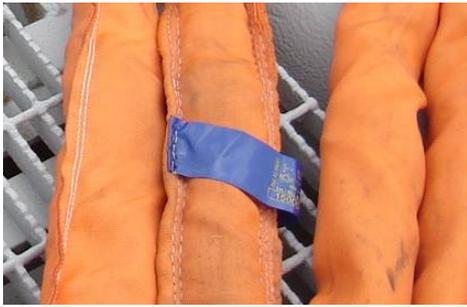
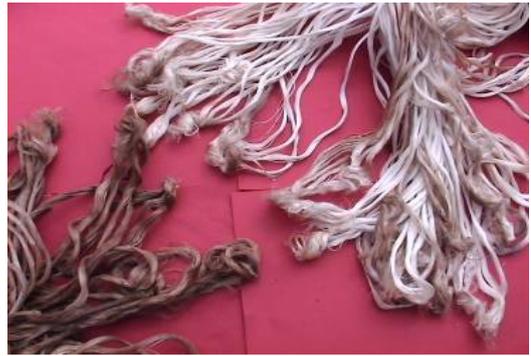
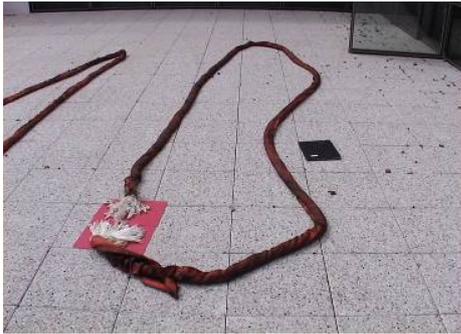
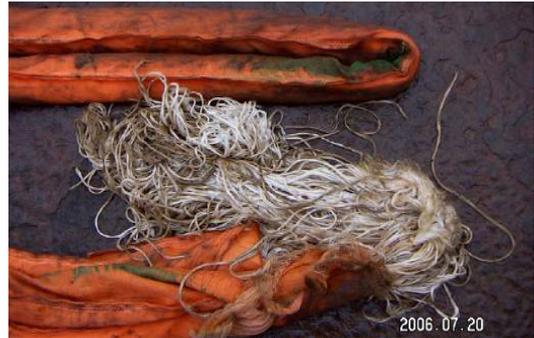
Investigation revealed that the four round slings obtained from a local supplier had been modified incorrectly and without due authorisation from the original manufacturer.

- ◆ Close examination of the slings revealed that the fibre had been cut and re-spliced using numerous knots, hidden under the protective fabric (this could not have been spotted without dismantling the sling)
- ◆ Whereas 6 metre (working length) slings had been procured from the local supplier, the manufacturer advised that the serial number on the round slings actually corresponded to 12 metre (working length) round slings. The manufacturer also advised that it did not fabricate 6 m (working length) round slings of 15 tonne SWL
- ◆ There was no manufacturer certificate for the slings available from the supplier
- ◆ The blue label showing SWL was stitched to the sling, when it normally should slide around it.

- ◆ Rigging equipment shall in future only be procured from approved and recognised suppliers
- ◆ Rigging materials are to be always subject to testing and inspection as required by the applicable international standards and company rules
- ◆ Exceptions to the above should be subject to a rigorous and thoroughly documented management of change process covering all aspects of the rigging operation.
