IMCA Safety Flash 11/14

July 2014

I Failure of Master Link during Subsea Lifting Operations

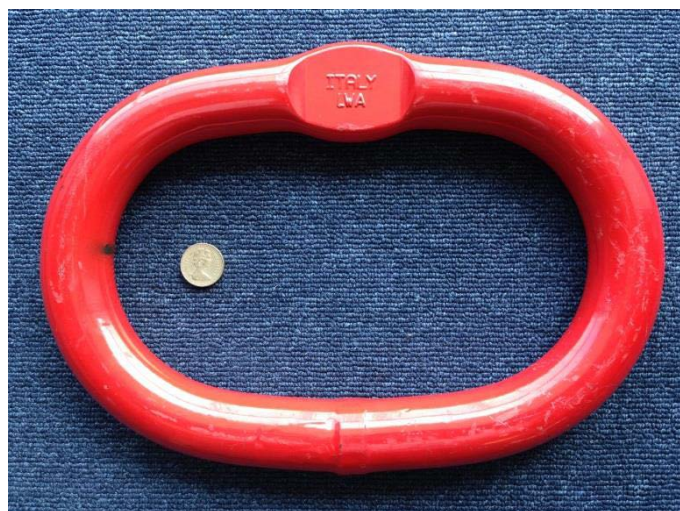
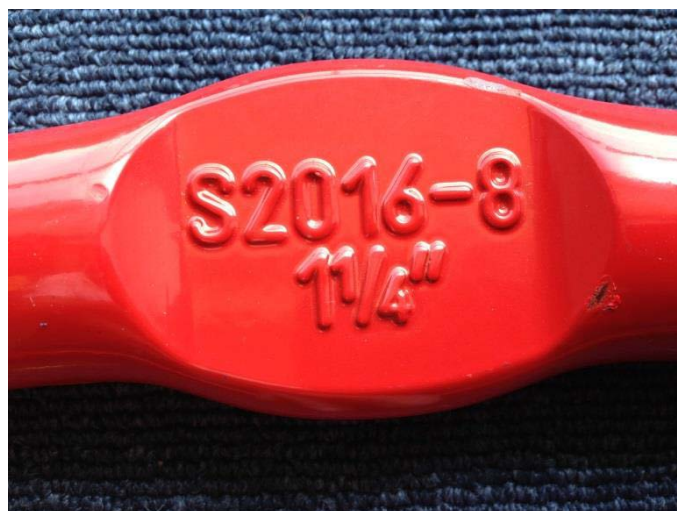
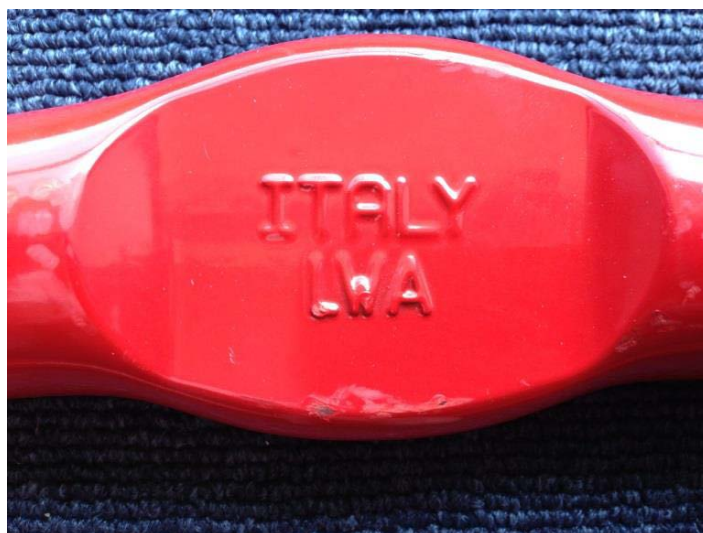
An incident has been brought to IMCA's attention in which a master link (lifting ring) fitted to a 10t air lift bag failed in use during subsea lifting. This style of master links are also fitted to 10t water load bags.

Showing the overall size of the master link, and the part number embossed on the flat section

Unique Seaflex has identified the batch number of the parted master link. However, as these links are interchangeable, as a precaution, the company has decided to advise all owners or users of 10t air lift bags and 10t water load bags to inspect the master links fitted to their bags and quarantine any products marked with the following two possible lot numbers (which can be found embossed within the pressed section opposite the weld in the centre of one long side):

- ◆ IWA;
- ◆ LWA

Members using 10t air lift bags or 10t water load bags fitted with a red master link marked IWA or LWA should contact Ian Margham at ian.margham@uniquegroup.com for further information in regards to ring change-out and replacement instructions.

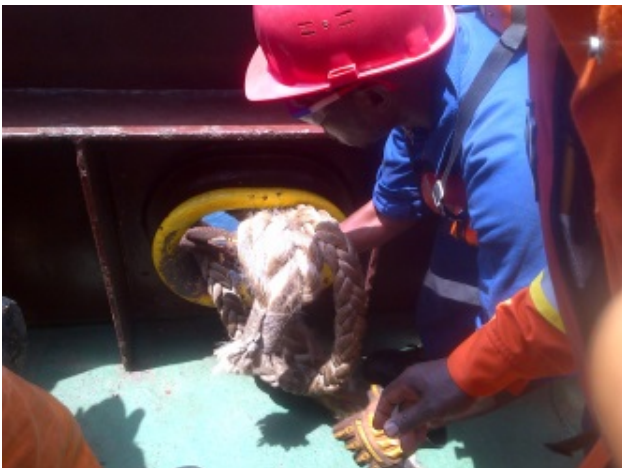
An incident has come to IMCA's attention in which a crewman lost his right hand during mooring operations. The incident occurred when a service vessel was moving floating hoses away from an incoming tanker (a routine procedure) using soft 'pick up ropes' attached to each hose. Members of the deck crew and Bosun picked up and secured the first pick up rope. They had difficulty in securing the second hose. The Chief Mate (the injured party) came down from bridge and physically took over the job. He held the pick-up rope close to the 'panama eye' of the vessel with his arm through the eye of the rope. A sudden sea swell tightened the rope. His right hand was caught against the hard edge of the panama eye, and severed.

Showing elbow linked through pick up rope soft eye

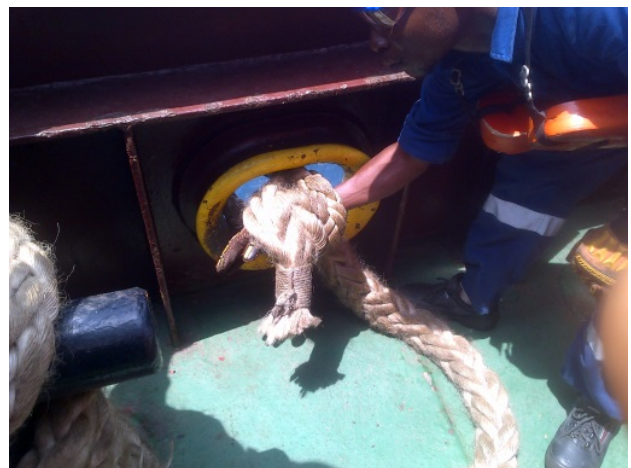
Showing pick-up rope (re-enactment)

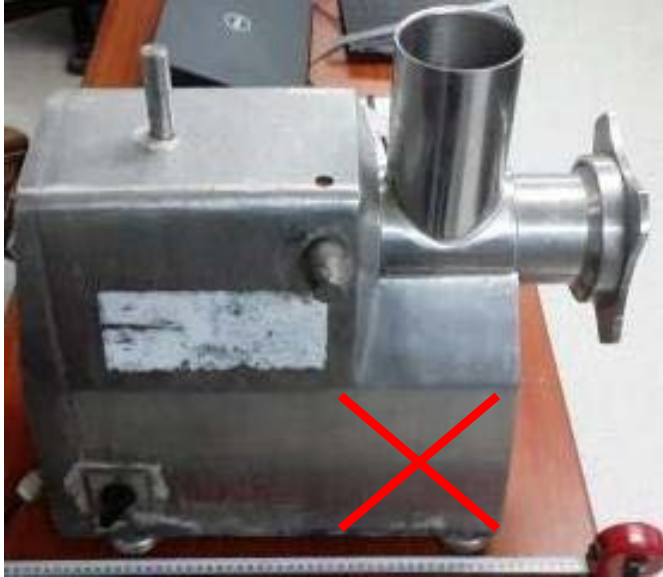
Showing INCORRECT set-up with no plunger or top tray

- ◆ The equipment was not properly configured for safe use – see photographs;
- ◆ All the necessary guards were not in place;
- ◆ The machine was being operated by someone who was not fully familiar with how to operate it;
- ◆ The machine was not being used for the purpose for which it was intended.

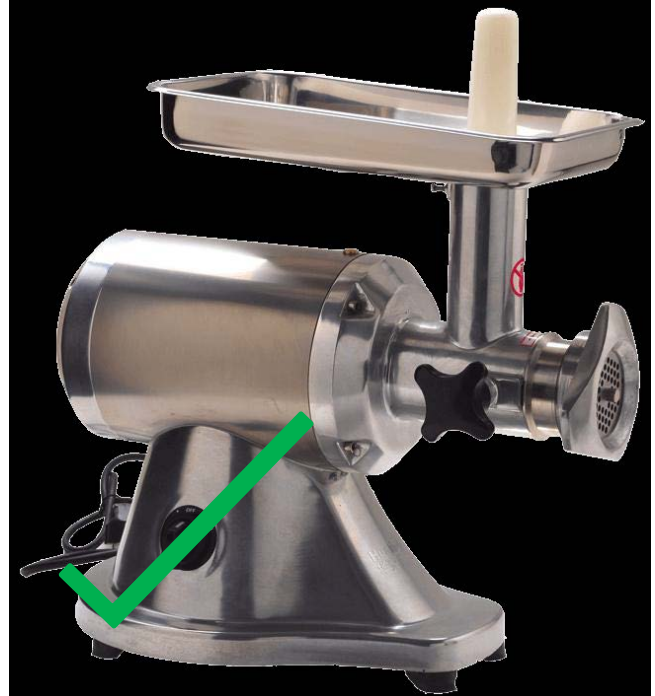
Showing CORRECT set-up with plunger and top tray

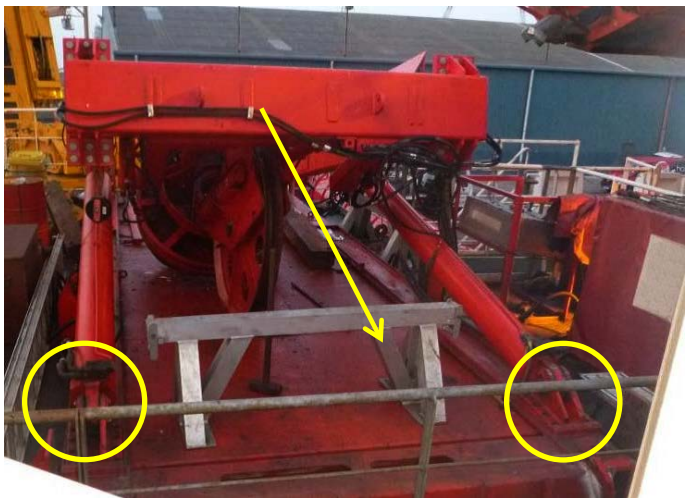
During the disassembly of the LARS, existing company procedures were not consulted by the ROV team. As a result, an ROV supervisor attempted to lower the 'A' frame with his own perceived method, and subsequently the 'A' frame fell in an uncontrolled manner to the deck. The method of lowering one supporting hydraulic ram at a time whilst the other is firmly bolted into place was not followed. The supervisor removed all the securing bolts from the feet of both the hydraulic rams, believing the system would gently slide down into the stowage position. To aid the initial movement of the rams, the two supervisors stood on the LARS platform and started striking the feet with a sledge hammer, one ram at a time. Once the first ram moved approx. 13cm, they then struck the second ram which resulted in the 'A' frame collapsing at speed. Both supervisors were extremely fortunate that they were not struck by the falling 'A' frame - they were unharmed, but this incident had the potential for serious injury/loss of life.

'A' frame in final position after collapse – showing where bolts were removed from feet of hydraulic rams

NB: Actual worksite after event. Yellow arrow denotes direction in which 'A' frame collapsed

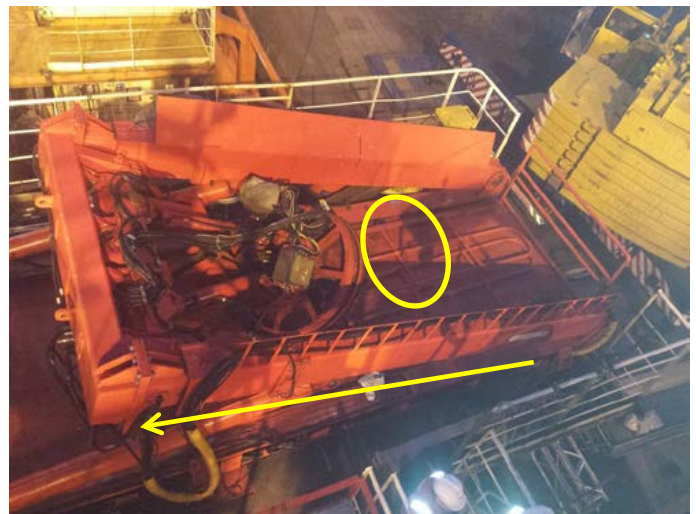
Position of the two supervisors after 'A' frame collapse

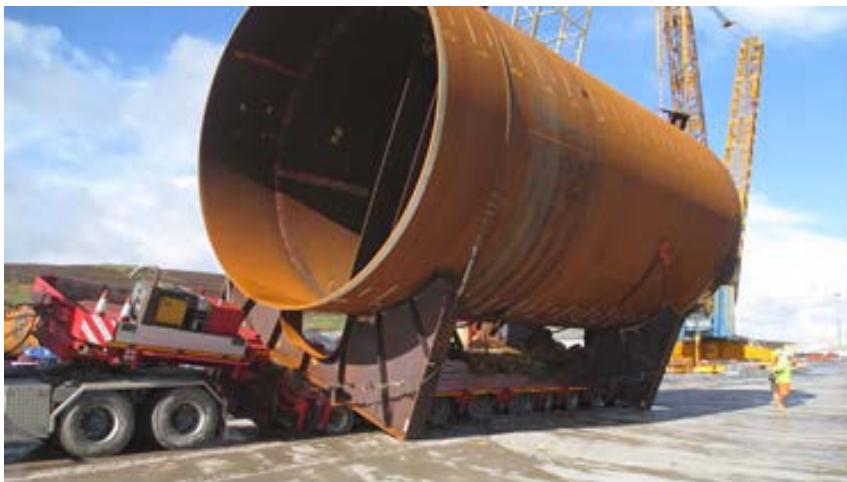
Whilst the trailer was moving at a slow walking speed along the quayside, one of its hydraulic hoses burst. The hose was located near the rear of the trailer. This caused a loss of hydraulic pressure which caused the trailer to sink on the nearside which in turn made the load lower toward the quay. The wheels on the trailer's offside lifted clear of the ground approximately 20cm and on the nearside of the trailer the suction pile saddles made contact with the concrete.

Suction pile after hose failure

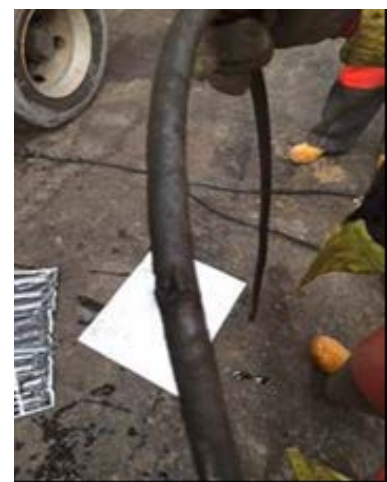
Damaged hose

- ◆ The hydraulic hose that failed was located behind the wheel arch running along the chassis of the trailer; it was quite inaccessible for regular cleaning, inspection and maintenance;
- ◆ The location of the hose was considered a 'dirt trap' which is considered likely to have led to its deterioration and subsequent failure;
- ◆ The critical nature of this hose was not understood, and it was not recognised that failure could cause the trailer to list;
- ◆ As a consequence of the above, no hose inspection or change out frequency had been specified;
- ◆ The potential for failure of the suspension to cause the load to list was not considered at the risk assessment.

- ◆ Check planned inspection and maintenance systems of equipment – are critical items considered;
- ◆ Risk assessments – are potential failures and effects considered and assessed;
- ◆ Consider pre-use checks of similar trailers – can a test to working pressure be conducted prior to loading.
