IMCA Safety Flash 11/15

August 2015

I Lost Time Injury (LTI) and Restricted Workday Case (RWC) following Failure of Diving Bell Door System

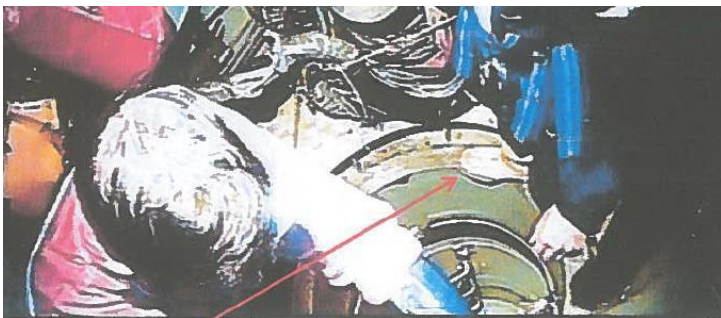
SCREEN GRAB SHOWING POSITON OF THE I.P.'S FOOT IN THE PATH OF THE DOOR PRIOR TO THE INTERNAL DOOR DESCENDING ONTO HIS FOOT.

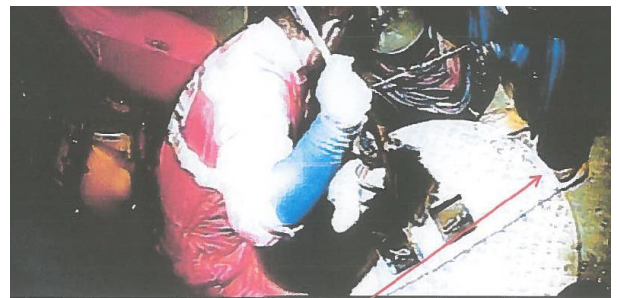
SCREEN GRAB SHOWING POSITON OF THE I.P.'S FOOT TRAPPED BY THE BELL DOOR AFTER THE INTERNAL DOOR DESCENDED ONTO HIS FOOT.

- ◆ The hydraulic ram used to open and close the door had failed;
- ◆ When the ram cylinder was opened, it was identified that the shaft had broken internally at the end where the locking nut holds the piston onto the shaft causing the shaft to pull freely from the cylinder body. This resulted in the door dropping down in an uncontrolled manner;
- ◆ The hand operated hydraulic Enerpac pump had a greater operating pressure than that of the ram and relied on a pressure relief valve to prevent over-pressurisation;
- ◆ Additionally, the failure of the door component prevented free movement of the door during the bellman's attempt to raise it so as to release the trapped diver's feet.

- ◆ Direct Cause:
 - Failure of the hydraulic ram piston rod threaded end at the locking nut inside the ram, resulting in the ram piston rod detaching from the unit, thus allowing the door to fall;
- ◆ Underlying Root Causes:
 - Failure to secure the door in an open position
 - Incorrect placement of divers feet
 - No Planned or Preventive Maintenance System in place for the hydraulic ram
 - Safety Risk Assessment for hydraulic use not applied or assessed
 - No secured guard around trapment area to prevent incorrect foot placement
 - Single point failure, no stage latching of door during raising operation, preventing door closing
 - Too much hydraulic pressure facilitated by hand pump to ensure opening of door;
- ◆ A factor in these root causes was that there was a design failure of the door securing ram system, having a single point failure with no backup.

This was a very nasty incident, and similar incidents have occurred in the industry in the past. Ensuring that secondary systems are in place to prevent unplanned closure of the door, and ensuring that door hydraulic systems are included in planned maintenance schedules, will go a long way to preventing recurrence.

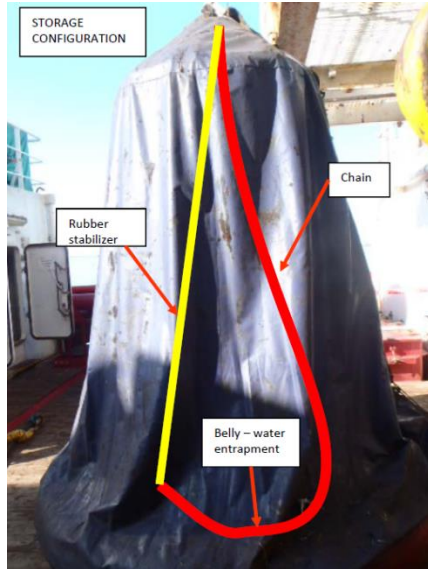
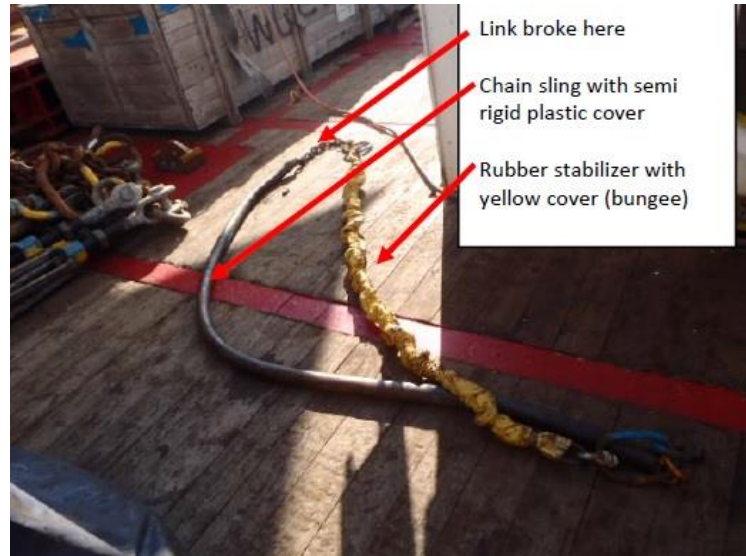
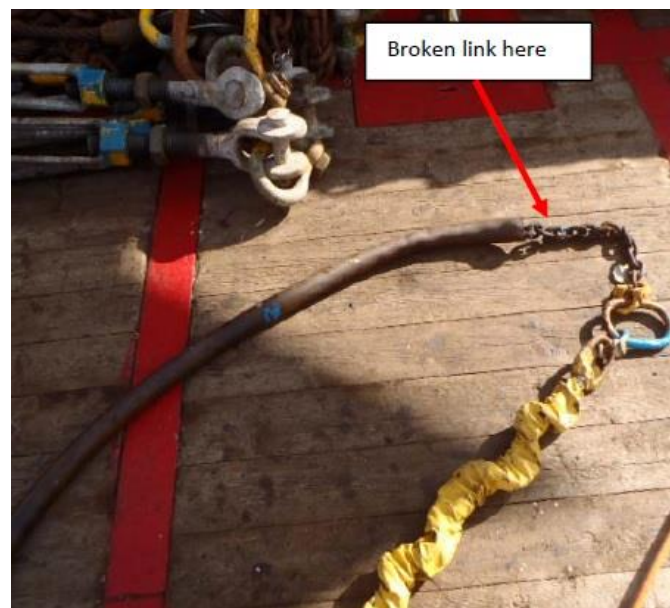
A member has reported a near miss incident in which a chain link snapped under load. The incident occurred during a six monthly on-board lifting and rigging inspection. A deck foreman was required to arrange the lifting of an empty personnel basket from one place to another on the vessel. The basket was connected to the crane block, the deck foreman gave the command to lift, and as soon as the crane took up the full load of the basket, one of the chain links from the main chain sling of the basket snapped. There were no injuries.

- ◆ The configuration of the rigging (the "bungee" was shorter than the chain) created a space or belly during storage, with water trapped inside the plastic cover around the chain. Accelerated corrosion occurred, which may have contributed to chain failure. Corrosion, shock load and/or chain manufacturing process are potential causes for rigging failure;

- ◆ The inspection company did not remove the plastic protection cover to inspect the chain, which meant that the visual inspection was not complete.

- ◆ Removed protection cover from rigging and performed thorough visual inspection;
- ◆ Checked that the storage configuration of the rigging does not allow water entrapment and associated corrosion;
- ◆ Investigated the possibility of replacing the plastic protection cover by an easy-to-remove cover type, for easier inspection;
- ◆ Checked personnel basket user manual and reviewed if rigging inspection sub-contractor was meeting manufacturer recommendations during last recertification campaign.
