## IMCA Safety Flash 11/16

April 2016

### 1 Fatality – Crew Member Struck By Forklift during Quayside Operations

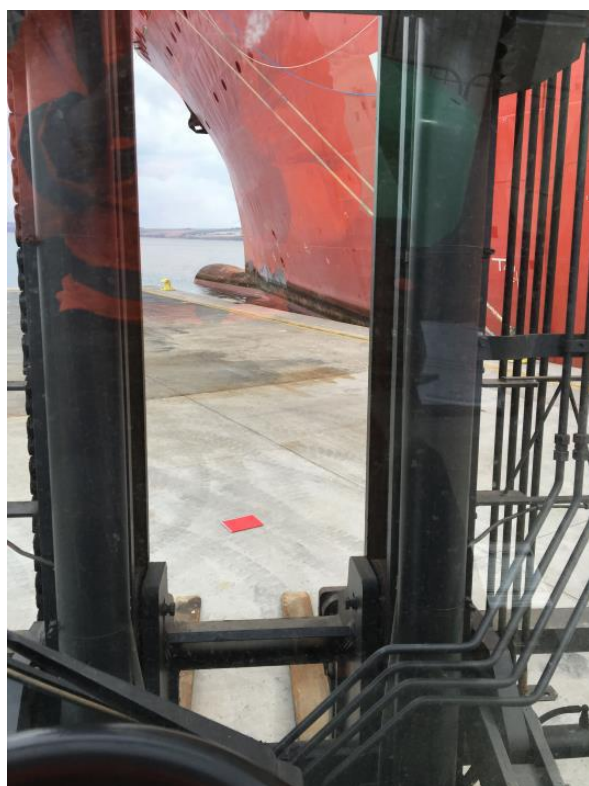
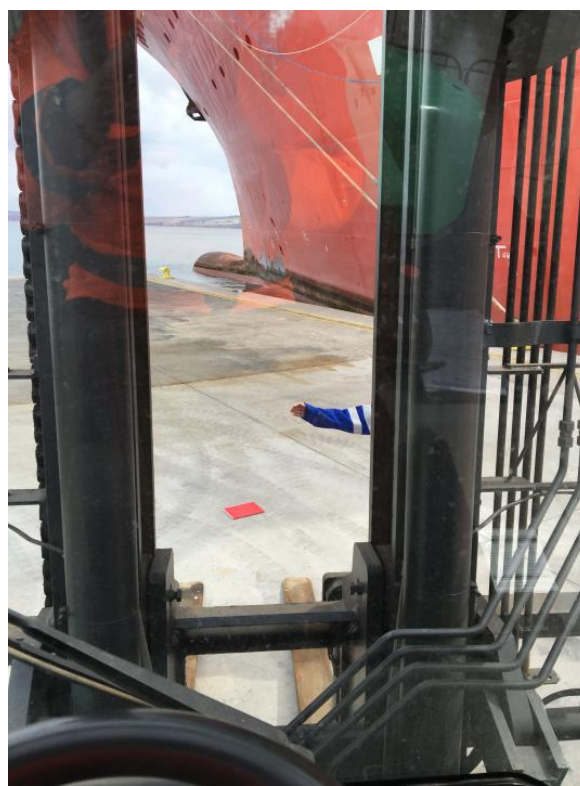
- ◆ Blind spots within the forklift operators field of view from the operating cab;
- ◆ Obscured vision due to sunlight.

*A mock-up showing the forklift operator's field of view, as impaired by the forklift mast. The two pictures demonstrate how a person can easily be concealed behind the forklift mast and missed by the operator. The picture on the left demonstrates the person fully hidden and the picture on the right demonstrates the person extending his arm to reveal his position.*

- ◆ Circulated a safety notice to vessel crews via a scheduled 'Time Out for Safety' and to the industry via IMCA;
- ◆ Revisit and reassess mobilisation and demobilisation plans, procedures, practices and briefings in light of the above;
- ◆ Review all Project Hazard Identification & Risk Analysis (HIRA) and Vessel/Site Risk Assessments to ensure appropriate mitigation and controls are in place;
- ◆ Review effectiveness of toolbox talks, supervision and working practices on mobilisation sites.

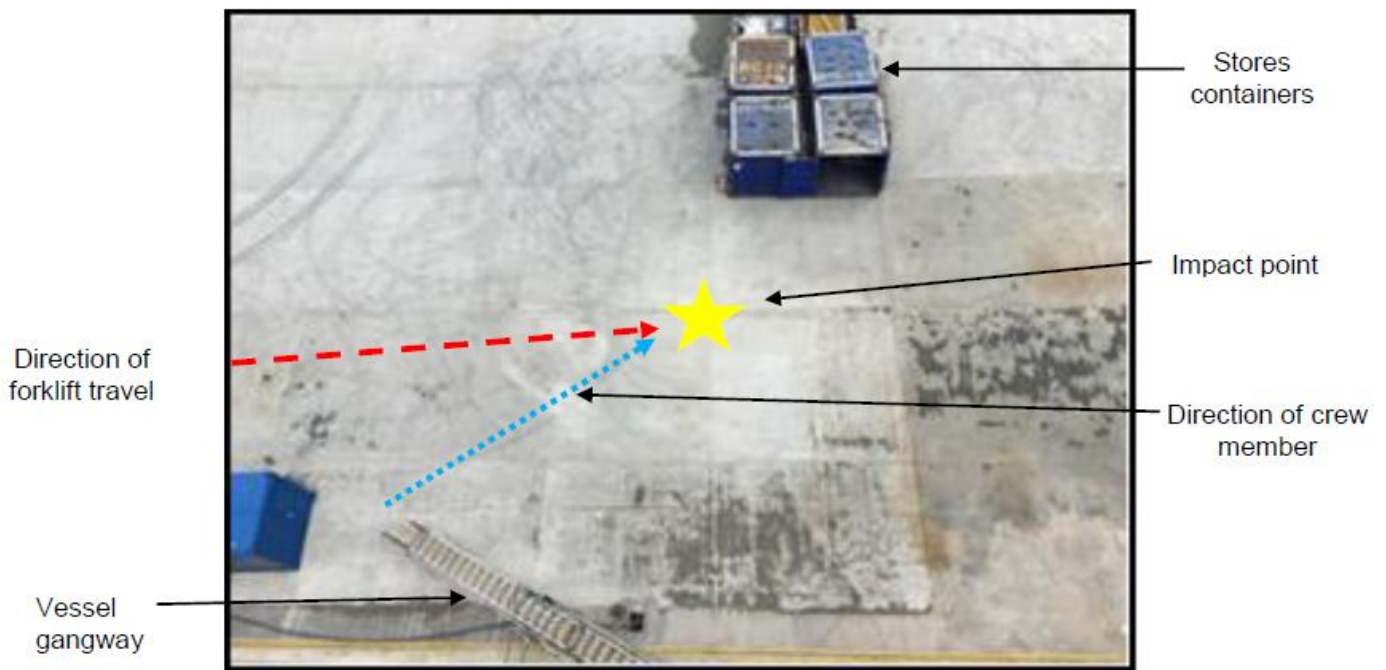
**Incident site**

A member has reported an incident in which a crew member was struck by a forklift truck during quayside operations, and suffered fatal injuries. The incident happened when a vessel crew member was tasked with unloading stores from a container on the quayside. He descended the vessel gangway and headed towards the containers situated close by. It was during this short excursion that the crew member was struck by a forklift and fatally injured.

*Showing incident site and directions of travel*

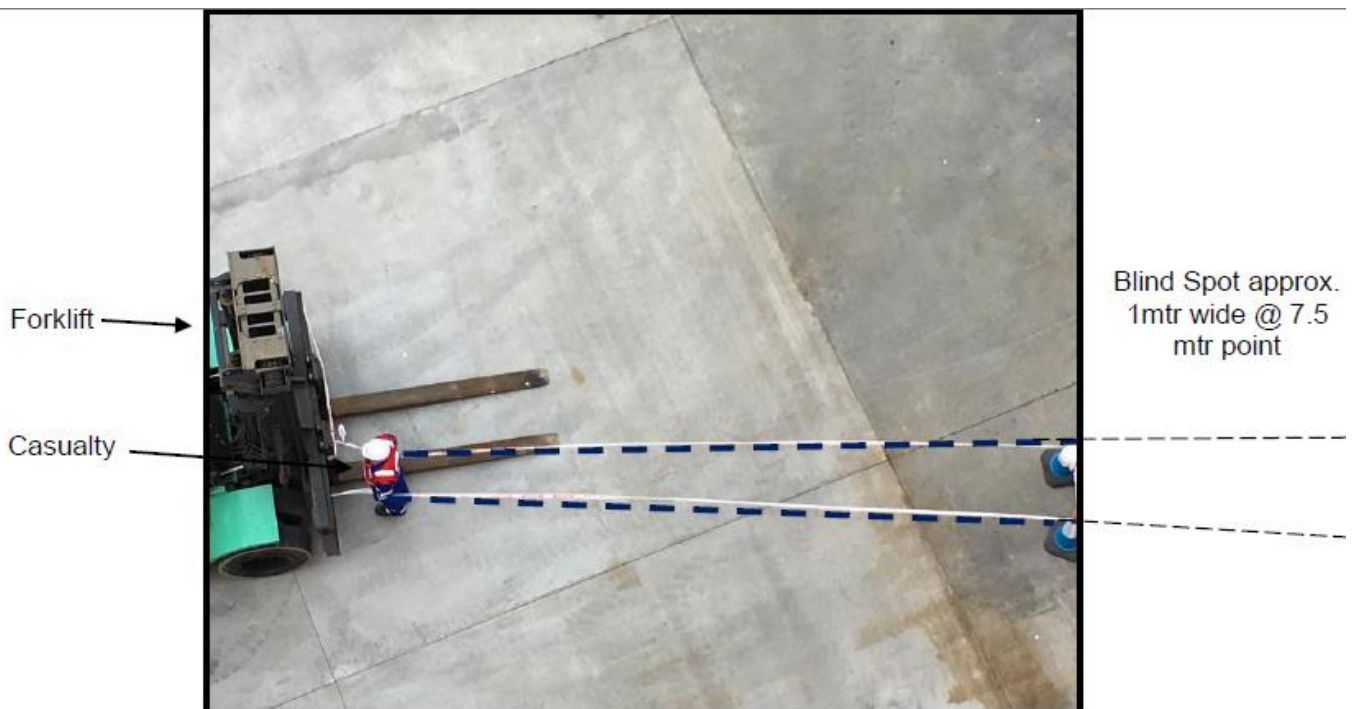
**Operators "Blind spot"**

*Showing forklift operator's 'blind spot'*

- ◆ This tragedy is a stark reminder that when working near moving vehicles or heavy equipment, persons must remain in the operator's full view;
- ◆ If you can't see the operator, they won't be able to see you;
- ◆ Remain vigilant at all times around routine activities through exercising situational awareness;
