IMCA Safety Flash 11/18

June 2018

1 Uncontrolled Movement of a Riser

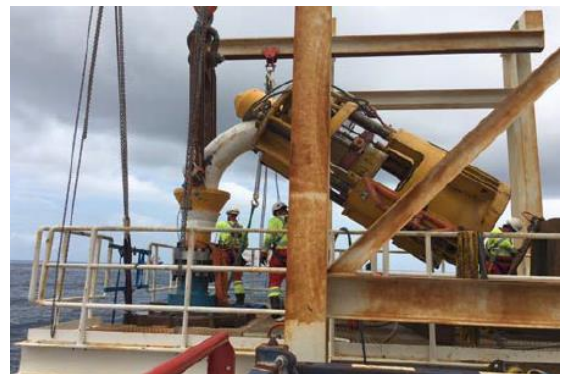
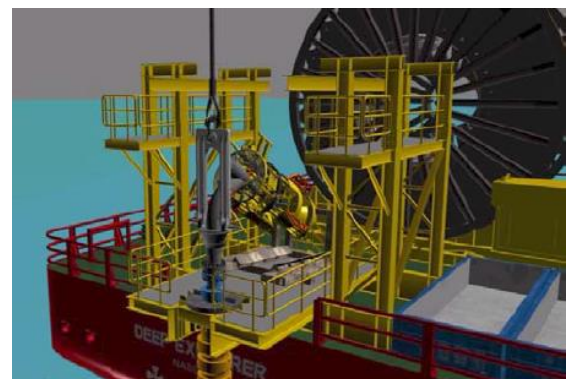
A riser moved unexpectedly away from the vessel. The incident occurred during the deployment of a production riser from a hang-off frame located starboard aft. All rigging had been connected and the crane had taken the load and slewed inboard to allow the removal of the hang-off plates and beam. A 3-tonne lever hoist was also attached to assist in this activity. The rigging team were about to remove the chain hoist (before slewing the crane outboard) when there was an unexpected sudden movement of the riser to starboard. The chain hoist parted and the riser moved clear of the hang-off platform to approximately 8m off the vessels side.

The proposed arrangement had been risk assessed and it was noted that the riser was leading away from the vessel (this was in line with the written procedure). A decision was made to install a bellyband (soft sling) around the riser which would be connected to a lever hoist. This would be used to steady the riser to assist the riggers in the removal of the hang-off collars and beam. This rigging was arranged and secured to the riser end fittings and the process of deployment continued. The bellyband was in addition to the existing procedural requirements, but there had been no management of change (MoC) process followed for this addition.

The crane was slewed inboard to allow the removal of the beam (as per procedure). Once the hang-off collars and beam had been removed, the crane operator requested a movement outboard as he was concerned with the 3° side lead on the crane wire. The confirmation was to move the crane outboard 'just a touch'. Two personnel remained in position to remove the additional rigging. The CCTV footage showed the crane slew to the left and come to a stop. Almost immediately, the bellyband lever hoist failed. The riser suddenly moved left, bending a section of handrail on the hang off platform as it moved.

Our members' investigation concluded that the causes of the incident were a lack of risk perception and the failure to follow procedures (engineering and MoC). Key points include:

- ♦ The introduction of the bellyband rigging was not identified as a change and therefore was not managed via the MoC process;

- ◆ The effects of moving the crane jib on the riser were not considered;
- ◆ As the risk was not identified and managed via the MoC process, once the movement of the riser began, the 3-Tonne lever hoist was not sufficient to prevent the incident from occurring;
- ◆ There was ineffective communication between the rigging supervisor and the crane operator;
- ◆ It was important to ensure supervisor involvement in shift briefings and toolbox talks (TBT) and communicating relevant information which allowed personnel to understand the task (step by step) and hazards associated with each step.

- ◆ A clear task outline should be provided so that all personnel involved understand all the steps involved;
- ◆ Instructions should be precise, accurate and free of ambiguity;
- ◆ Any change, no matter how small, should be subject to the MoC process.

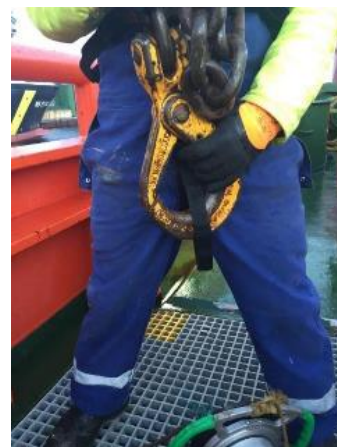
The Marine Safety Forum (MSF) have released [Safety Alert 18-07](#), which shows that during routine operations using a platform crane to transfer a bulk hose between a platform and a platform supply vessel (PSV) a worker got caught in the rigging and was lifted off of the deck by the crane. As the hose landed on the vessel deck, an AB went to release the hook from the lifting sling. While slightly bending forward and down to clear the hook, the crotch strap of his lifejacket formed a larger than normal bight. As the AB released the hook, it was incorrectly placed inside the bight and as he returned to the upright position the hook was caught. Unfortunately, the AB did not notice this, and signalled to the crane operator to 'hoist'. This resulted in the AB being lifted above the deck and out over the side of the vessel. The AB's immediate reaction was to hold onto the pennant wire to keep tension off the crotch strap. The crane driver and second AB quickly became aware of the situation and were able to land the AB safely back on deck. The AB remained suspended for around 11 seconds and was unharmed.

- ◆ The crotch strap on the lifejacket was not suitably tightened on this occasion. A change in body posture created a larger than normal 'bight' which allowed the hook to become attached;
- ◆ The hook and lifting sling landing directly on the deck of the vessel;
- ◆ The AB's posture during the disconnection of hook;
- ◆ A momentary lack of awareness on the actual location of the hook, i.e. left open, close to the body.

- ◆ Hook awareness - ensure hook is clear of the body and any snagging hazards;
- ◆ Buddy check during the TBT before work starts;
- ◆ Raise awareness across the fleet for all lifting operations;

- ◆ Discuss amongst the industry and fleet deck crews on a suitable “pause point” before giving signal to crane operator.

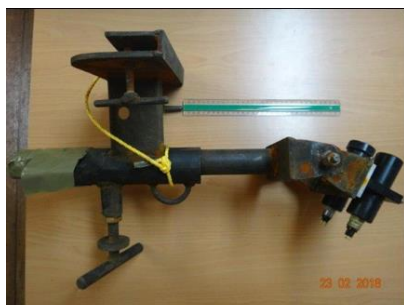
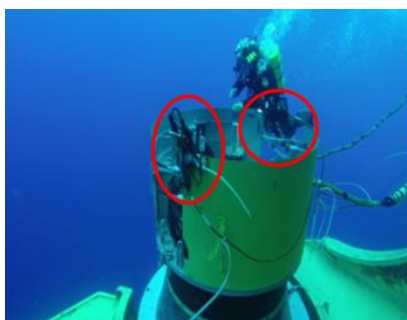
1. Subsea lights fixed to steel support

An investigation discovered that the lamps were temporarily fixed to the TBM by the diving team, and should have been removed after they had finished their task in accordance with their post installation dive tasks. All other subsea lamps used during the task had been removed.

- ◆ Not all subsea lamps were recovered as per post-installation dive tasks;
- ◆ The missing subsea lamps were not identified immediately;
- ◆ The company was unaware of the missing subsea lamps; there was no notification given by the subcontractor;
- ◆ There was no awareness of the possibility of loose equipment being left behind, causing a dropped object threat to the company lifting crew.

- ◆ Ensure that subcontractor personnel are properly reminded of the company procedures for subsea material recovery;
- ◆ Further emphasize to crew the importance of stop work authority and of speaking up when they see an unsafe condition – which in this case was found to be very effective.

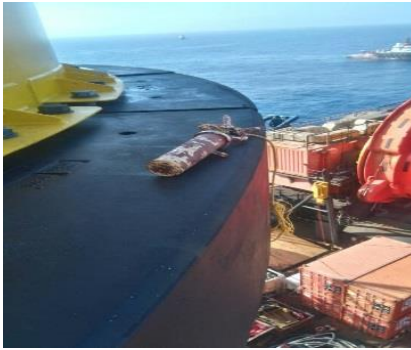
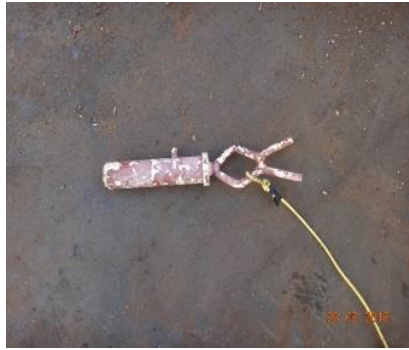
Incident 2 – A wire cable retaining pin was found lying loose on top of the TBM

Investigation discovered that the object was an 'ROV friendly' wire cable-retaining pin. The pin was used to retain a wire in a sheave from which a ball grab was suspended. In order to retrieve the ball grab, an ROV was used to remove the retaining pin. After removal of the pin, the ROV was to let go of the pin, which would then stay suspended under water hanging from a rope. As this pin was not lashed properly, it became loose and landed on top of the upper bumper.

- ◆ Inadequate lashing using inappropriate rope made it possible for the pin to drop;
- ◆ The importance of proper lashing was not acknowledged by the divers or the dive supervisor.

- ◆ This incident would be circulated as a lesson learned.

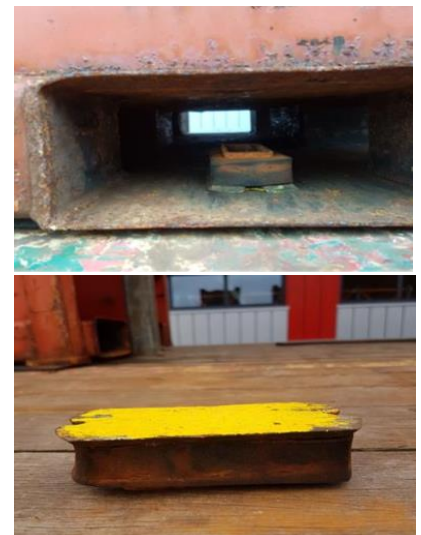
Vessel crew found a twist lock pocket cover missing from the aft main deck. The cover had washed out during heavy weather in transit. The vessel was later informed that the cover had been found in the pocket of a five-foot container which had been offloaded ashore. This would have constituted a serious high potential dropped object scenario to the crew, shore side workers and the general public.

An investigation discovered that the rubber which keeps these deck covers in place was in poor condition. This enabled them to become loose and be washed out. Some additional observations were made and listed as contributing to this incident:

- ◆ Inadequate inspection;
- ◆ Inadequate maintenance;
- ◆ Adverse weather and sea conditions.

- ◆ A temporary deck cover was made to remove the tripping hazards created by the missing cover. New covers were ordered and delivered on board;
- ◆ Regular checks on the condition of the covers were to be made; this was to be added on the planned maintenance system (PMS);

- ◆ After heavy weather, visually check the deck to see if anything is missing.

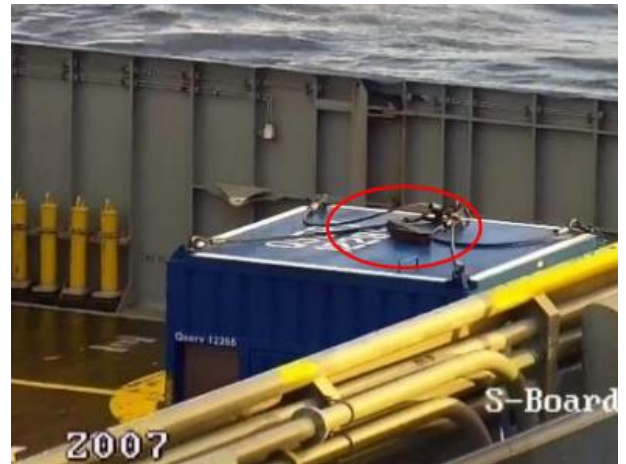
The crew on a platform noticed an object on top of a container onboard the supply vessel. The object was later found to be a large piece of wood weighing 1kg, with a possible fall height of 15–30 meters during lifting operations; there was the potential for a fatality. The origin of the wood was not known. CCTV images were captured of the container arriving at port and before being lifted onto the vessel; the wood was not seen on top of the container at either of these points. Therefore, the wood appeared on top of the container at some point between being loaded onto the boat and arriving at the offshore installation.

- ◆ The vessel Master was contacted, who arranged for the object to be removed;
- ◆ No preventative actions were taken – it was a great spot by the deck crew;
- ◆ This potential dropped object demonstrates the importance of pre-lift checks and good observation at all stages in the supply chain.
