1 Dropped Object Risk

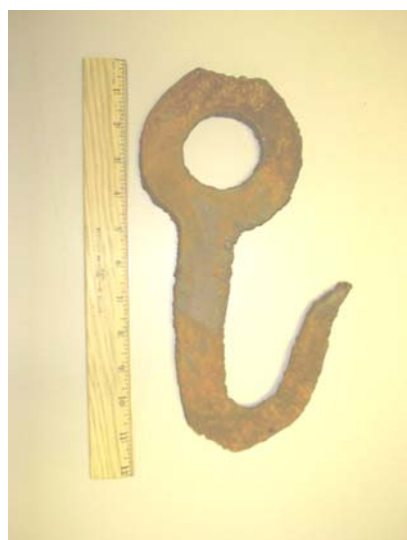
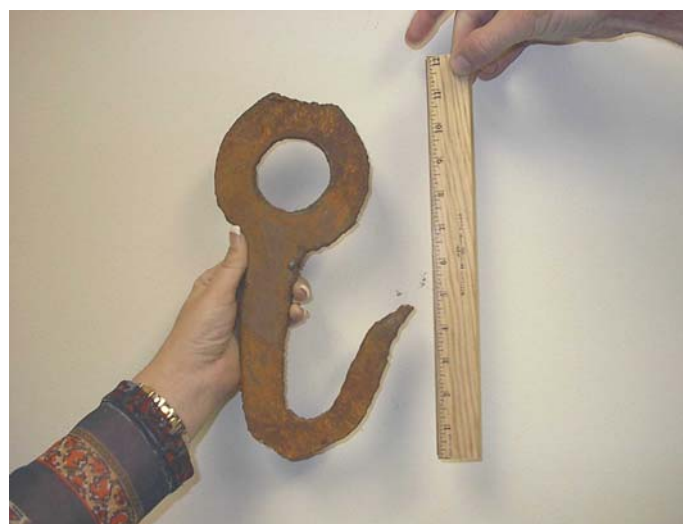
A member has reported finding the 'job-made' lifting hook shown below, rough cut from half inch steel plate, during a routine safety check at a vendor's shipyard. The lifting hook was lying near a pad eye on a lifting frame for a piece of equipment about the size of an office desk and estimated to weigh 500-750kg. The company concerned confiscated the hook and intend using it for safety training of new staff, as an example of unsafe practice.

- ◆ Use only certified lifting gear in good condition;
- ◆ Routine inspections of all lifting gear, such as wire rope slings, nylon slings, shackles, hooks, etc. for good condition and proper certification is a necessary practice;
- ◆ All lifting frames for equipment should be fitted with properly certified and suitably rated lifting gear when put in service by the rigging supervisor.
