## IMCA Safety Flash 12/08

July 2008

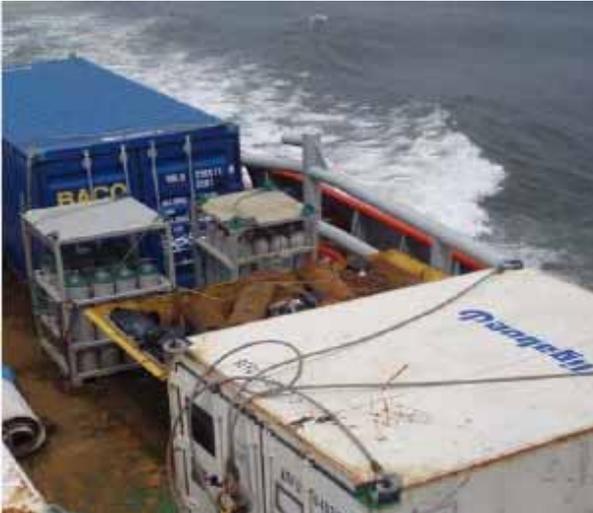
Owing to the sea swell, when the gas cylinder rack was lifted, it moved suddenly towards an adjacent waste skip and the crew member trapped his right hand between the gas rack and the waste skip causing a serious injury to the hand. The crew member received first aid treatment and was later medevaced to shore for surgical treatment.

*Deck layout on third-party vessel at time of incident*

- ◆ Poor sea conditions (sea state approximately 2m);
- ◆ Congested deck owing to small size of vessel on which incident occurred.

- ◆ Crews on third-party supply vessels to be provided with appropriate instruction on proper lifting and handling working practice;
- ◆ Ensure all personnel are aware that they can stop the job when unsafe acts or conditions are observed on third-party vessels;
- ◆ Ensure proper selection of type/size of vessel for cargo operations;
- ◆ Ensure better planning onshore and better organisation of deck space to minimise pinch points;
- ◆ Ensure crew are fully aware of the danger of pinch points;
- ◆ Ensure good communication between contractor vessel and third-party attending vessels during at-sea loading and unloading operations.

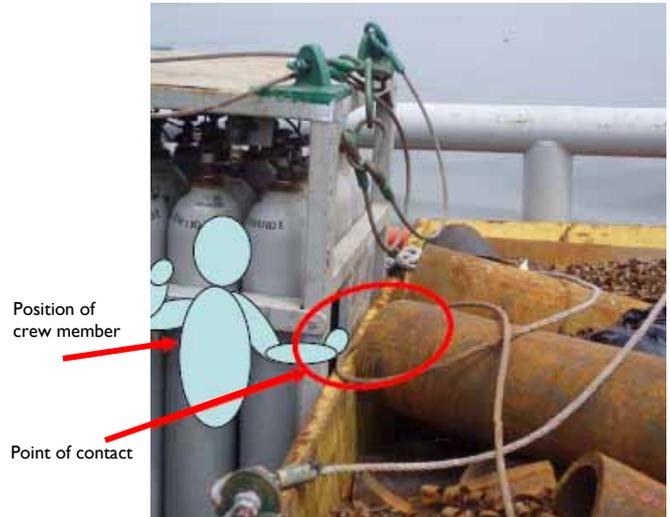
*Position of crew member at time of incident*

- ◆ The crew member was not warned by his colleagues that he was in an unsafe situation;
- ◆ The crew member was in an improper or unsafe position for the task and did not follow established lifting procedures;
- ◆ There was a lack of experience in cargo operations.
