## IMCA Safety Flash 12/09

August 2009

### I Pillar Valve Failure

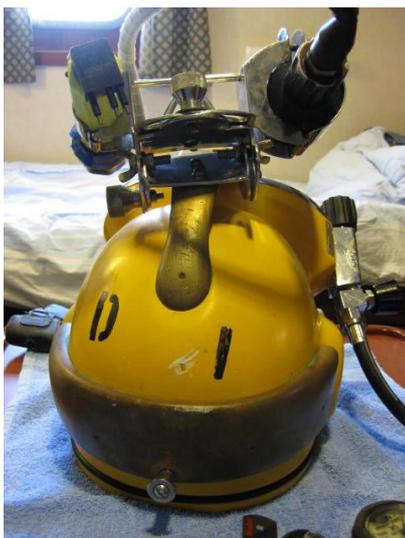
A member has reported an incident in which a pillar valve from an emergency gas cylinder separated from the bottle while under pressure, rapidly releasing 50 cu ft of air to atmosphere and hitting a diver's helmet. A trial run dive was planned in an anchorage prior to mobilisation to a job site. Dive checks were carried out as per standard procedures and the diver was cleared to enter the dive basket, ready for the water. As the diver turned upon entering the basket a loud bang was heard and there followed an escape of gas. The diver collapsed to the stage grating and suffered multiple contusions and a dental insult. He was evacuated to shore for further evaluation and treatment but made a full recovery.

*Diver's hat with the indentation where valve hit the hat*

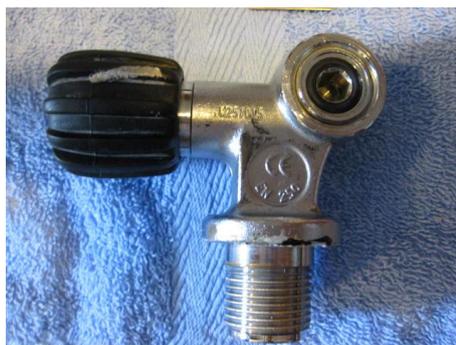
It was discovered subsequently that the bottles had been sent by a subcontractor to a third party for hydrostatic testing. On their return the bottles were delivered to the dive support vessel. The bottles had been charged to full working pressure of 2800 psi and had held pressure for several days prior to the incident. Investigation revealed that the cylinder (Luxfur S50 brand) had an imperial thread and the pillar valve (MDE 232 bar) which failed had a metric thread. It is considered that the most likely cause of the incident is that the valves were mixed up at the third party testing agency after the hydrostatic test.

*Pillar valve with metric threads*

- ◆ Subcontractor to initiate further investigation and auditing of the receiving, testing and dispatching process at the third party testing agency;
- ◆ Remove from circulation the cylinders from the recent hydrostatic test; test and condemn failed or damaged equipment;
- ◆ Ensure all cylinders and pillar valves held and in use at company sites are of the approved thread combination;
- ◆ Review acceptance criteria for third party hired equipment to ensure quality remains of the highest standard.

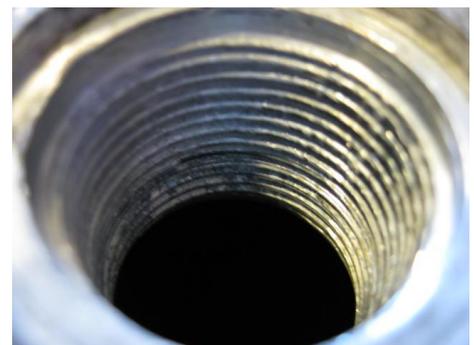
*Imperial threads on the bottle*

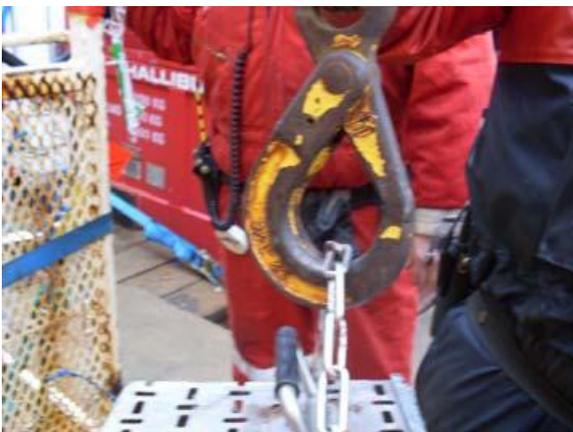
The incident was immediately reported to the offshore construction manager, who temporarily suspended operations. Initial inspection of the toolbox, the deployment pennant and hook onboard the vessel rigger did not identify any defects. However, the toolbox had been deployed by attaching it to the crane pennant hook by a section of long link chain bolted to the toolbox.

Investigation revealed that the small diameter long link chain had passed through the wear gap in the hook when the toolbox was transiting through the splash zone, allowing the toolbox to drop. The hook was certified and the wear was within design and wear specification limits.

*Toolbox, chain and crane pennant hook*

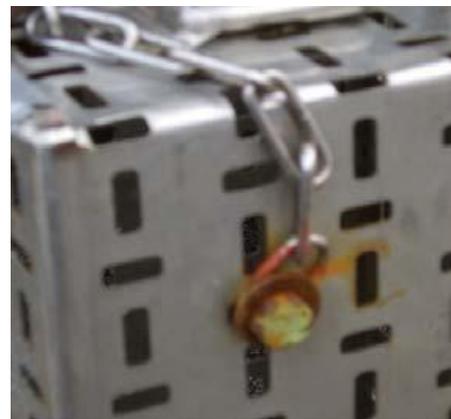
*Detail of small diameter chain used*

- ◆ The type of long link chain being used was unsuitable for deployment;
- ◆ Laying the chain over the throat of a hook was improper rigging practice;
- ◆ Neither the requirements of an existing risk assessment nor company control processes were complied with;

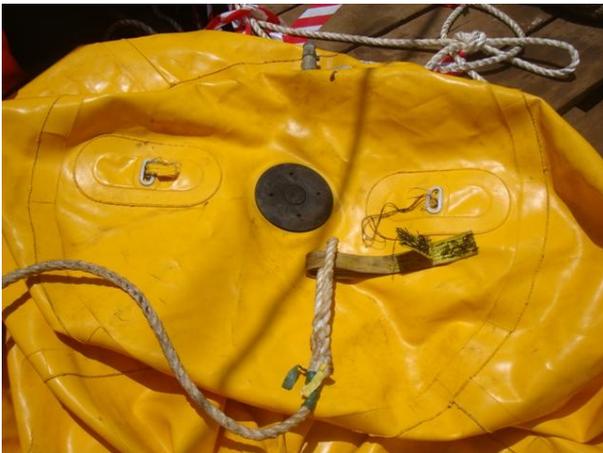
Further inspection revealed that the webbing strops of the bag had been cut through when the strip-out wire was pulled at an acute angle across the plane of the pipe relative to the bag. It was also discovered that the inversion line had pulled the attachment points away from the crown of the bag. These strops remained secured to the inverter line which in turn remained attached to the pipeline. It was further determined that the strops at the top of the bags used for attaching the inversion lines were intended for handling purposes only and were not designed as inversion line attachment points.

*Incorrect attachment of inversion line to handling strops*

- ◆ When feasible remove lift bags in advance of potentially conflicting tasks;
- ◆ Re-circulate existing safety recommendations, including IMCA safety flash [07/07](#);
- ◆ Check identification and marking of dedicated inversion point attachments and lift bags;
- ◆ Amend work instructions to include a reference to the inclusion of purpose-built and labelled inversion line attachment points for all future rentals/procurement of this equipment;
- ◆ Consider retrofitting inversion attachment points to bags not currently having this feature.

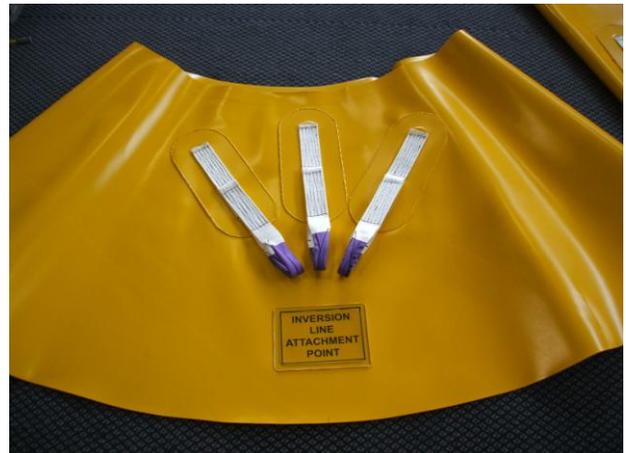
*Sample inversion line attachment points and label*

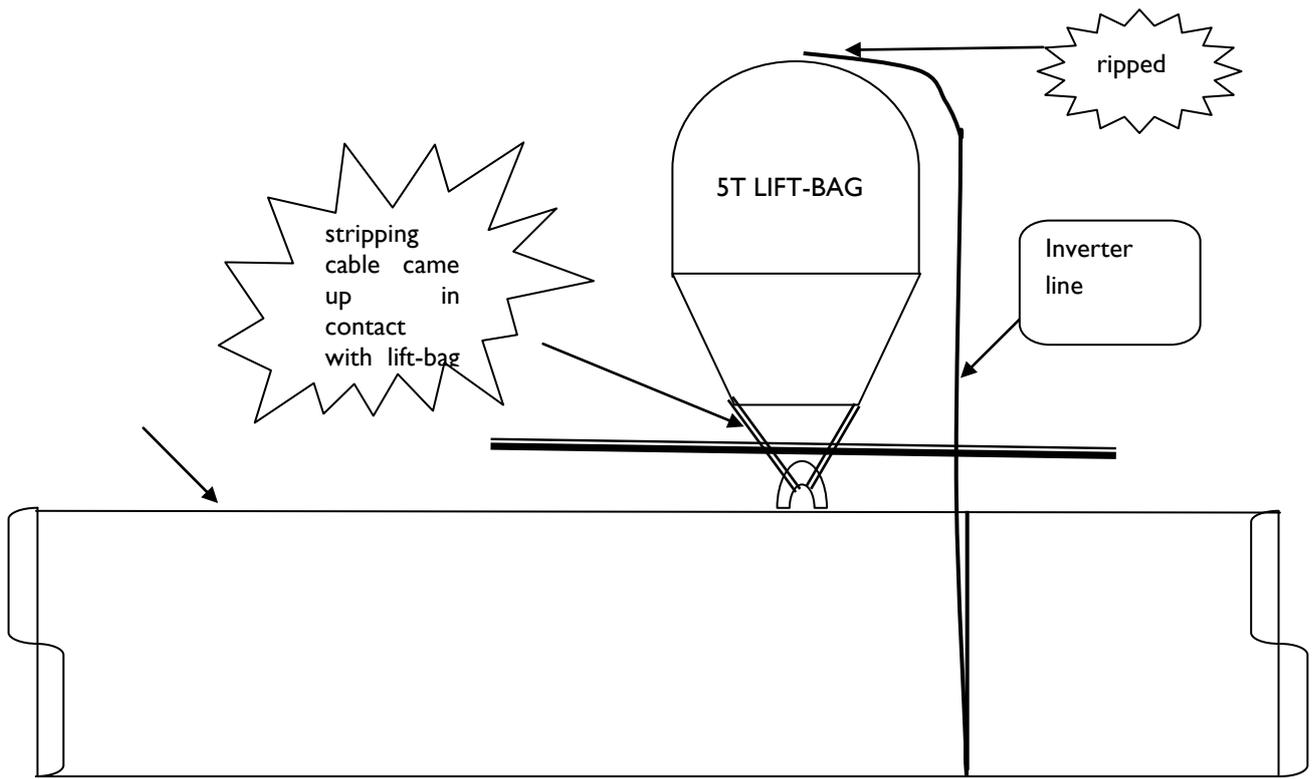
A member has reported an incident in which a lift bag was released to surface upon parting of the rigging attachment point straps. The lift bag was of the open bottomed parachute type. In order to provide additional buoyancy to a pipeline, two five-ton lift bags were secured to the pipe in between pre-installed foam buoys. The buoys were secured by the traditional method of steel straps and bandit clamps. A 'strip-out' wire was in place and was run underneath the straps along the length of the pipe to assist removal of the foam buoys once the pipe was in position. The lift bags were rigged and secured to the pipe with appropriately selected and certified rigging. It was determined that the additional ten tons of lift was not sufficient force to cause a loss of control of the pipe. The inverter line was secured to the pipeline and 'snugged-up' to avoid a snatch load in the event of failure or an unplanned release of the rigging. Later, upon up-hauling of the strip-out wire to remove the buoys, one of the two bags was found to have parted and was floating on the surface.

*Schematic diagram of pipeline and lift bags illustrating incident*
